Appendix A

LOCATION NAME: METRA UP-N RECONSTRUCTION
KENOSHA SUBDIVISION

TITLE: PROJECT LIMITS

Shift Track Alignment & Replace Retaining Walls and 11 Bridges, UP North Line
Between Bridge Milepost 3.27 (North of Deering) and Milepost 5.22 (Grace Street Bridge)
METRA-4840
SHPO Log #026081921

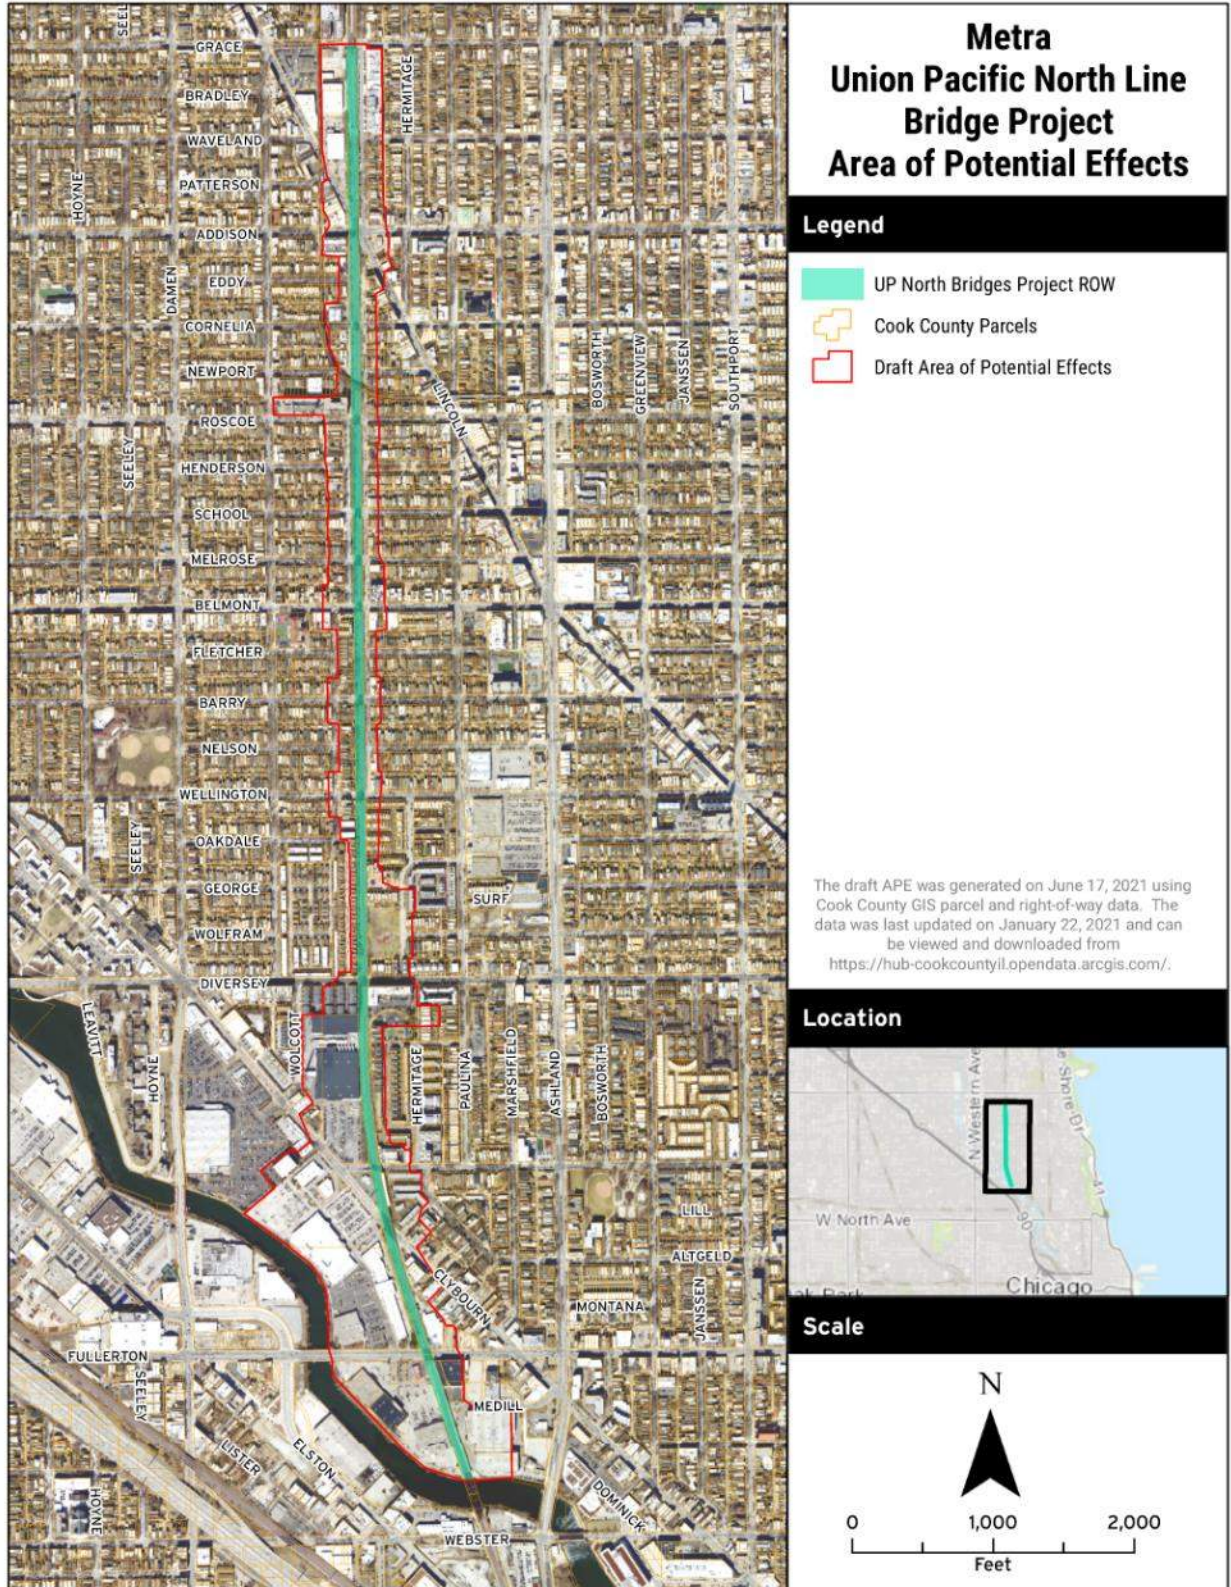
Figure 1: Union Pacific North Line Bridge Project Area of Potential Effects

The APE for this project considers the location of the proposed Project as well as the potential for visual, noise or vibrational changes that could impact historic or cultural resources. The APE is based on site visits, reviews of aerial maps, and preliminary engineering details. **Figure 1** provides a map of the proposed Project and APE boundaries

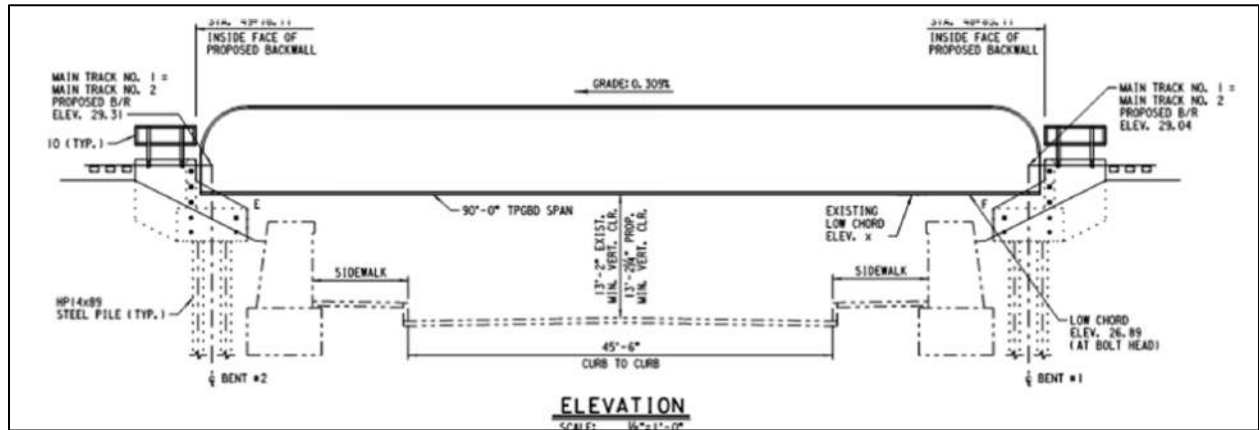
Existing limestone abutments would be maintained at eight (8) of the 11 bridges by repurposing the abutments as retaining walls and constructing new abutments behind them. The new abutments would support the bridge superstructure (**Figure 2-1**). Abutments at the Clybourn Avenue and Fullerton Avenue bridges would need to be replaced in the same location with concrete abutments because of the limited right-of-way, abutment skew, and required phased construction. These conditions are also present at the Wrightwood Avenue bridge; subsequent final design will determine if the abutment can be preserved at this location.

Figure 2-1: Elevation Drawing for Maintaining Existing Limestone Abutments as Retaining Walls While Constructing New Abutments

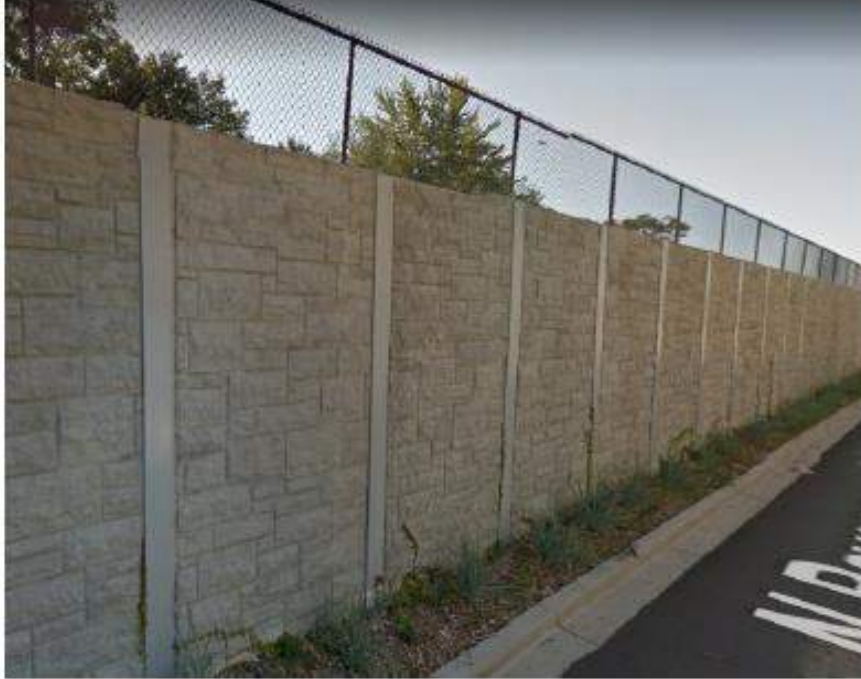
final design for the Project. The current design for the retaining walls includes soldier piles and pre-cast panels; however, the retaining wall type would be determined during final design. The retaining walls would look similar to those previously installed as part of the UP North Grace to Balmoral Project (**Figure 2-2**).

Figure 2-2: A Soldier Pile Retaining Wall Constructed for the Previous Grace to Balmoral Project

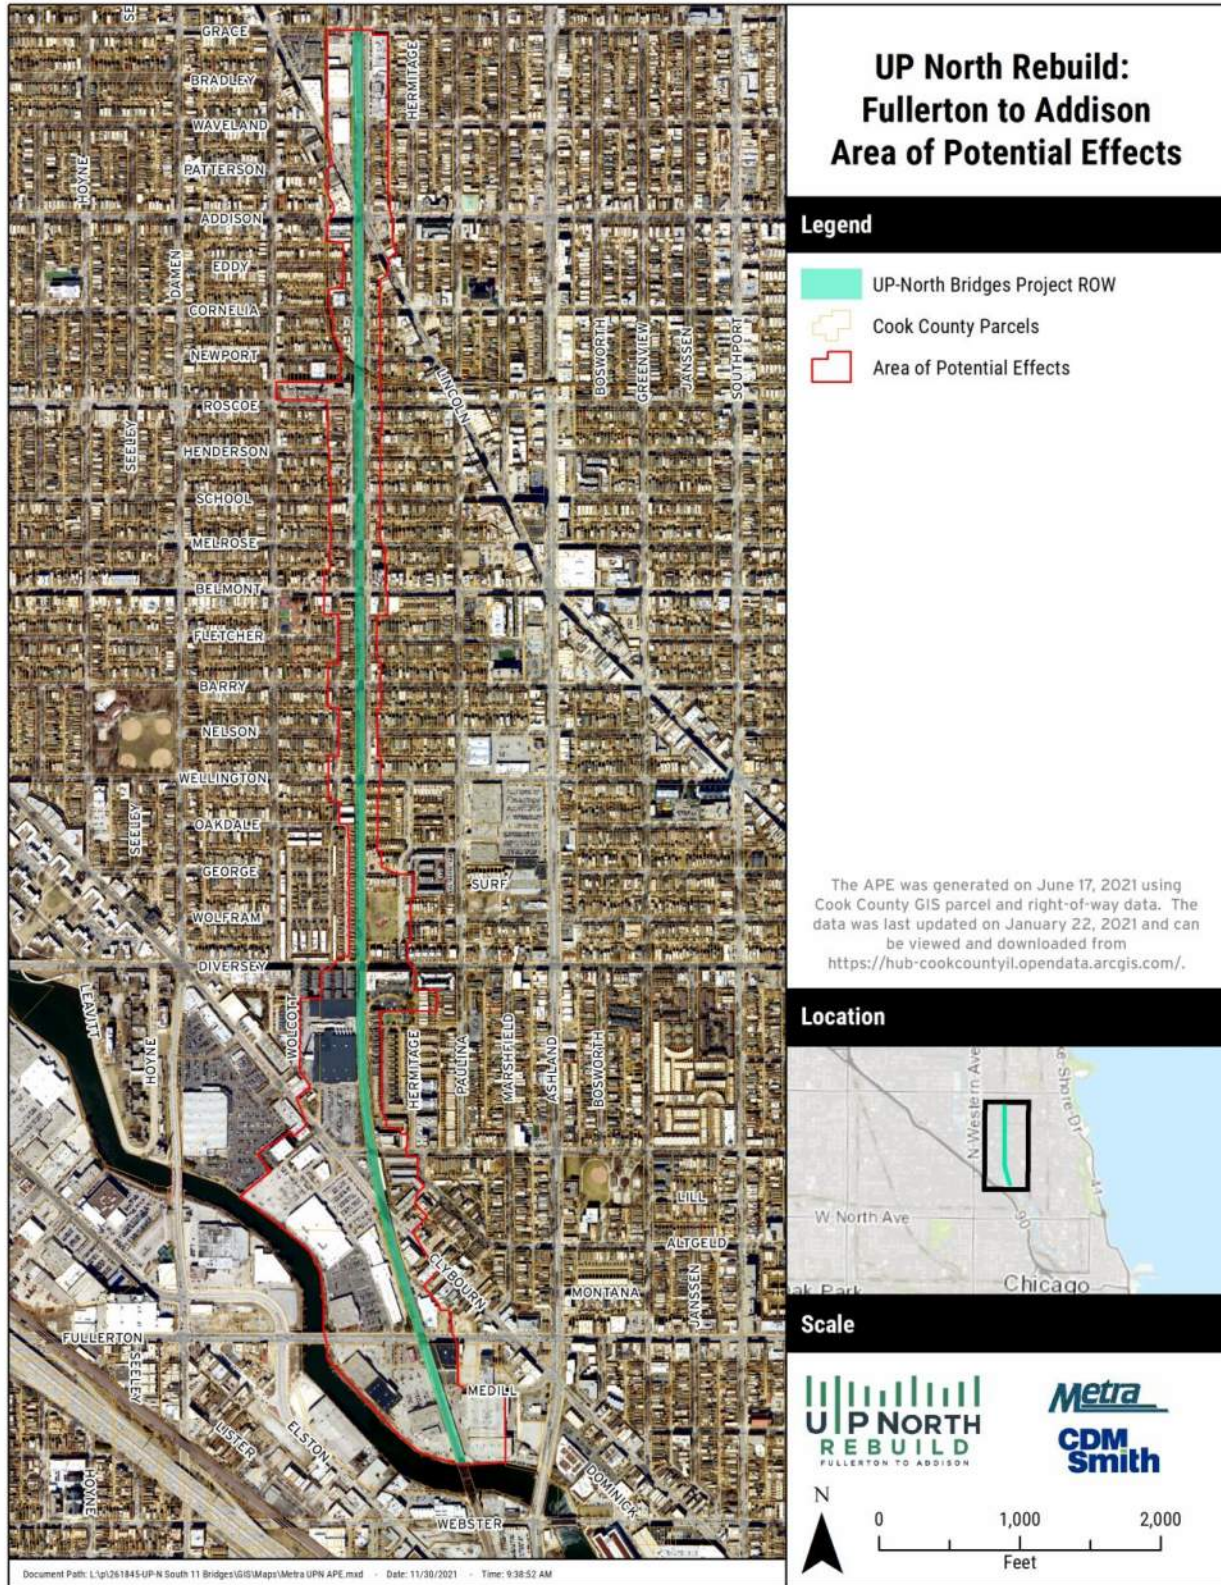
Figure 2-3: Area of Potential Effects

The APE for this Project considers the location of the proposed Project as well as the potential for visual, noise, or vibrational changes that could impact historic or cultural resources. The APE was determined based on site visits, reviews of aerial maps, and preliminary engineering details. **Figure 2-3** provides a map of the Project and APE boundaries. Detailed maps and APE boundaries are provided in **Appendix A**.

The project area is heavily urbanized, and the Project is located primarily in the existing railroad right-of-way. Boundaries for the APE are based on the area that could be potentially impacted by construction and the scale of the new construction, taking into consideration visual obstructions such as buildings and trees that may block views of the proposed improvements. The APE was developed using Cook County parcel data and generally follows the parcel boundaries. All parcels adjacent to the Project footprint or across a public right-of-way were included. At cross streets or where the Project is bounded by parking lots or open space, additional parcels and buildings were included to address potential visual effects. The additional parcels were selected to include buildings where the railroad corridor is partially visible when viewing the front facade of the building.

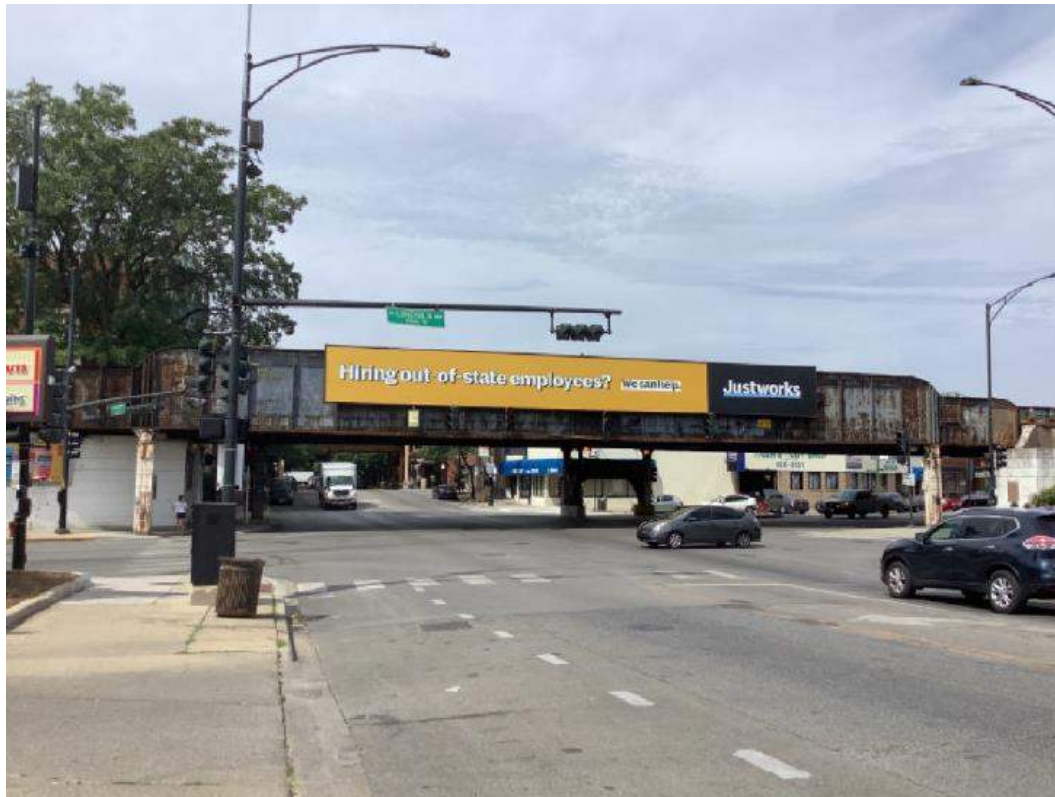
Figure 3-7: Lincoln Avenue/Addison Street Bridge

implemented until 1959 after Mayor Daley began promoting the project. The Lincoln Avenue/Addison Street Bridge is depicted in **Figure 3-7**.

Although important to freeing up circulation at the intersection, the bridge is not eligible under Criterion A because this association does not significantly contribute to the broad patterns of Chicago’s history. Likewise, under Criterion B for association with a person of significance, this bridge is associated with Mayor Daley’s contributions to the City of Chicago, but this association is not representative of his life’s work or his legacy that includes larger-scale urban redevelopment projects. The simple utilitarian bridge design does not represent the work of a master and does not offer distinctive characteristics for the type, period, or method of construction. Steel through girder bridges were a common bridge type for the period. Therefore, this bridge is recommended not eligible under Criterion C.

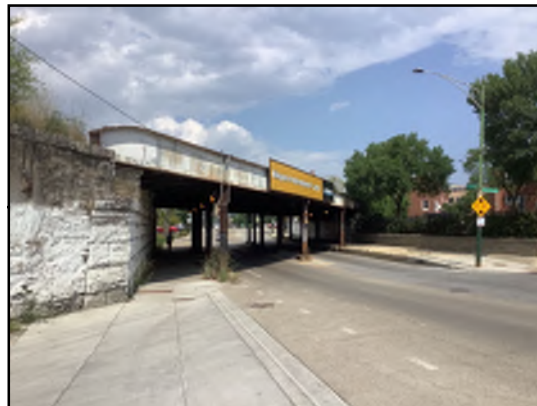
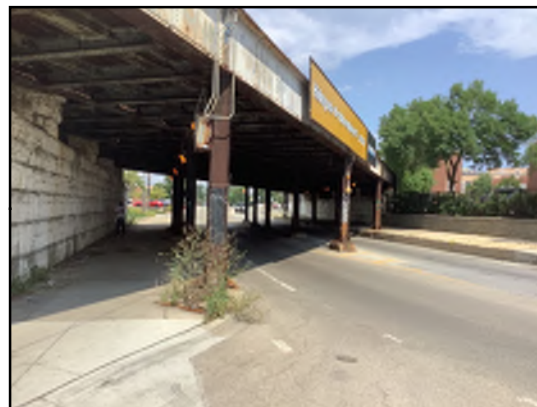
Eligibility Assessment Notes: This bridge is utilitarian in design. Steel through-girder bridges were a common bridge type for the period. Comprised of 4 parallel built-up rivetted plate steel and angles, the bridges members span across the subway created between the abutments to separate vehicular and railroad traffic. This bridge does not possess any distinguishing history or architectural features to qualify it as individually eligible for National Register listing. Visual inspection indicates poor condition with corrosion and deterioration of material.

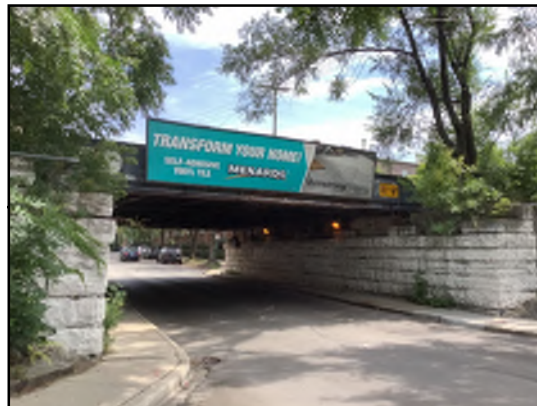
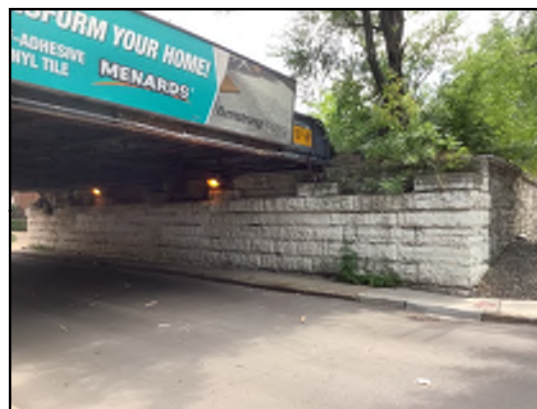
Eligibility Assessment Notes: This bridge is utilitarian in design. Steel through-girder bridges were a common bridge type for the period. Comprised of 4 parallel built-up rivetted plate steel and angles, the bridges members span across the subway created between the abutments to separate vehicular and railroad traffic. This bridge does not possess any distinguishing history or architectural features to qualify it as individually eligible for National Register listing. Visual inspection indicates poor condition with corrosion and deterioration of material.

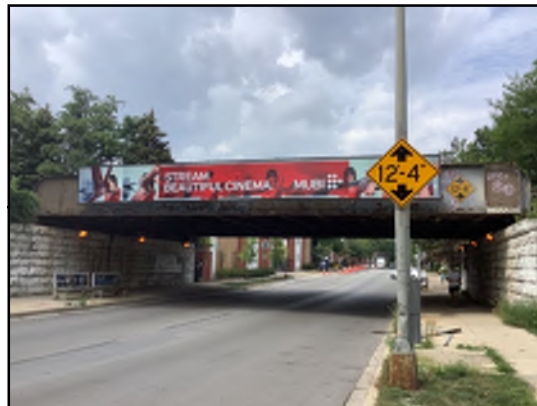
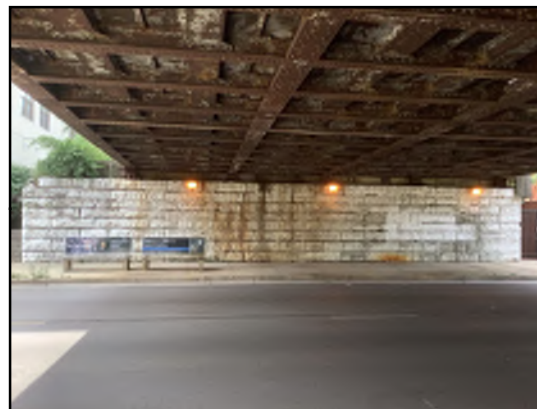
Eligibility Assessment Notes: This bridge is utilitarian in design. Steel through-girder bridges were a common bridge type for the period. Comprised of 4 parallel built-up rivetted plate steel and angles, the bridges members span across the subway created between the abutments to separate vehicular and railroad traffic. This bridge does not possess any distinguishing history or architectural features to qualify it as individually eligible for National Register listing. Visual inspection indicates poor condition with corrosion and deterioration of material.

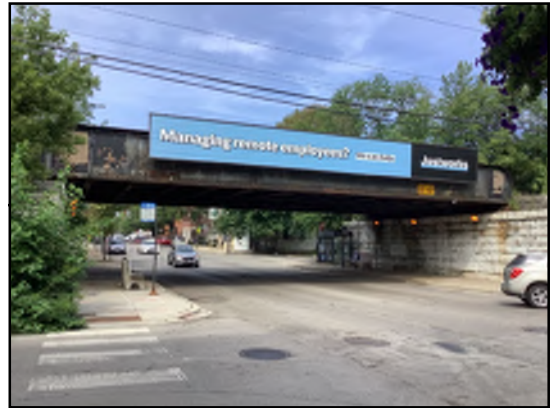
Eligibility Assessment Notes: This bridge is utilitarian in design. Steel through-girder bridges were a common bridge type for the period. Comprised of 4 parallel built-up rivetted plate steel and angles, the bridges members span across the subway created between the abutments to separate vehicular and railroad traffic. This bridge does not possess any distinguishing history or architectural features to qualify it as individually eligible for National Register listing. Visual inspection indicates poor condition with corrosion and deterioration of material.

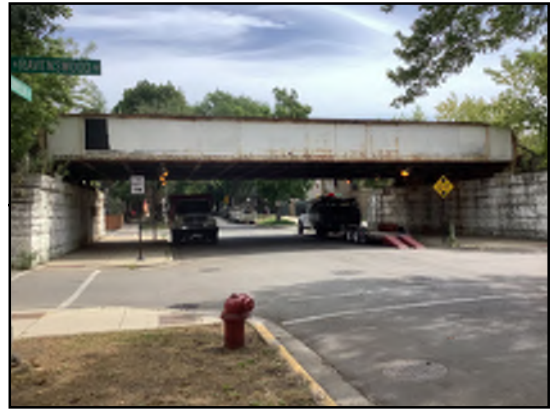
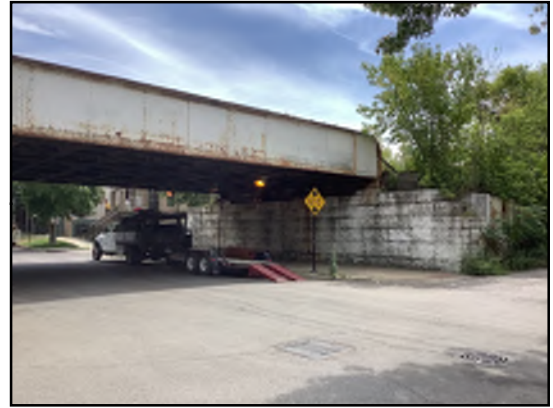
Eligibility Assessment Notes: This bridge is utilitarian in design. Steel through-girder bridges were a common bridge type for the period. Comprised of 4 parallel built-up rivetted plate steel and angles, the bridges members span across the subway created between the abutments to separate vehicular and railroad traffic. This bridge does not possess any distinguishing history or architectural features to qualify it as individually eligible for National Register listing. Visual inspection indicates poor condition with corrosion and deterioration of material.

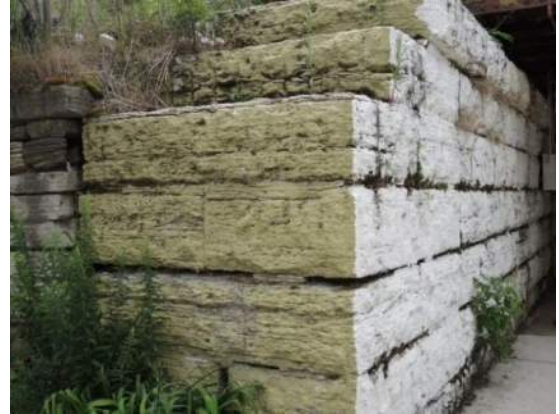
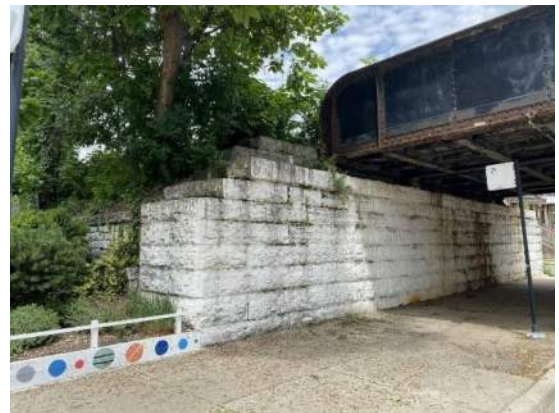
The masonry and concrete abutments within the APE are considered components of the UP North Line. These components are not individually eligible for National Register of Historic Places. The Historic Eligibility and Effects Report provides the determination of eligibility for the UP North Line.

Masonry Abutment
Photo by S. Hands

Masonry Abutment
Photo by E. Stoner

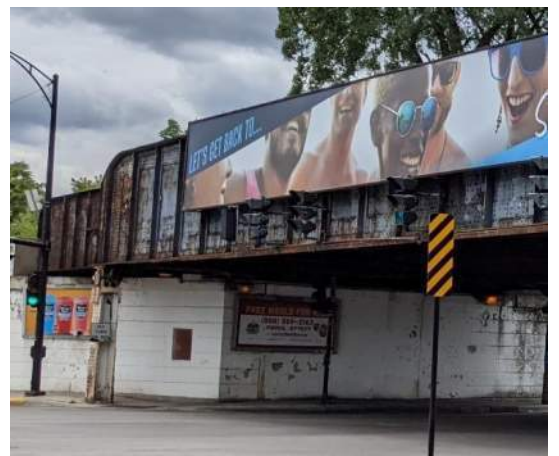
Concrete Abutment Supporting Addison/Lincoln Street Bridge
Photo by S. Hands

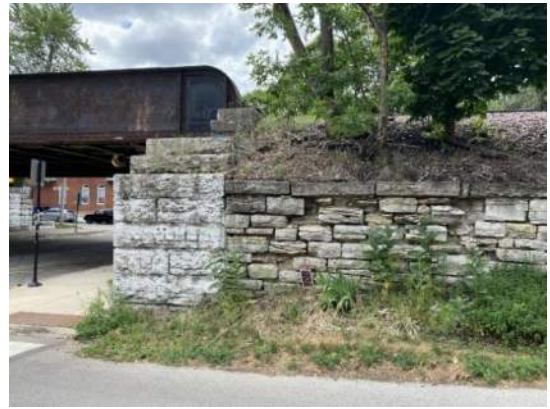
Stone Retaining Wall
Photo by E. Stoner

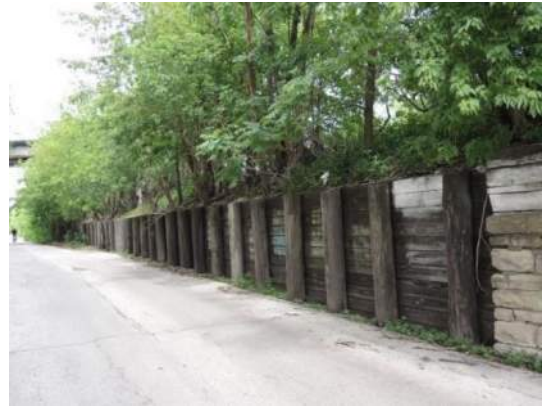
Wood Sheeting
Photo by S. Hands

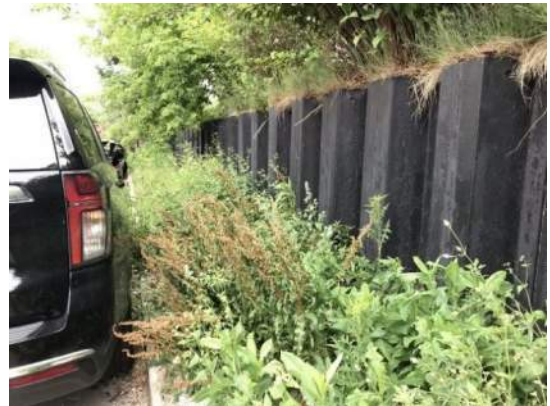
Metal Sheeting
Photo by J. Mengler

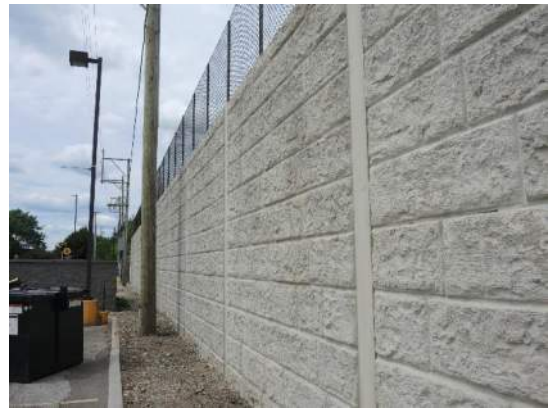
4. Concrete: Retaining walls made of concrete are located along the UP right-of-way, east and west of the existing tracks. These retaining walls are constructed of cast-in-place or precast concrete panels. The concrete retaining walls are newer infill replacement retaining walls that were added when the original retaining walls deteriorated.

Concrete Retaining Wall
Photo by S. Hands

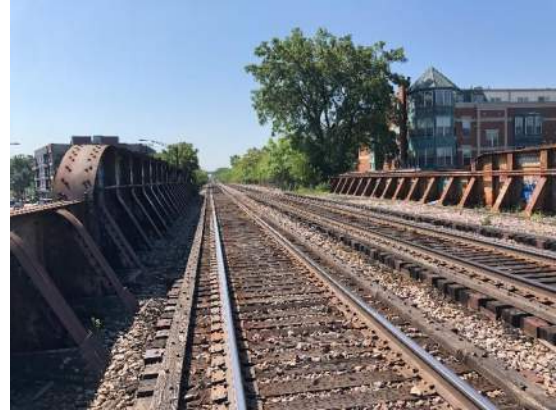
The railroad trackbed is considered a component of the UP North Line. This component is not individually eligible for the NRHP. The Historic Eligibility and Effects Report provides the determination of eligibility for the UP North Line within the APE.

Railroad Trackbed
Photo by K. Walsh

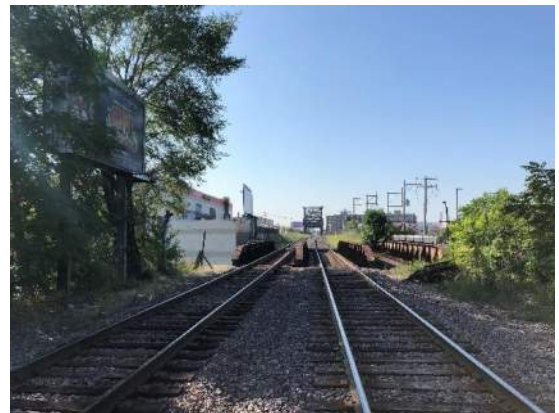
Railroad Trackbed
Photo by K. Walsh

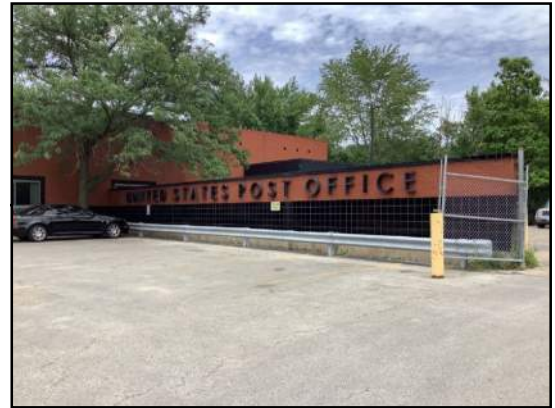
Front façade

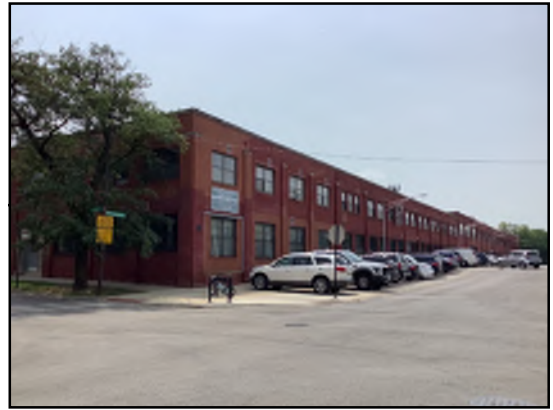
Front façade

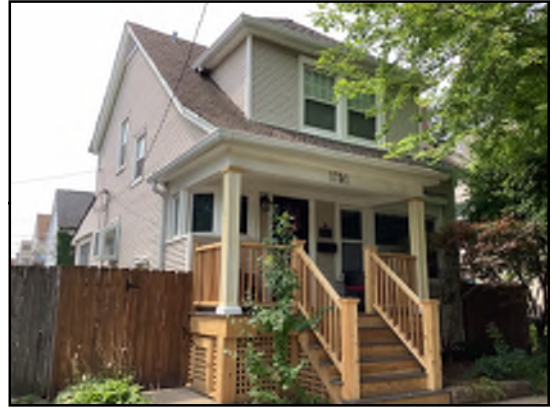
Side view

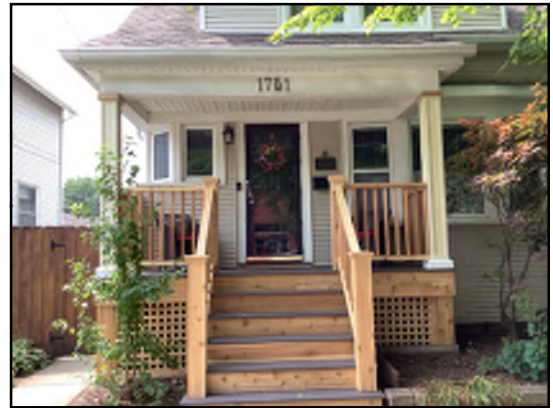
Front façade

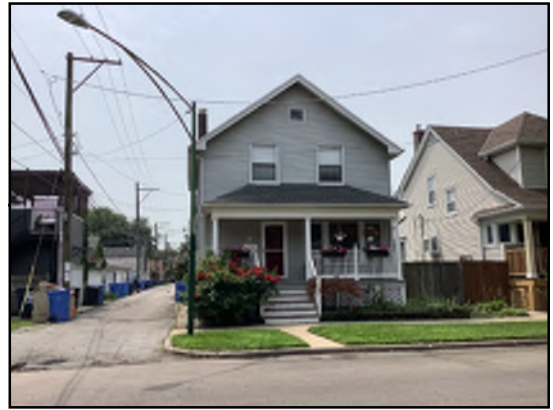
Front façade

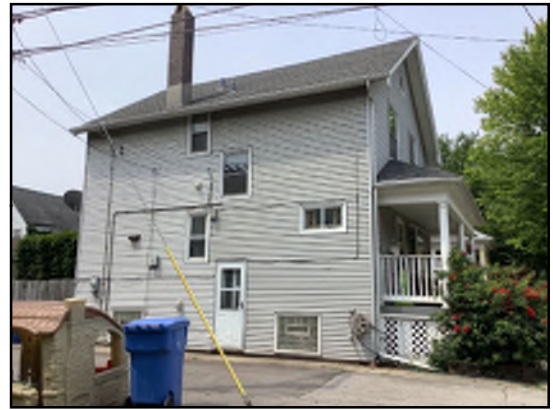
Side view

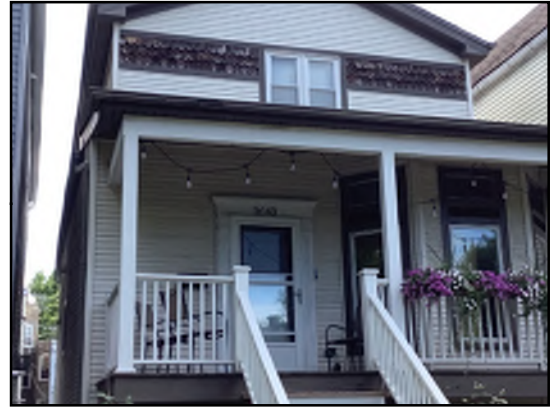
Architectural detail

Integrity: Fair Condition: Good
 Notes

Found. Mat. Not Visible
 Wall Mat. Vinyl Siding, Wood Shingle
 Window Type Double-hung, Bay, Fixed, Awning/Hopper
 Window Mat. Vinyl/Fiberglass
 Door Mat. Wood, Glass, Vinyl/Fiberglass
 Roof Type Front Gable
 Roof Features None Visible
 Roof Material Asphalt Shingles
 Outbuildings Garage
 Additions Front
 Features Open Porch

Eligibility Assessment Notes: Modifications to this resource have compromised the integrity necessary to convey its significance. The historic qualities of design, materials, workmanship, and feeling have been diminished by the alterations. This building does not possess sufficient distinguishing architectural characteristics to qualify as individually eligible for listing on the National Register. Character defining features include classical style wooden entryway and wooden shingles belt course. The building has been re-sided and the windows have been replaced. The front porch has been altered.

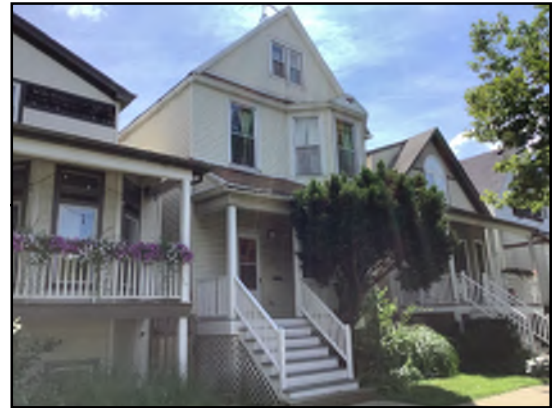
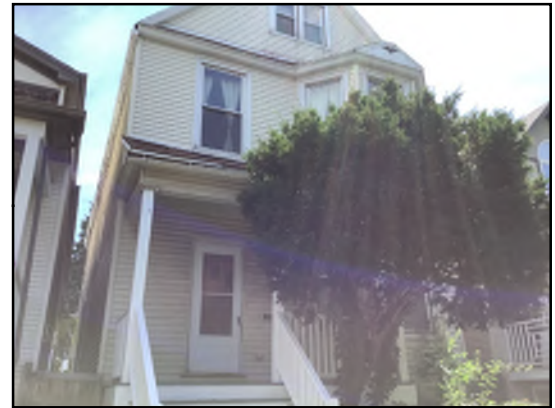
Front façade

Architectural detail

Integrity: Fair Condition: Fair
 Notes

Found. Mat. Not Visible
 Wall Mat. Vinyl Siding
 Window Type Double-hung, Bay
 Window Mat. Vinyl/Fiberglass
 Door Mat. Glass, Vinyl/Fiberglass
 Roof Type Front Gable
 Roof Features Chimney
 Roof Material Asphalt Shingles
 Outbuildings None
 Additions None
 Features Open Porch

Eligibility Assessment Notes: Modifications to this resource have compromised the integrity necessary to convey its significance. The historic qualities of design, materials, workmanship, and feeling have been diminished by the alterations. This building does not possess sufficient distinguishing architectural characteristics to qualify as individually eligible for listing on the National Register. All the character defining details have been removed excluding the architectural detail on the roof of the bay. The building has been re-sided and the windows have been replaced.

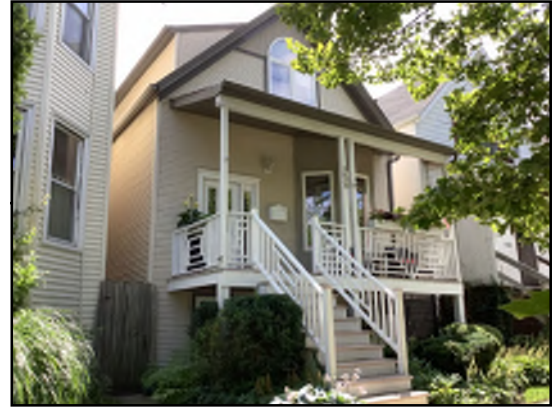
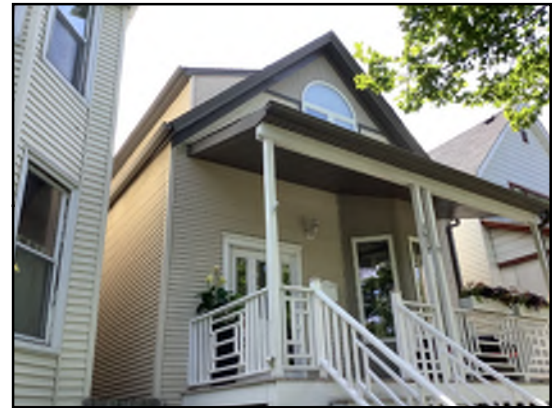
Integrity: Poor Condition: Excellent
 Notes

Found. Mat. Not Visible
 Wall Mat. Vinyl Siding
 Window Type Double-hung, Casement
 Window Mat. Vinyl/Fiberglass
 Door Mat. Wood, Glass
 Roof Type Front Gable
 Roof Features Dormer
 Roof Material Asphalt Shingles
 Outbuildings Garage
 Additions Front, Pop-up
 Features Open Porch

Front façade

Side view

Eligibility Assessment Notes: Modifications to this resource have compromised the integrity necessary to convey its significance. The historic qualities of design, materials, workmanship, and feeling have been diminished by the alterations. This building does not possess sufficient distinguishing architectural characteristics to qualify as individually eligible for listing on the National Register. All the character defining details have been removed. The building has been re-sided and the windows have been replaced.

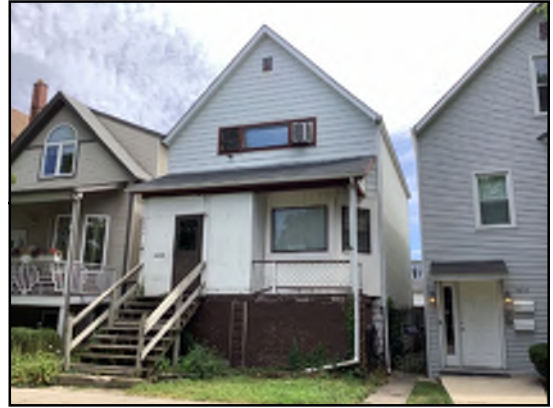
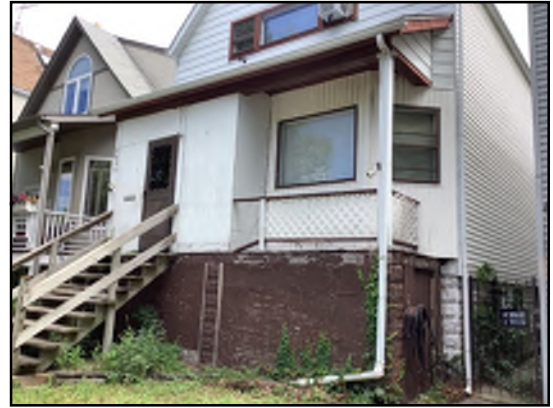
Front façade

Architectural detail

Integrity: Poor Condition: Fair
 Notes

Found. Mat. Concrete Block
 Wall Mat. Vinyl Siding, Wood Siding
 Window Type Double-hung, Bay, Fixed, Ribbon
 Window Mat. Vinyl/Fiberglass
 Door Mat. Vinyl/Fiberglass
 Roof Type Front Gable
 Roof Features Chimney, Dormer
 Roof Material Asphalt Shingles
 Outbuildings Garage
 Additions Front, Pop-up
 Features Enclosed Porch

Eligibility Assessment Notes: Modifications to this resource have compromised the integrity necessary to convey its significance. The historic qualities of design, materials, workmanship, and feeling have been diminished by the alterations. This building does not possess sufficient distinguishing architectural characteristics to qualify as individually eligible for listing on the National Register. All the character defining details have been removed. The building has been re-sided and the windows have been replaced. Front facade window configuration altered and the porch has been enclosed. The basement is enclosed with wooden planks.

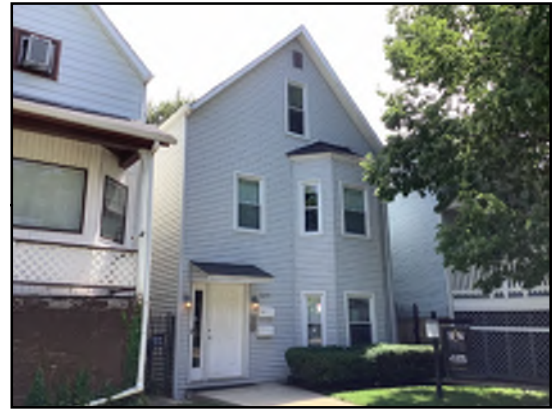
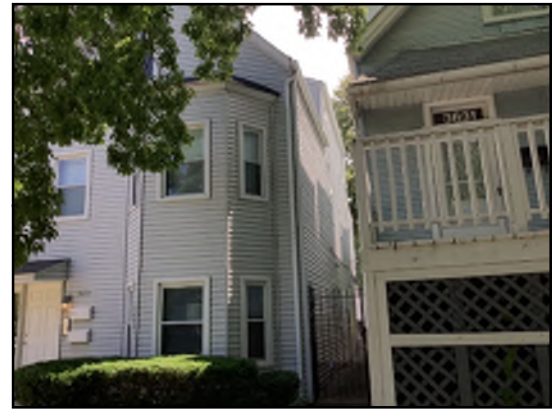
Integrity: Poor Condition: Good
 Notes
 Arch. Style Victorian-era
 Found. Mat. Not Visible
 Wall Mat. Vinyl Siding
 Window Type Double-hung, Bay
 Window Mat. Vinyl/Fiberglass
 Door Mat. Vinyl/Fiberglass
 Roof Type Front Gable
 Roof Features Chimney, Dormer, Skylights
 Roof Material Asphalt Shingles
 Outbuildings Garage
 Additions Pop-up
 Features None

Front façade

Side view

Eligibility Assessment Notes: Modifications to this resource have compromised the integrity necessary to convey its significance. The historic qualities of design, materials, workmanship, and feeling have been diminished by the alterations. This building does not possess sufficient distinguishing architectural characteristics to qualify as individually eligible for listing on the National Register. All the character defining details have been removed. The building has been re-sided and the windows have been replaced.

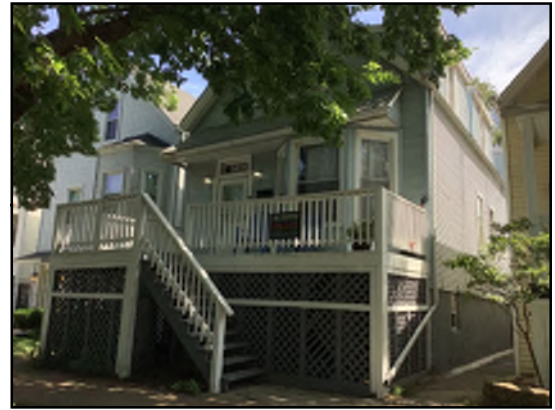
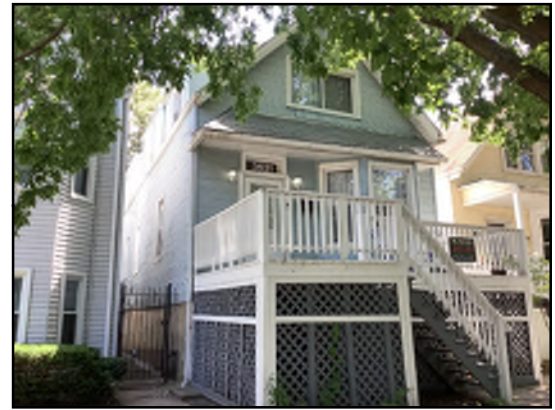
Integrity: Fair Condition: Fair
 Notes

Found. Mat. Concrete
 Wall Mat. Vinyl Siding, Concrete
 Window Type Double-hung, Sliding
 Window Mat. Vinyl/Fiberglass
 Door Mat. Wood, Glass, Vinyl/Fiberglass
 Roof Type Front Gable
 Roof Features Dormer
 Roof Material Asphalt Shingles
 Outbuildings None
 Additions Pop-up
 Features Open Porch

Front façade

Eligibility Assessment Notes: Modifications to this resource have compromised the integrity necessary to convey its significance. The historic qualities of design, materials, workmanship, and feeling have been diminished by the alterations. This building does not possess sufficient distinguishing architectural characteristics to qualify as individually eligible for listing on the National Register. All the character defining details have been removed. The building has been re-sided and the windows have been replaced.

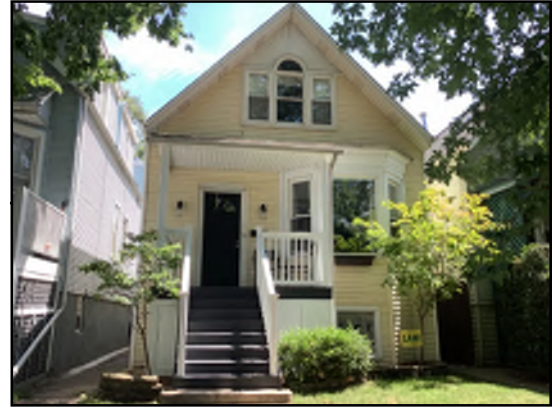
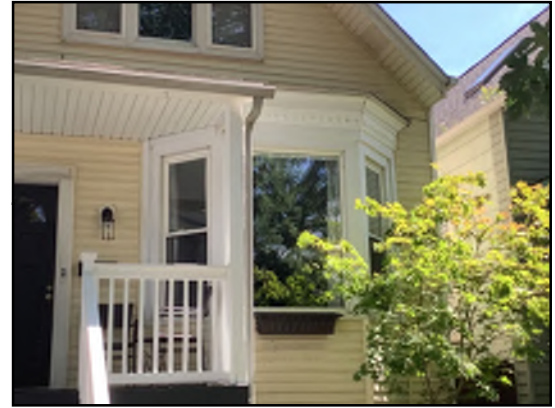
Front façade

Architectural detail

Integrity: Good Condition: Good
 Notes

Found. Mat. Not Visible
 Wall Mat. Vinyl Siding
 Window Type Single-hung, Bay, Fixed, Glass Block
 Window Mat. Vinyl/Fiberglass
 Door Mat. Vinyl/Fiberglass
 Roof Type Front Gable
 Roof Features Chimney
 Roof Material Asphalt Shingles
 Outbuildings Garage
 Additions None
 Features Open Porch

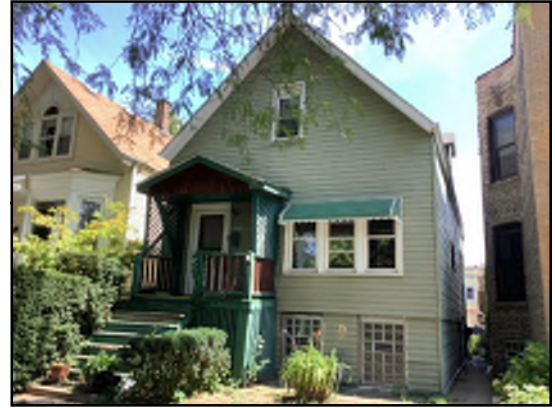
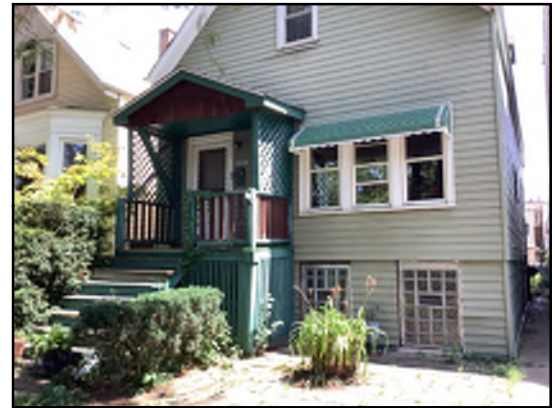
Integrity: Fair Condition: Fair
 Notes

Found. Mat. Not Visible
 Wall Mat. Vinyl Siding, Asphalt Shingle
 Window Type Double-hung, Glass Block
 Window Mat. Vinyl/Fiberglass
 Door Mat. Glass, Vinyl/Fiberglass
 Roof Type Front Gable
 Roof Features Dormer
 Roof Material Asphalt Shingles
 Outbuildings None
 Additions None
 Features Open Porch

Front façade

Eligibility Assessment Notes: Modifications to this resource have compromised the integrity necessary to convey its significance. The historic qualities of design, materials, workmanship, and feeling have been diminished by the alterations. This building does not possess sufficient distinguishing architectural characteristics to qualify as individually eligible for listing on the National Register. All the character defining details have been removed. The building has been re-sided and the windows have been replaced.

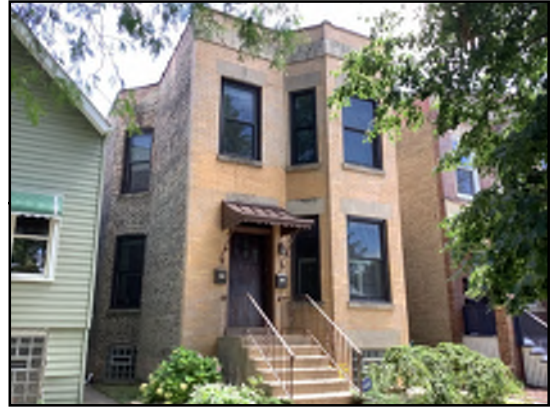
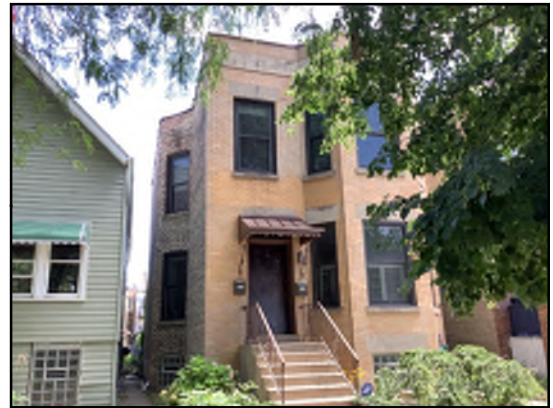
Integrity: Good Condition: Good
 Notes

Found. Mat. Brick
 Wall Mat. Brick
 Window Type Double-hung, Bay, Glass Block
 Window Mat. Vinyl/Fiberglass
 Door Mat. Wood
 Roof Type Flat
 Roof Features None Visible
 Roof Material Not Visible
 Outbuildings Garage
 Additions None
 Features Open Porch, Cornice/Belt Course, Parapet

Front façade

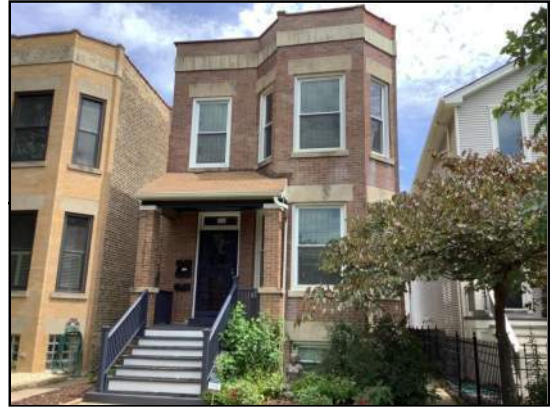
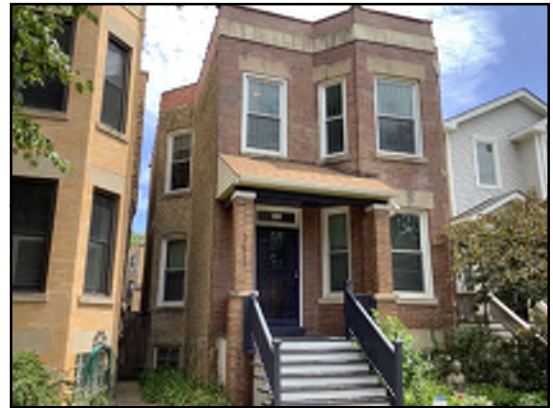
Integrity: Good Condition: Fair
 Notes

Found. Mat. Brick
 Wall Mat. Brick
 Window Type Double-hung
 Window Mat. Vinyl/Fiberglass
 Door Mat. Wood, Glass, Metal
 Roof Type Flat
 Roof Features None Visible
 Roof Material Not Visible
 Outbuildings Garage
 Additions None
 Features Open Porch, Cornice/Belt Course

Front façade

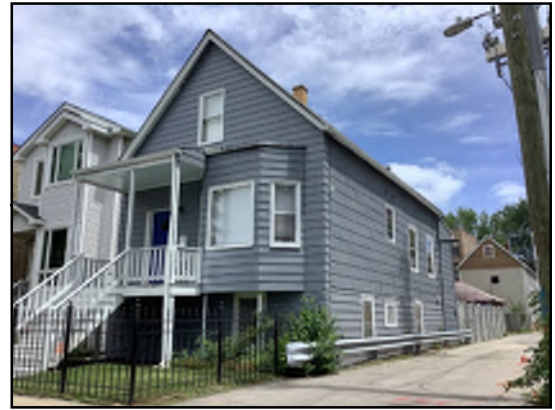
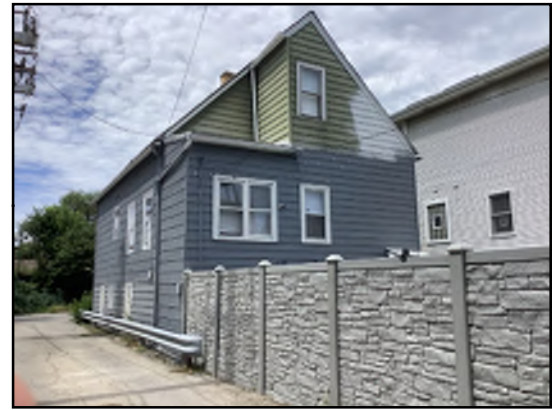
Integrity: Poor Condition: Excellent
 Notes

Found. Mat. Not Visible
 Wall Mat. Vinyl Siding, Perma-stone
 Window Type Double-hung, Bay, Fixed
 Window Mat. Vinyl/Fiberglass
 Door Mat. Glass, Vinyl/Fiberglass
 Roof Type Front Gable
 Roof Features Chimney
 Roof Material Asphalt Shingles
 Outbuildings None
 Additions None
 Features Open Porch

Front façade

Eligibility Assessment Notes: Modifications to this resource have compromised the integrity necessary to convey its significance. The historic qualities of design, materials, workmanship, and feeling have been diminished by the alterations. This building does not possess sufficient distinguishing architectural characteristics to qualify as individually eligible for listing on the National Register. All the character defining details have been removed. The building has been re-sided and the windows have been replaced.

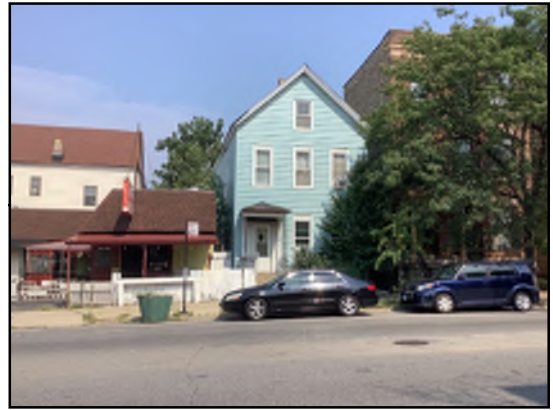
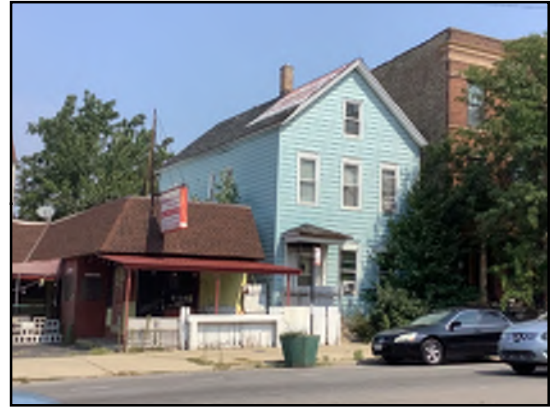
Front façade

Side view

Integrity: Fair Condition: Fair
 Notes

Found. Mat. Not Visible
 Wall Mat. Vinyl Siding
 Window Type Double-hung
 Window Mat. Vinyl/Fiberglass
 Door Mat. Glass, Vinyl/Fiberglass
 Roof Type Front Gable
 Roof Features Chimney
 Roof Material Asphalt Shingles
 Outbuildings Garage
 Additions None
 Features None

Eligibility Assessment Notes: Modifications to this resource have compromised the integrity necessary to convey its significance. The historic qualities of design, materials, workmanship, and feeling have been diminished by the alterations. This building does not possess sufficient distinguishing architectural characteristics to qualify as individually eligible for listing on the National Register. The siding and windows have been replaced, all character defining features have been removed.

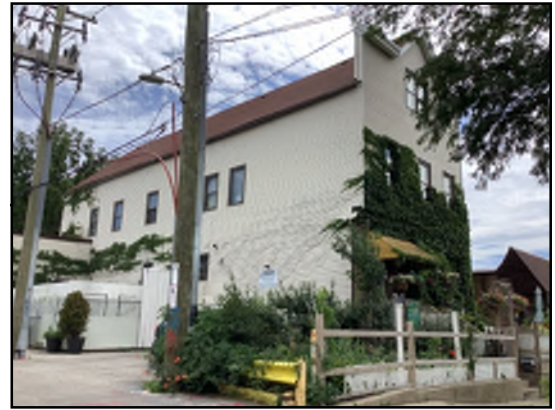
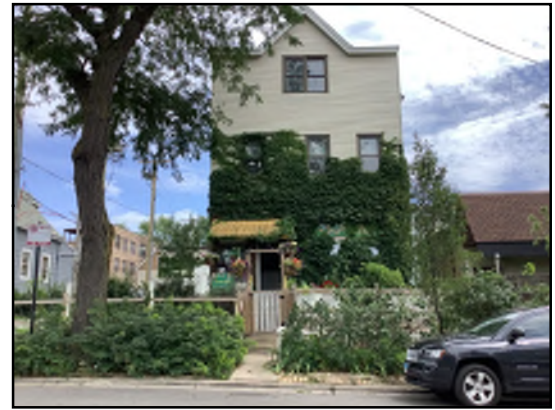
Integrity: Fair Condition: Fair
 Notes

Found. Mat. Brick
 Wall Mat. Brick, Vinyl Siding, Perma-brick
 Window Type Double-hung, Fixed
 Window Mat. Vinyl/Fiberglass
 Door Mat. Wood, Glass, Vinyl/Fiberglass
 Roof Type Front Gable
 Roof Features Chimney
 Roof Material Asphalt Shingles
 Outbuildings None
 Additions Rear
 Features Open Porch

Side view

Front façade

Eligibility Assessment Notes: Modifications to this resource have compromised the integrity necessary to convey its significance. The historic qualities of design, materials, workmanship, and feeling have been diminished by the alterations. This building does not possess sufficient distinguishing architectural characteristics to qualify as individually eligible for listing on the National Register. All the character defining details have been removed. The building has been re-sided and the windows have been replaced.
