Appendix A

LOCATION NAME: METRA UP-N RECONSTRUCTION
KENOSHA SUBDIVISION

TITLE: PROJECT LIMITS

Shift Track Alignment & Replace Retaining Walls and 11 Bridges, UP North Line
Between Bridge Milepost 3.27 (North of Deering) and Milepost 5.22 (Grace Street Bridge)
METRA-4840
SHPO Log #026081921

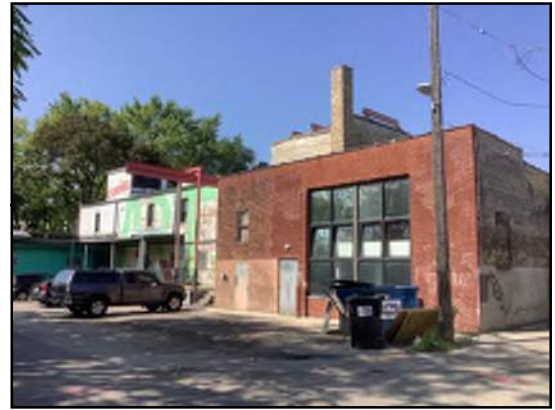
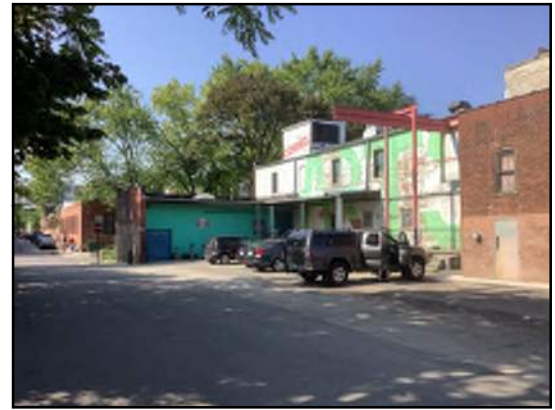
Integrity: Fair Condition: Fair
 Notes Portion of the building seems to be an addition or altered
 Arch. Style Utilitarian
 Found. Mat. Concrete, Brick
 Wall Mat. Brick
 Window Type Double-hung, Glass Block, Industrial
 Window Mat. Vinyl/Fiberglass
 Door Mat. Metal
 Roof Type Flat
 Roof Features Chimney
 Roof Material Not Visible
 Outbuildings None
 Additions Front
 Features Cornice/Belt Course, Parapet, Ornamental Masonry

Side view

Eligibility Assessment Notes: Modifications to this resource have compromised the integrity necessary to convey its significance. The historic qualities of design, materials, workmanship, and feeling have been diminished by the alterations. This building does not possess sufficient distinguishing architectural characteristics to qualify as individually eligible for listing on the National Register. The windows have been replaced. Architectural detail includes limestone sill belt course

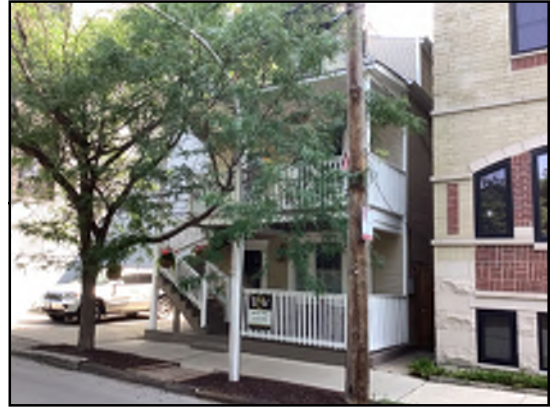
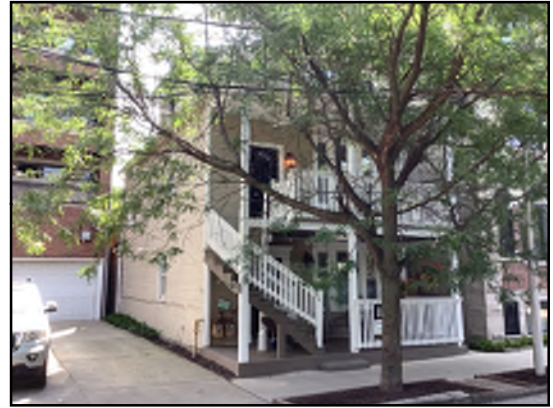
Integrity: Poor Condition: Excellent
 Notes

Found. Mat. Concrete
 Wall Mat. Vinyl Siding, Wood Shingle
 Window Type Double-hung
 Window Mat. Vinyl/Fiberglass
 Door Mat. Vinyl/Fiberglass
 Roof Type Front Gable
 Roof Features Dormer
 Roof Material Asphalt Shingles
 Outbuildings None
 Additions Pop-up
 Features Open Porch

Eligibility Assessment Notes: Modifications to this resource have compromised the integrity necessary to convey its significance. The historic qualities of design, materials, workmanship, and feeling have been diminished by the alterations. This building does not possess sufficient distinguishing architectural characteristics to qualify as individually eligible for listing on the National Register. All the character defining details have been removed. The building has been re-sided and the windows have been replaced. The 2nd floor has been remodeled to be used as Airbnb. Architectural detail includes fish scale siding on the gable.

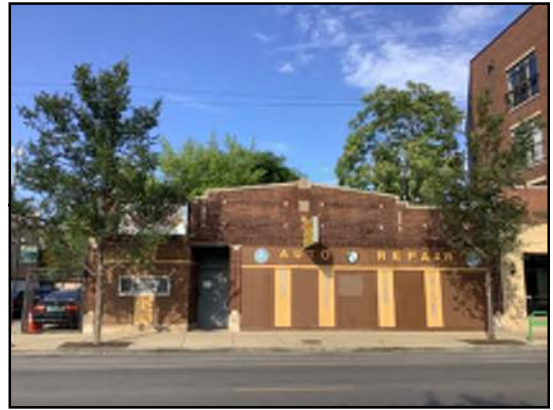
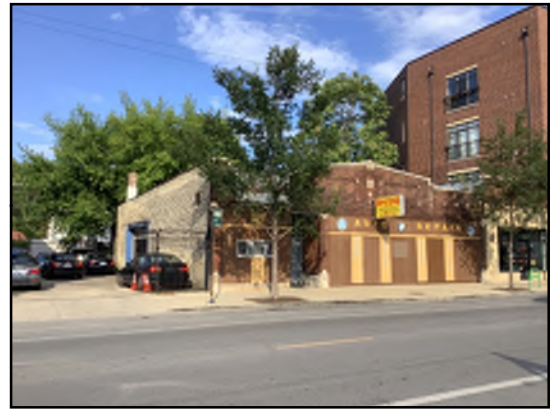
Integrity: Fair Condition: Good
 Notes

Found. Mat. Stone
 Wall Mat. Stone, Brick
 Window Type Ribbon
 Window Mat. Vinyl/Fiberglass
 Door Mat. Wood
 Roof Type Flat
 Roof Features Chimney
 Roof Material Not Visible
 Outbuildings None
 Additions None
 Features Parapet, Ornamental Masonry

Eligibility Assessment Notes: Modifications to this resource have compromised the integrity necessary to convey its significance. The historic qualities of design, materials, workmanship, and feeling have been diminished by the alterations. This building does not possess sufficient distinguishing architectural characteristics to qualify as individually eligible for listing on the National Register. The windows have been replaced. The building is Utilitarian in design and some features include decorative masonry.

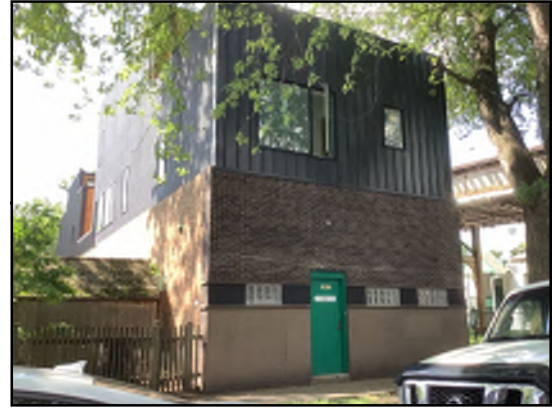
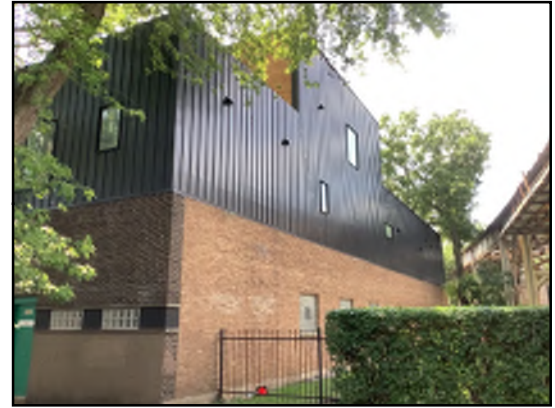
Integrity: Poor Condition: Excellent
 Notes

Found. Mat. Concrete
 Wall Mat. Brick, Metal Siding
 Window Type Fixed, Casement, Glass Block
 Window Mat. Vinyl/Fiberglass
 Door Mat. Metal
 Roof Type Flat
 Roof Features None Visible
 Roof Material Not Visible
 Outbuildings None
 Additions Second Floor
 Features Enclosed Porch

Eligibility Assessment Notes: Modifications to this resource have compromised the integrity necessary to convey its significance. The historic qualities of design, materials, workmanship, and feeling have been diminished by the alterations. This building does not possess sufficient distinguishing architectural characteristics to qualify as individually eligible for listing on the National Register. The windows have been replaced. The addition on the second floor is visible from the row.

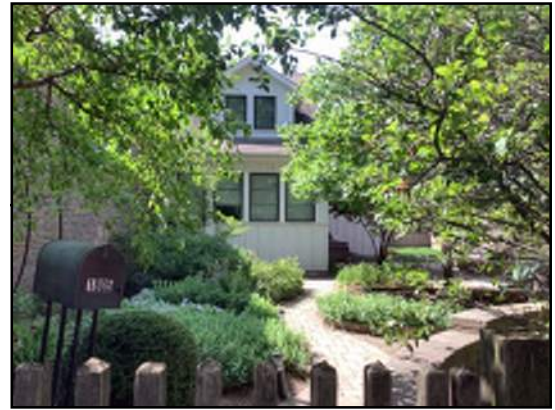
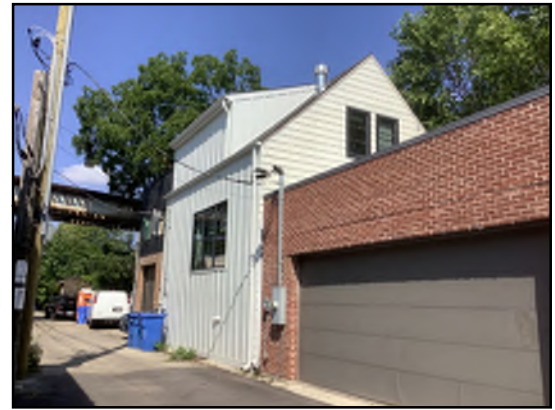
Integrity: Poor Condition: Excellent
 Notes

Found. Mat. Not Visible
 Wall Mat. Vinyl Siding
 Window Type Double-hung, Fixed
 Window Mat. Vinyl/Fiberglass
 Door Mat. Vinyl/Fiberglass
 Roof Type Side Gable
 Roof Features Dormer
 Roof Material Asphalt Shingles
 Outbuildings None
 Additions Front, Pop-up
 Features Open Porch, Parapet

Eligibility Assessment Notes: Modifications to this resource have compromised the integrity necessary to convey its significance. The historic qualities of design, materials, workmanship, and feeling have been diminished by the alterations. This building does not possess sufficient distinguishing architectural characteristics to qualify as individually eligible for listing on the National Register. All the character defining details have been removed. The building has been re-sided and the windows have been replaced. The addition on the side with flat roof is visible from the row. Some window openings are modified.

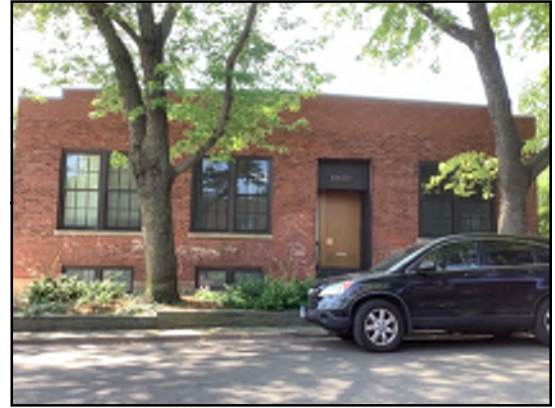
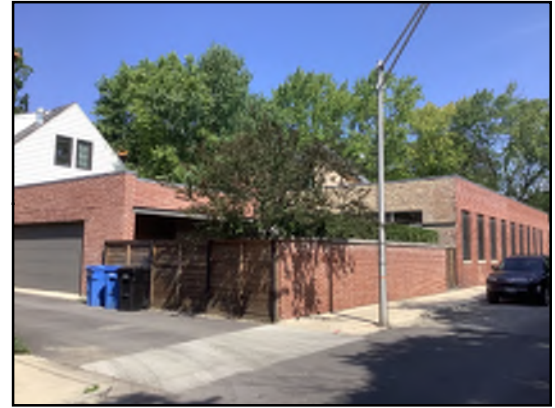
Integrity: Fair Condition: Excellent
 Notes

Found. Mat. Concrete
 Wall Mat. Stone, Brick, Perma-stone
 Window Type Double-hung, Awning/Hopper
 Window Mat. Vinyl/Fiberglass
 Door Mat. Vinyl/Fiberglass
 Roof Type Flat
 Roof Features None Visible
 Roof Material Not Visible
 Outbuildings Garage
 Additions Pop-up
 Features Open Porch, Parapet

Eligibility Assessment Notes: Modifications to this resource have compromised the integrity necessary to convey its significance. The historic qualities of design, materials, workmanship, and feeling have been diminished by the alterations. This building does not possess sufficient distinguishing architectural characteristics to qualify as individually eligible for listing on the National Register. The windows have been replaced to double-hung windows in industrial size openings with limestone sill. Entryway remodeled. Addition of a small room on the roof not visible from row.

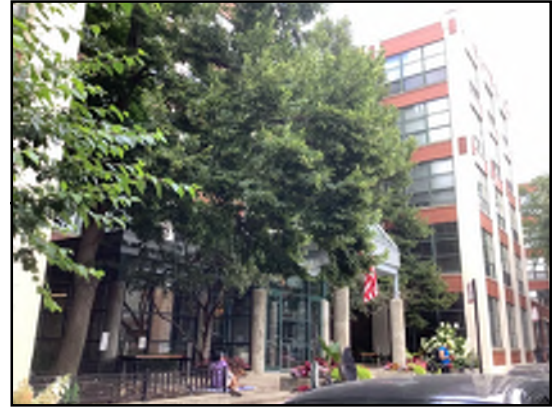
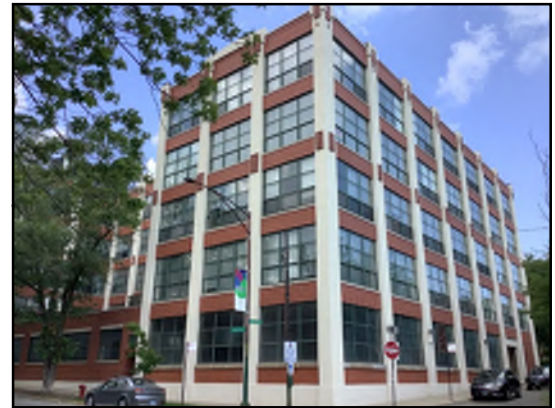
Integrity: Good Condition: Excellent
 Notes

Found. Mat. Concrete
 Wall Mat. Stone, Brick
 Window Type Industrial
 Window Mat. Vinyl/Fiberglass
 Door Mat. Glass, Metal
 Roof Type Flat
 Roof Features None Visible
 Roof Material Not Visible
 Outbuildings None
 Additions None
 Features Exterior Vestibule/Entry

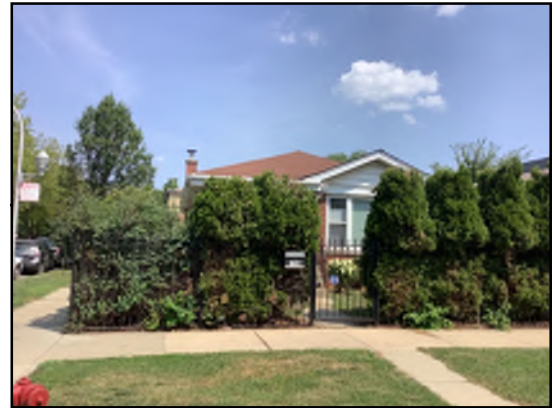
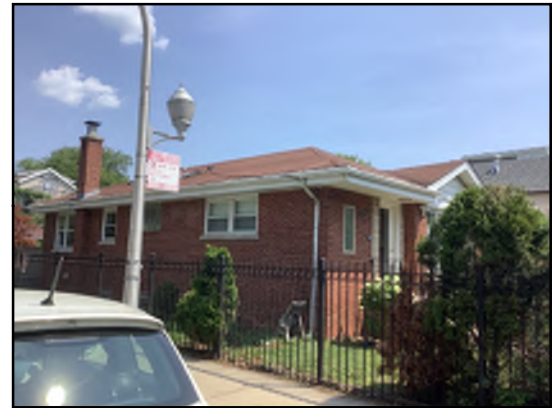
Front façade

Side view

Integrity: Good Condition: Good
 Notes

Found. Mat. Not Visible
 Wall Mat. Brick, Perma-stone
 Window Type Double-hung, Fixed, Glass Block
 Window Mat. Vinyl/Fiberglass
 Door Mat. Glass, Vinyl/Fiberglass
 Roof Type Hipped
 Roof Features Chimney, Skylights
 Roof Material Asphalt Shingles
 Outbuildings Garage
 Additions None
 Features Open Porch

Eligibility Assessment Notes: : This building does not possess any distinguishing history or architectural features to qualify it as individually eligible for National Register listing. The windows have been replaced.

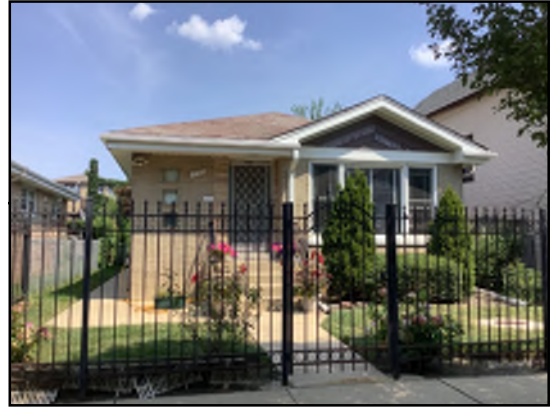
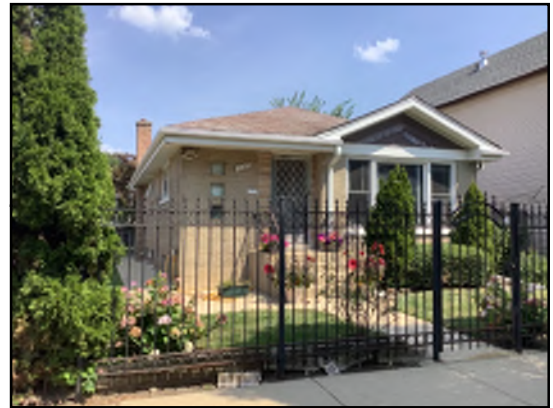
Front façade

Integrity: Good Condition: Good
 Notes

Found. Mat. Not Visible
 Wall Mat. Brick
 Window Type Double-hung, Fixed, Glass Block
 Window Mat. Vinyl/Fiberglass
 Door Mat. Glass, Metal
 Roof Type Hipped
 Roof Features Chimney
 Roof Material Asphalt Shingles
 Outbuildings Garage
 Additions None
 Features Open Porch

Eligibility Assessment Notes: This building does not possess any distinguishing history or architectural features to qualify it as individually eligible for National Register listing. The windows have been replaced. Some details include front gable with wood siding above windows.

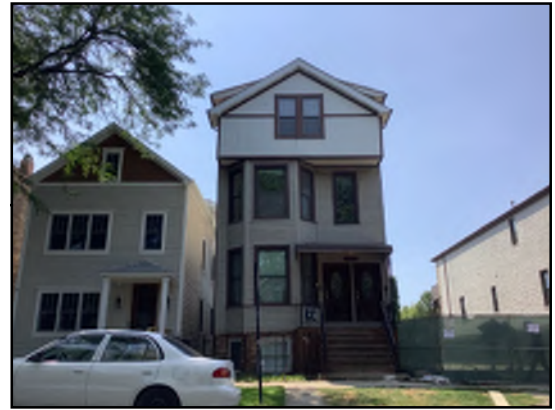
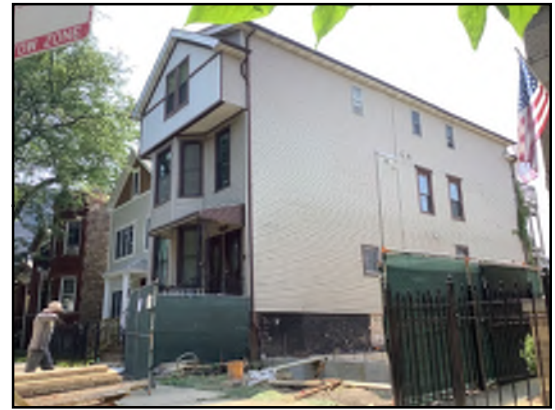
Front façade

Side view

Integrity: Fair Condition: Good
 Notes

Found. Mat. Stone
 Wall Mat. Brick, Vinyl Siding, Wood Shingle
 Window Type Double-hung, Bay
 Window Mat. Vinyl/Fiberglass
 Door Mat. Wood, Glass
 Roof Type Front Gable
 Roof Features None Visible
 Roof Material Asphalt Shingles
 Outbuildings Garage
 Additions Pop-up
 Features Open Porch

Eligibility Assessment Notes: Modifications to this resource have compromised the integrity necessary to convey its significance. The historic qualities of design, materials, workmanship, and feeling have been diminished by the alterations. This building does not possess sufficient distinguishing architectural characteristics to qualify as individually eligible for listing on the National Register. All the character defining details have been removed excluding the fish scale siding at the gable. The building has been re-sided and the windows have been replaced.

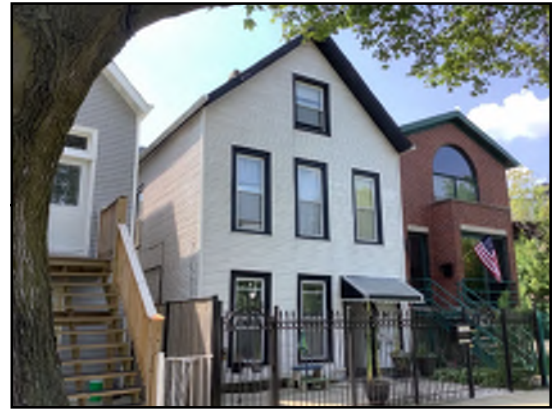
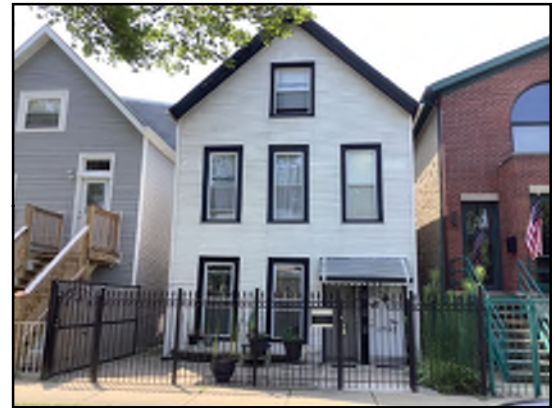
Integrity: Poor Condition: Excellent
 Notes

Found. Mat. Not Visible
 Wall Mat. Vinyl Siding
 Window Type Double-hung
 Window Mat. Vinyl/Fiberglass
 Door Mat. Vinyl/Fiberglass
 Roof Type Front Gable
 Roof Features Chimney, Skylights
 Roof Material Asphalt Shingles
 Outbuildings None
 Additions Rear
 Features None

Front façade

Eligibility Assessment Notes: Modifications to this resource have compromised the integrity necessary to convey its significance. The historic qualities of design, materials, workmanship, and feeling have been diminished by the alterations. This building does not possess sufficient distinguishing architectural characteristics to qualify as individually eligible for listing on the National Register. All the character defining details have been removed. The building has been re-sided and the windows have been replaced.

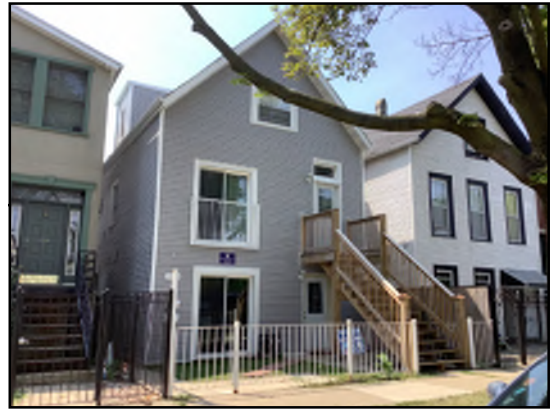
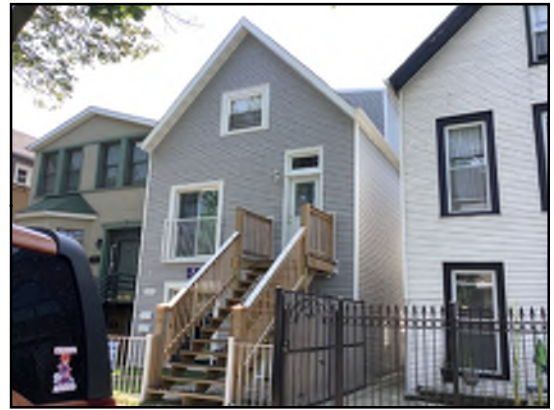
Integrity: Poor Condition: Excellent
 Notes

Found. Mat. Not Visible
 Wall Mat. Vinyl Siding
 Window Type Double-hung, Sliding
 Window Mat. Vinyl/Fiberglass
 Door Mat. Glass, Vinyl/Fiberglass
 Roof Type Front Gable
 Roof Features Dormer
 Roof Material Asphalt Shingles
 Outbuildings Garage
 Additions Pop-up
 Features None

Front façade

Eligibility Assessment Notes: Modifications to this resource have compromised the integrity necessary to convey its significance. The historic qualities of design, materials, workmanship, and feeling have been diminished by the alterations. This building does not possess sufficient distinguishing architectural characteristics to qualify as individually eligible for listing on the National Register. All character defining details have been removed. The building has been re-sided and the windows have been replaced. The porch has been modified.

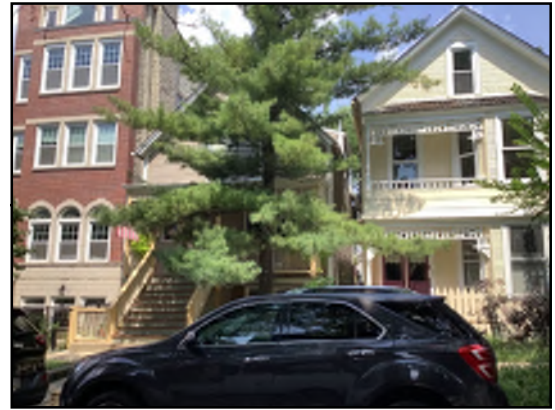
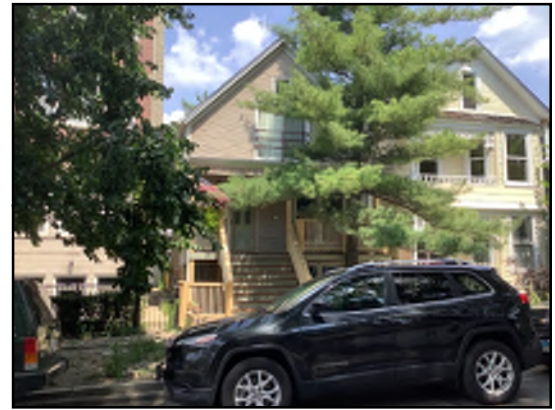
Integrity: Fair Condition: Good
 Notes

Found. Mat. Brick
 Wall Mat. Brick, Vinyl Siding
 Window Type Double-hung, Fixed, Glass Block
 Window Mat. Vinyl/Fiberglass
 Door Mat. Glass, Vinyl/Fiberglass
 Roof Type Front Gable
 Roof Features Chimney, Dormer
 Roof Material Asphalt Shingles
 Outbuildings Garage
 Additions Pop-up
 Features Open Porch

Front façade

Eligibility Assessment Notes: Modifications to this resource have compromised the integrity necessary to convey its significance. The historic qualities of design, materials, workmanship, and feeling have been diminished by the alterations. This building does not possess sufficient distinguishing architectural characteristics to qualify as individually eligible for listing on the National Register. The porch has been modified. The windows have been replaced and the building have been re-sided. All character defining details have been removed.

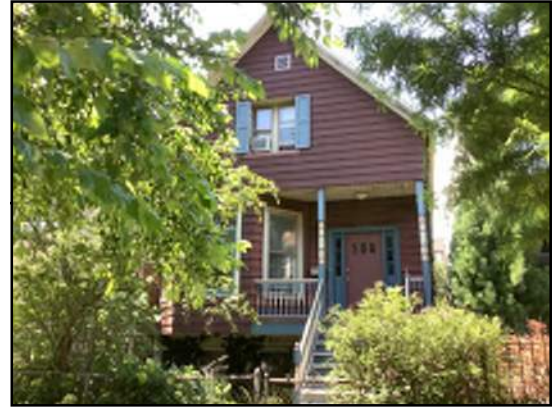
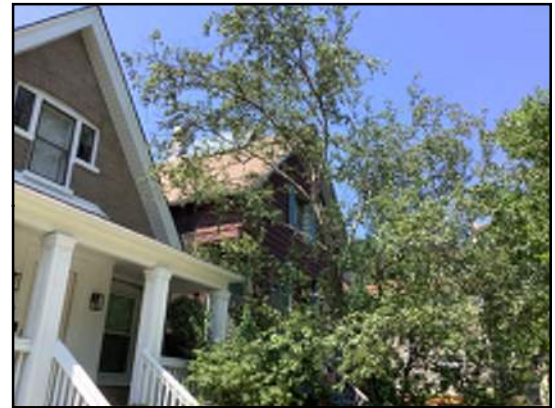
Front façade

Architectural detail

Integrity: Good Condition: Good
 Notes

Found. Mat. Brick
 Wall Mat. Brick, Vinyl Siding
 Window Type Double-hung, Bay
 Window Mat. Wood, Vinyl/Fiberglass
 Door Mat. Glass, Vinyl/Fiberglass
 Roof Type Front Gable
 Roof Features Chimney, Skylights
 Roof Material Asphalt Shingles
 Outbuildings Garage
 Additions None
 Features Open Porch

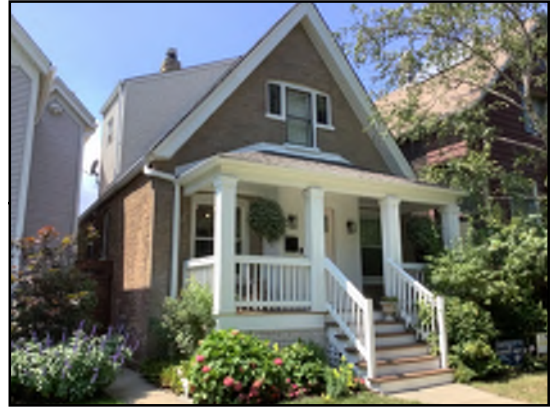
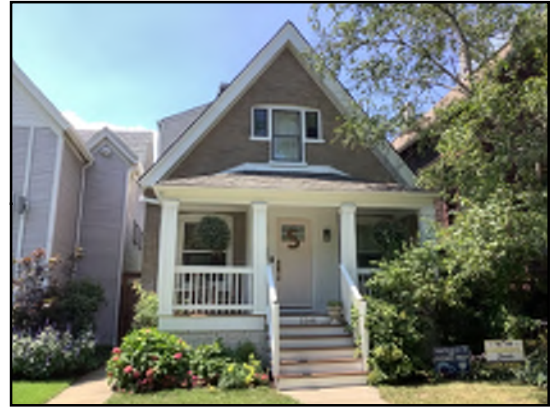
Front façade

Integrity: Good Condition: Good
 Notes

Found. Mat. Brick
 Wall Mat. Brick, Vinyl Siding, Perma-brick
 Window Type Double-hung
 Window Mat. Vinyl/Fiberglass
 Door Mat. Glass, Vinyl/Fiberglass
 Roof Type Front Gable
 Roof Features Chimney, Dormer
 Roof Material Asphalt Shingles
 Outbuildings Garage
 Additions Pop-up
 Features Open Porch

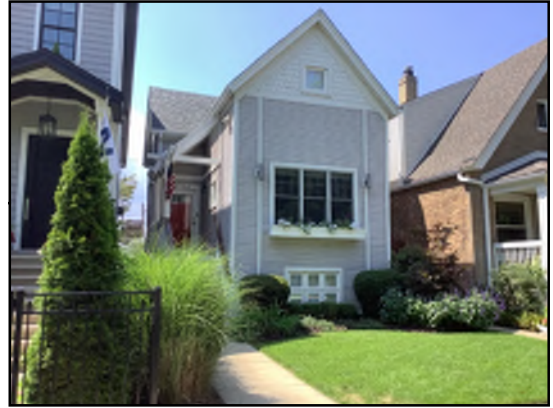
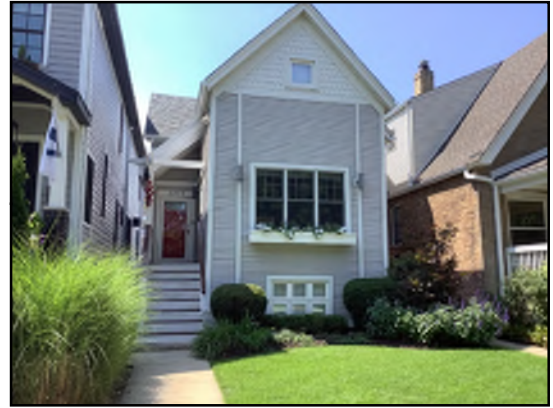
Front façade

Integrity: Fair Condition: Good
 Notes

Found. Mat. Not Visible
 Wall Mat. Vinyl Siding, Wood Shingle
 Window Type Bay, Awning/Hopper
 Window Mat. Vinyl/Fiberglass
 Door Mat. Glass, Vinyl/Fiberglass
 Roof Type Front Gable
 Roof Features Skylights
 Roof Material Asphalt Shingles
 Outbuildings Garage
 Additions None
 Features Open Porch

Eligibility Assessment Notes: Modifications to this resource have compromised the integrity necessary to convey its significance. The historic qualities of design, materials, workmanship, and feeling have been diminished by the alterations. This building does not possess sufficient distinguishing architectural characteristics to qualify as individually eligible for listing on the National Register. All the character defining details have been removed. The building has been re-sided and the windows have been replaced. Some window openings have been modified. The building has cross gable roof with fish scale siding at the front gable.

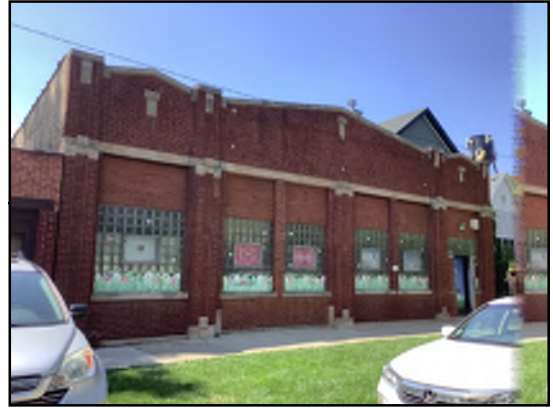
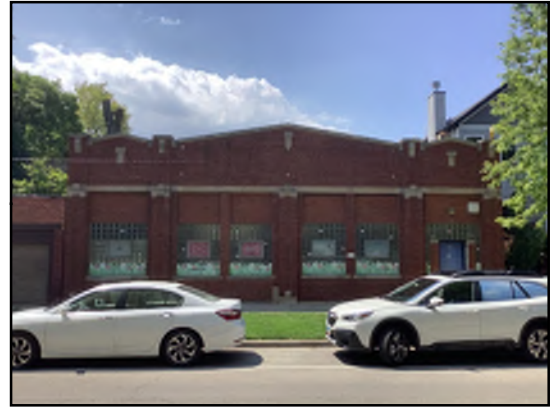
Integrity: Good Condition: Fair
 Notes

Found. Mat. Stone
 Wall Mat. Stone, Brick
 Window Type Glass Block
 Window Mat. Vinyl/Fiberglass
 Door Mat. Vinyl/Fiberglass
 Roof Type Flat
 Roof Features None Visible
 Roof Material Not Visible
 Outbuildings None
 Additions None
 Features Cornice/Belt Course, Parapet, Ornamental Masonry

Front façade

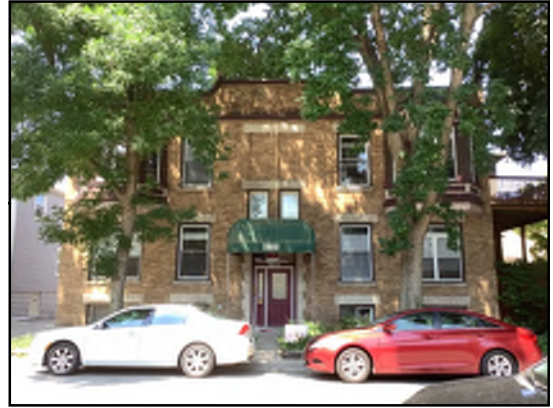
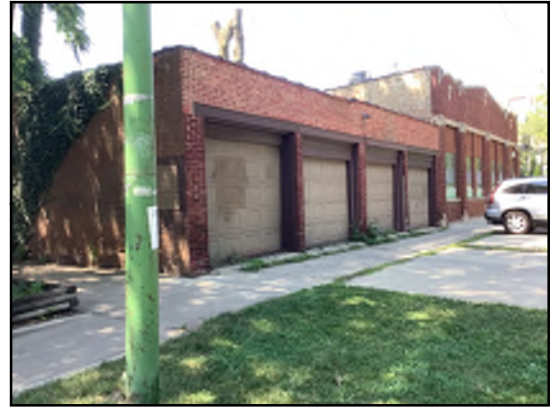
Front façade

Side view

Integrity: Good Condition: Fair
 Notes

Found. Mat. Brick
 Wall Mat. Stone, Brick
 Window Type Double-hung, Bay, Sliding
 Window Mat. Vinyl/Fiberglass
 Door Mat. Glass, Vinyl/Fiberglass
 Roof Type Flat
 Roof Features None Visible
 Roof Material Not Visible
 Outbuildings Garage
 Additions None
 Features Parapet

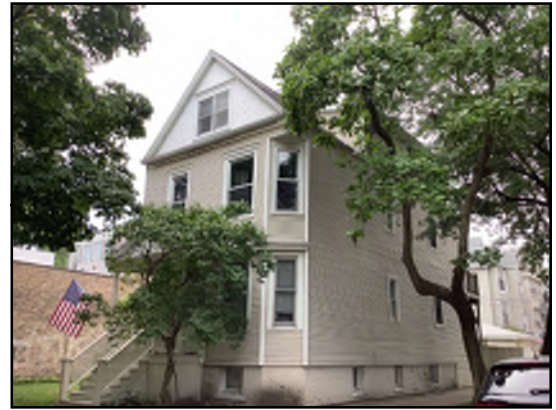
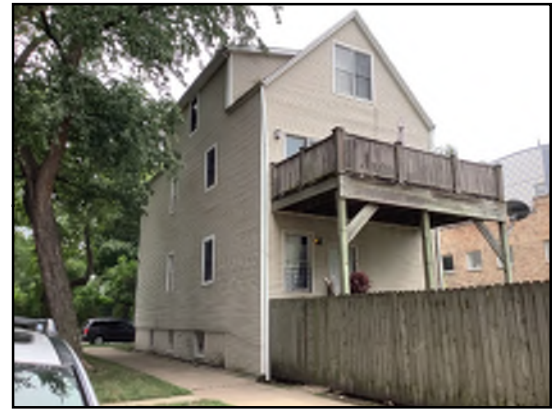
Integrity: Good Condition: Good
 Notes

Found. Mat. Brick
 Wall Mat. Brick, Vinyl Siding
 Window Type Double-hung, Fixed, Awning/Hopper
 Window Mat. Vinyl/Fiberglass
 Door Mat. Vinyl/Fiberglass
 Roof Type Front Gable
 Roof Features Chimney
 Roof Material Asphalt Shingles
 Outbuildings Garage
 Additions Rear, Pop-up
 Features Open Porch

Side view

Eligibility Assessment Notes: This building does not possess any distinguishing history or architectural features to qualify it as individually eligible for National Register listing. The addition of the pop-up is visible from the row. Windows and siding have been replaced. Some character defining features include dentil ornamentation on second floor and fish scale siding on the gable.

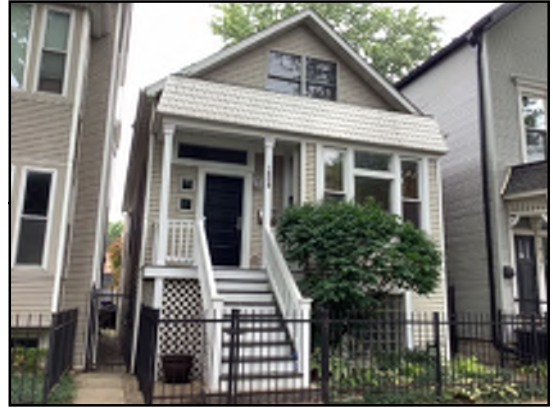
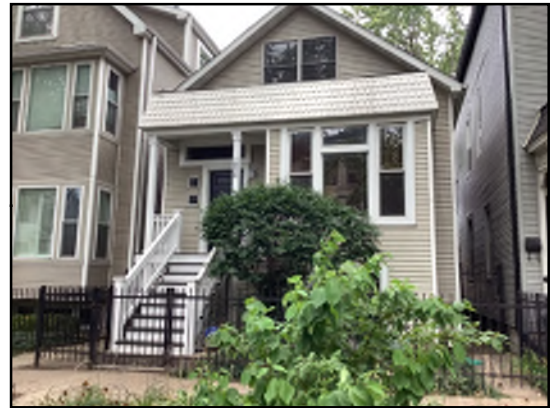
Integrity: Fair Condition: Good
 Notes

Found. Mat. Not Visible
 Wall Mat. Vinyl Siding
 Window Type Double-hung, Fixed
 Window Mat. Vinyl/Fiberglass
 Door Mat. Metal
 Roof Type Front Gable
 Roof Features None Visible
 Roof Material Asphalt Shingles
 Outbuildings None
 Additions None
 Features Open Porch

Front façade

Eligibility Assessment Notes: Modifications to this resource have compromised the integrity necessary to convey its significance. The historic qualities of design, materials, workmanship, and feeling have been diminished by the alterations. This building does not possess sufficient distinguishing architectural characteristics to qualify as individually eligible for listing on the National Register. The porch has been altered and partially enclosed. Windows have been replaced and some openings have been modified.

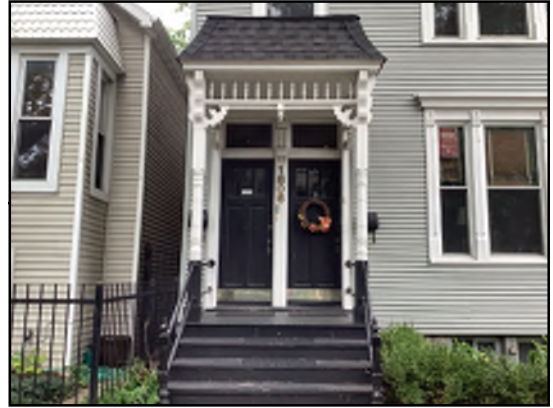
Integrity: Good Condition: Good
 Notes Italianate wooden details, cast iron porch railings
 Arch. Style Italiante
 Found. Mat. Not Visible
 Wall Mat. Vinyl Siding
 Window Type Double-hung
 Window Mat. Vinyl/Fiberglass
 Door Mat. Wood, Glass
 Roof Type Front Gable
 Roof Features None Visible
 Roof Material Asphalt Shingles
 Outbuildings Garage
 Additions None
 Features Open Porch, Ornamental Wood Trim

Architectural detail

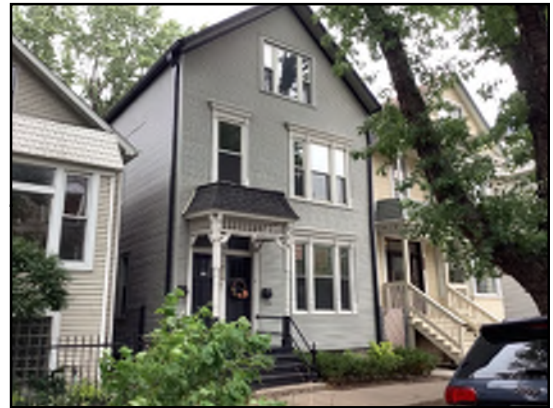
Front façade

Eligibility Assessment Notes: This building does not possess any distinguishing history or architectural features to qualify it as individually eligible for National Register listing. Some character defining features include the highly decorative porch and decorative window hoods. The siding and windows have been replaced.

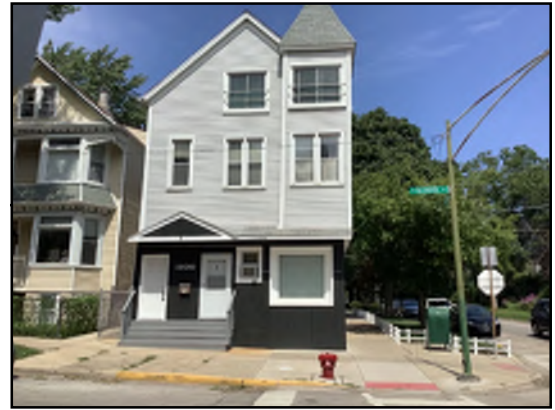
Front façade

Eligibility Assessment Notes: Modifications to this resource have compromised the integrity necessary to convey its significance. The historic qualities of design, materials, workmanship, and feeling have been diminished by the alterations. This building does not possess sufficient distinguishing architectural characteristics to qualify as individually eligible for listing on the National Register. The exterior materials have been altered and windows have been replaced. Some window openings have been modified. Character defining feature includes the turret at the corner of the building.

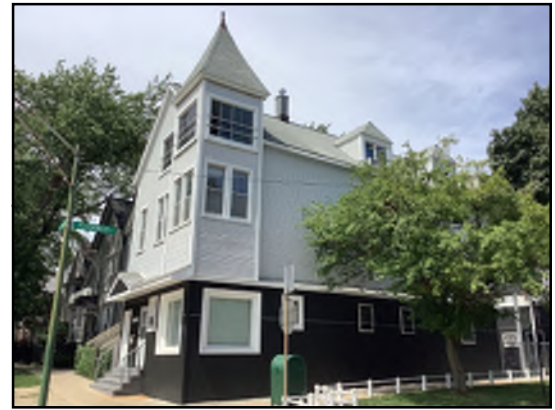
Side view

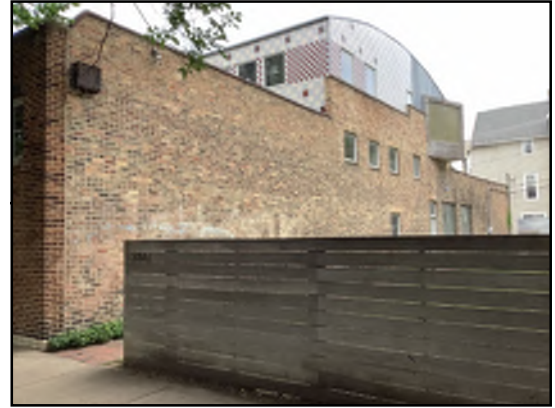
Found. Mat. Not Visible
 Wall Mat. Brick
 Window Type Double-hung, Fixed
 Window Mat. Vinyl/Fiberglass
 Door Mat. Metal
 Roof Type Flat
 Roof Features None Visible
 Roof Material Not Visible
 Outbuildings Garage
 Additions Second Floor
 Features None

Side view

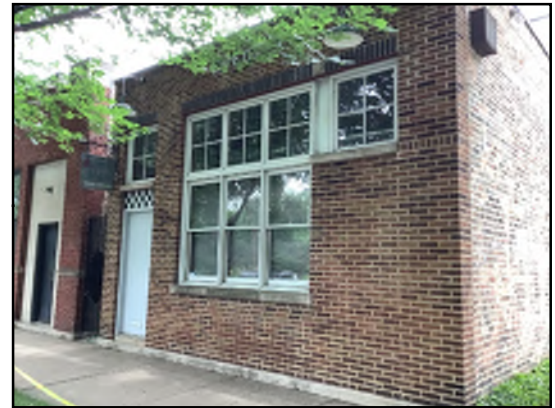
Front façade

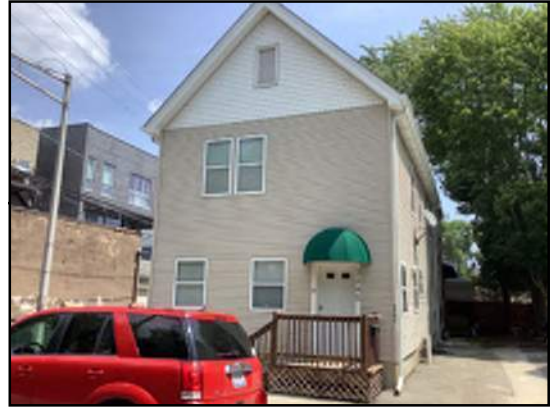
Front façade

Eligibility Assessment Notes: Modifications to this resource have compromised the integrity necessary to convey its significance. The historic qualities of design, materials, workmanship, and feeling have been diminished by the alterations. This building does not possess sufficient distinguishing architectural characteristics to qualify as individually eligible for listing on the National Register. All character defining details have been removed excluding the fish scale shingles on gable. The windows have been replaced and the building has been re-sided.

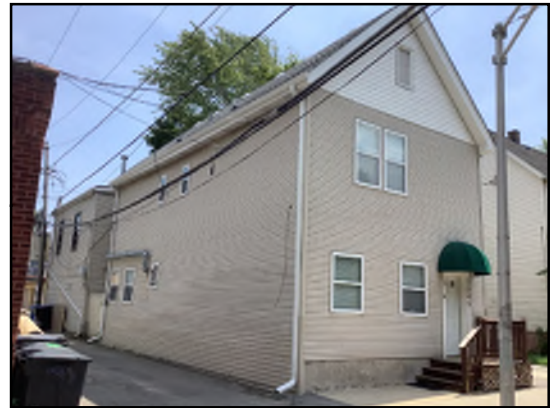
Side view

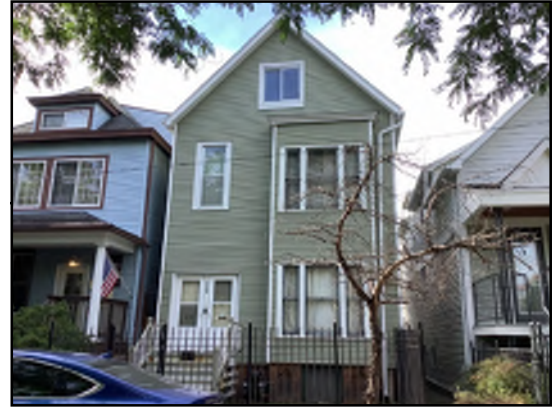
Front façade

Eligibility Assessment Notes: Modifications to this resource have compromised the integrity necessary to convey its significance. The historic qualities of design, materials, workmanship, and feeling have been diminished by the alterations. This building does not possess sufficient distinguishing architectural characteristics to qualify as individually eligible for listing on the National Register. The building is a multi family residential building. All character defining architectural details have been removed. The building has been re-sided and the windows have been replaced.

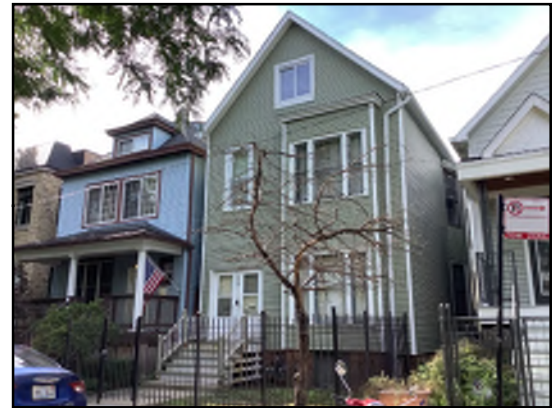
Side view

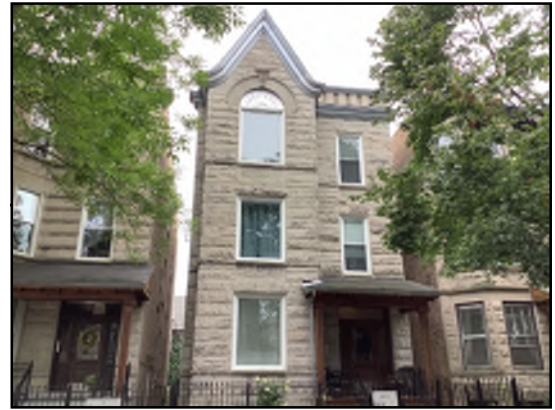
Found. Mat. Not Visible
 Wall Mat. Stone, Brick
 Window Type Double-hung, Fixed, Sliding
 Window Mat. Vinyl/Fiberglass
 Door Mat. Wood, Glass
 Roof Type Flat
 Roof Features None Visible
 Roof Material Not Visible
 Outbuildings None
 Additions None
 Features Open Porch, Cornice/Belt Course, Parapet

Front façade

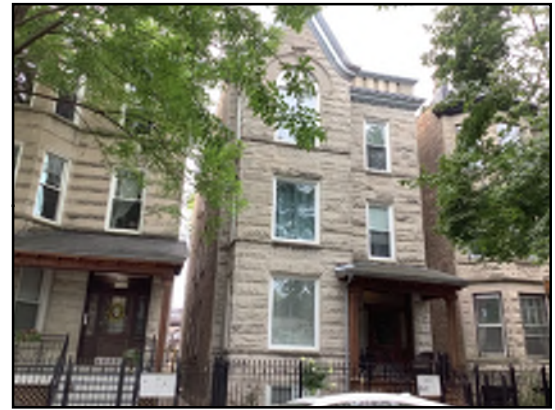
Side view

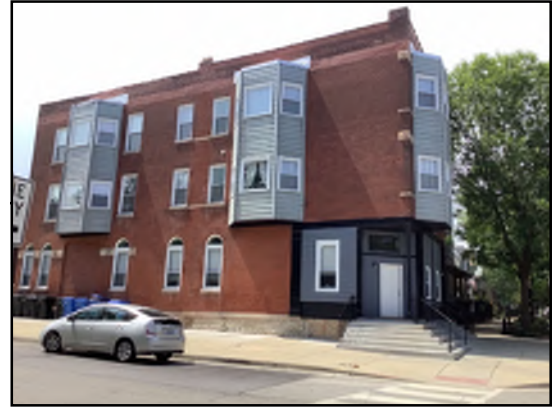
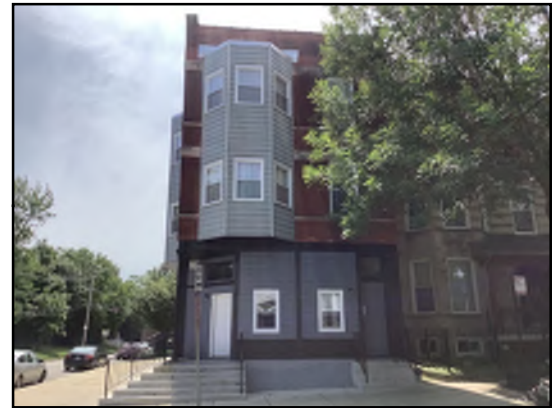
Found. Mat. Concrete
 Wall Mat. Stone, Brick, Vinyl Siding
 Window Type Double-hung, Bay
 Window Mat. Vinyl/Fiberglass
 Door Mat. Wood, Vinyl/Fiberglass
 Roof Type Flat
 Roof Features None Visible
 Roof Material Not Visible
 Outbuildings None
 Additions None
 Features Open Porch, Cornice/Belt Course

Side view

Front façade

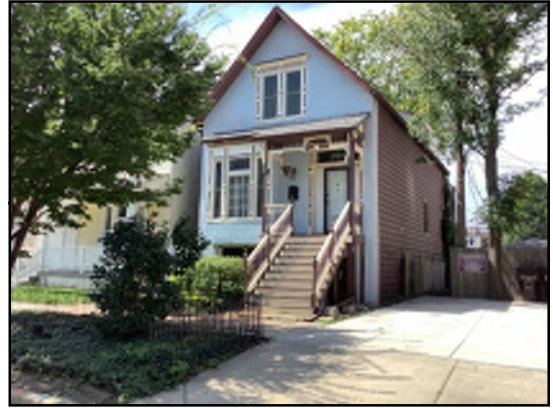
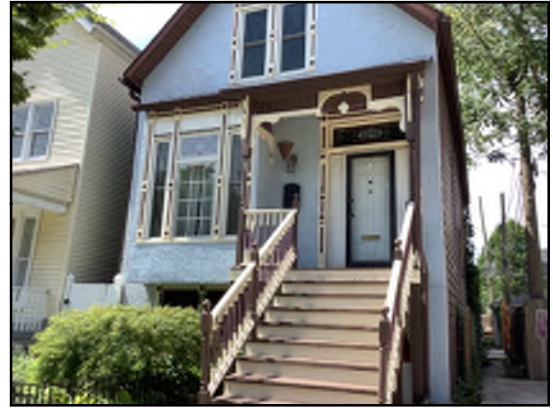
Front façade

Integrity: Good Condition: Good
 Notes Italianate details at porch and windows

Eligibility Assessment Notes: This building does not possess any distinguishing history or architectural features to qualify it as individually eligible for National Register listing. Character defining features include the highly ornamented porch and railings and window hoods. The siding on the side facade of the building and windows have been replaced.

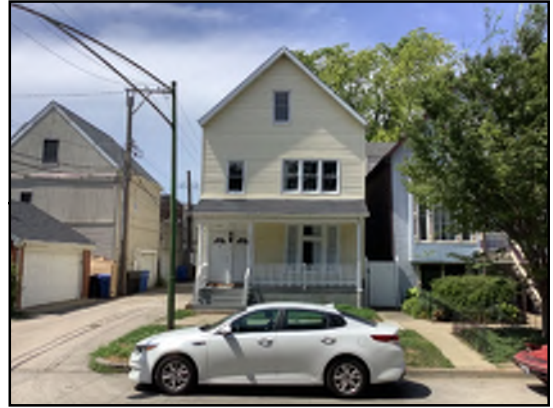
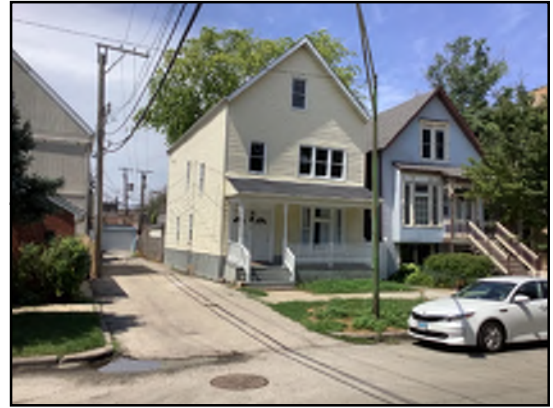
Front façade

Side view

Integrity: Fair Condition: Good
 Notes

Found. Mat. Not Visible
 Wall Mat. Vinyl Siding
 Window Type Double-hung, Fixed
 Window Mat. Vinyl/Fiberglass
 Door Mat. Vinyl/Fiberglass
 Roof Type Front Gable
 Roof Features None Visible
 Roof Material Asphalt Shingles
 Outbuildings Garage
 Additions None
 Features Open Porch

Eligibility Assessment Notes: Modifications to this resource have compromised the integrity necessary to convey its significance. The historic qualities of design, materials, workmanship, and feeling have been diminished by the alterations. This building does not possess sufficient distinguishing architectural characteristics to qualify as individually eligible for listing on the National Register. All character defining architectural details excluding the dentil ornamentation at porch have been removed. The exterior material of the building has been altered and windows have been replaced. Window openings have been modified.

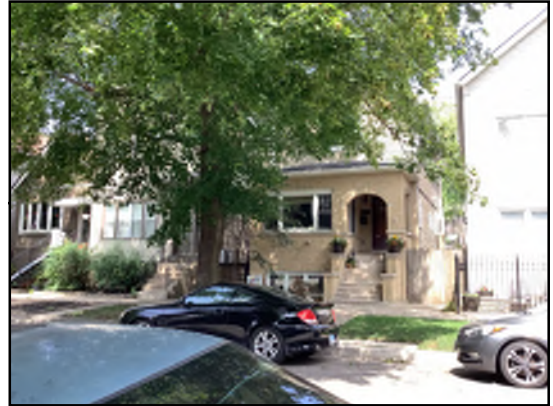
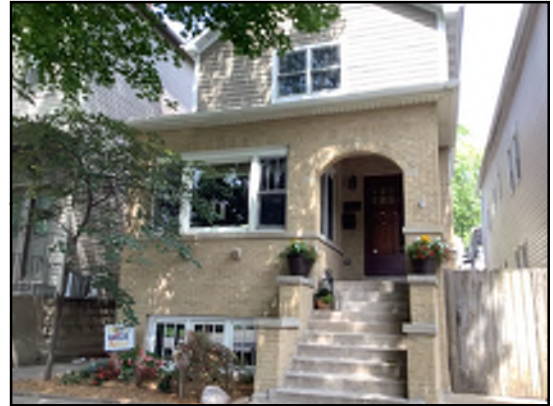
Front façade

Integrity: Fair Condition: Good
 Notes

Found. Mat. Not Visible
 Wall Mat. Brick, Vinyl Siding
 Window Type Double-hung
 Window Mat. Vinyl/Fiberglass
 Door Mat. Wood, Glass
 Roof Type Front Gable
 Roof Features None Visible
 Roof Material Asphalt Shingles
 Outbuildings Garage
 Additions Second Floor
 Features Open Porch

Eligibility Assessment Notes: Modifications to this resource have compromised the integrity necessary to convey its significance. The historic qualities of design, materials, workmanship, and feeling have been diminished by the alterations. This building does not possess sufficient distinguishing architectural characteristics to qualify as individually eligible for listing on the National Register. The second floor has been added and not original to the building. The addition is visible from the public row. The windows and siding have been replaced.

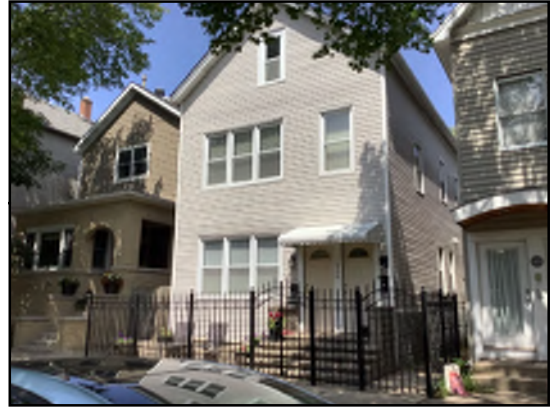
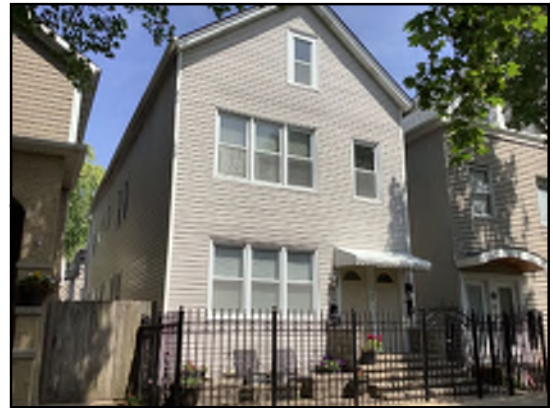
Front façade

Integrity: Poor Condition: Good
 Notes

Found. Mat. Not Visible
 Wall Mat. Vinyl Siding
 Window Type Double-hung
 Window Mat. Vinyl/Fiberglass
 Door Mat. Glass, Metal
 Roof Type Front Gable
 Roof Features None Visible
 Roof Material Asphalt Shingles
 Outbuildings Garage
 Additions None
 Features None

Eligibility Assessment Notes: Modifications to this resource have compromised the integrity necessary to convey its significance. The historic qualities of design, materials, workmanship, and feeling have been diminished by the alterations. This building does not possess sufficient distinguishing architectural characteristics to qualify as individually eligible for listing on the National Register. All character defining architectural details have been removed and all original materials have been replaced.

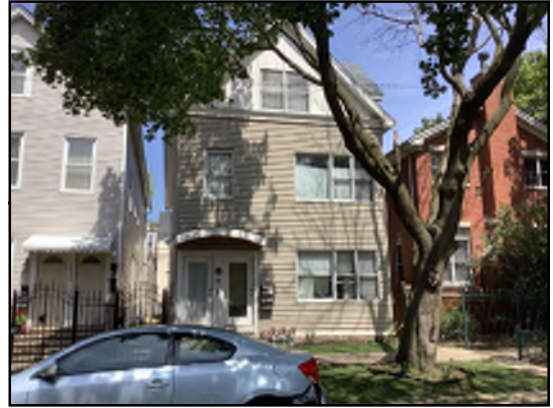
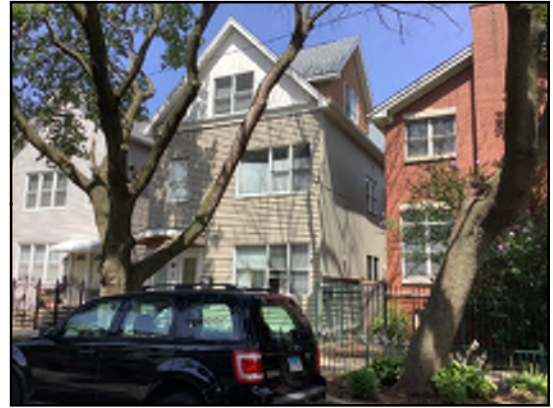
Front façade

Side view

Integrity: Fair Condition: Good
 Notes

Found. Mat. Concrete
 Wall Mat. Vinyl Siding, Wood Siding
 Window Type Double-hung, Fixed
 Window Mat. Vinyl/Fiberglass
 Door Mat. Glass, Vinyl/Fiberglass
 Roof Type Front Gable
 Roof Features Dormer
 Roof Material Asphalt Shingles
 Outbuildings Garage
 Additions Pop-up
 Features None

Eligibility Assessment Notes: Modifications to this resource have compromised the integrity necessary to convey its significance. The historic qualities of design, materials, workmanship, and feeling have been diminished by the alterations. This building does not possess sufficient distinguishing architectural characteristics to qualify as individually eligible for listing on the National Register. The wood siding on gable appears to be original to the building. The addition of the dormer is visible from the row. The windows have been replaced and some window openings have been modified. The porch has been altered.

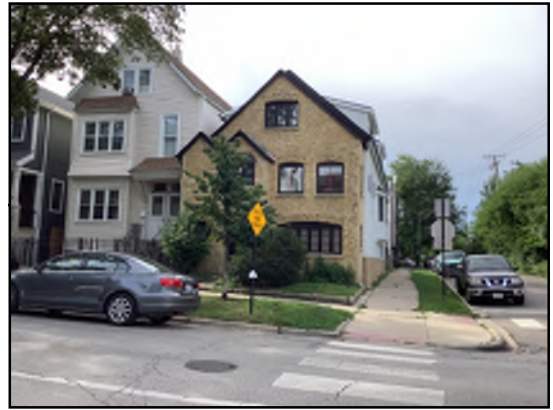
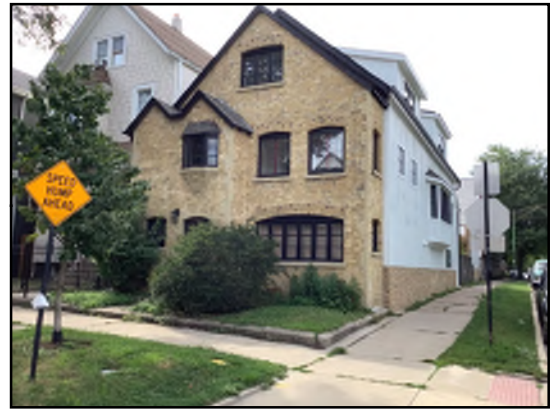
Integrity: Poor Condition: Excellent
 Notes Heavily renovated

Found. Mat. Not Visible
 Wall Mat. Brick, Wood Siding
 Window Type Casement
 Window Mat. Vinyl/Fiberglass
 Door Mat. Wood
 Roof Type Front Gable
 Roof Features Dormer
 Roof Material Asphalt Shingles
 Outbuildings Garage
 Additions Front, Rear, Pop-up
 Features None

Front façade

Eligibility Assessment Notes: Modifications to this resource have compromised the integrity necessary to convey its significance. The historic qualities of design, materials, workmanship, and feeling have been diminished by the alterations. This building does not possess sufficient distinguishing architectural characteristics to qualify as individually eligible for listing on the National Register. The exterior materials of the buildings have been altered. The addition of the pop-ups are visible from the row and the windows have been replaced.

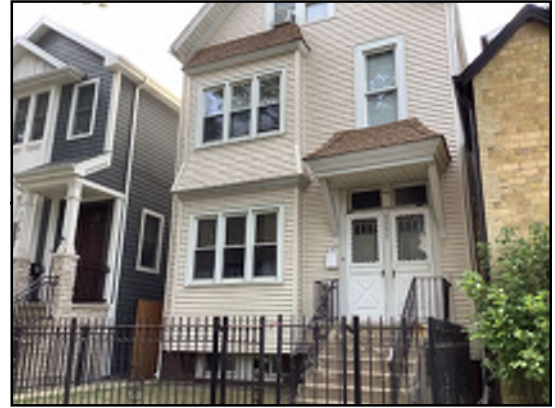
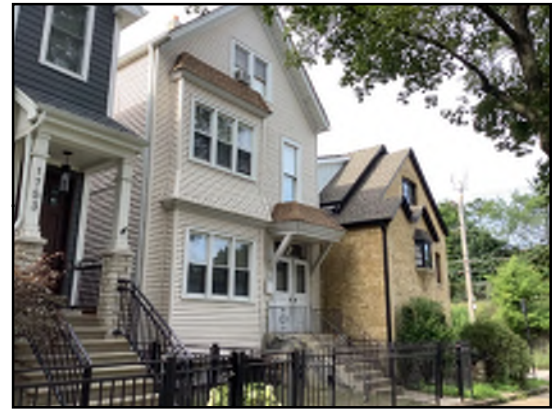
Front façade

Integrity: Fair Condition: Good
 Notes

Found. Mat. Not Visible
 Wall Mat. Vinyl Siding
 Window Type Double-hung
 Window Mat. Vinyl/Fiberglass
 Door Mat. Glass, Metal
 Roof Type Front Gable
 Roof Features None Visible
 Roof Material Asphalt Shingles
 Outbuildings None
 Additions None
 Features None

Eligibility Assessment Notes: Modifications to this resource have compromised the integrity necessary to convey its significance. The historic qualities of design, materials, workmanship, and feeling have been diminished by the alterations. This building does not possess sufficient distinguishing architectural characteristics to qualify as individually eligible for listing on the National Register. The windows have been replaced. The building has been resided. The porch has been modified and the bay appears to have been altered.
