Appendix A

LOCATION NAME: METRA UP-N RECONSTRUCTION
KENOSHA SUBDIVISION

TITLE: PROJECT LIMITS

Shift Track Alignment & Replace Retaining Walls and 11 Bridges, UP North Line
Between Bridge Milepost 3.27 (North of Deering) and Milepost 5.22 (Grace Street Bridge)
METRA-4840
SHPO Log #026081921

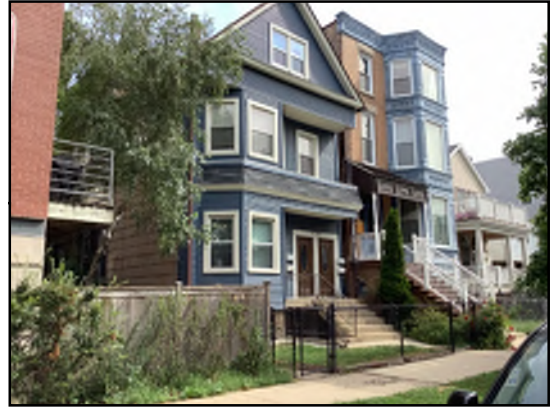
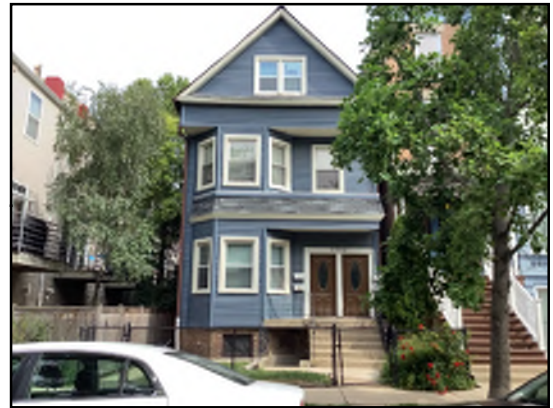
Integrity: Poor Condition: Good
 Notes

Found. Mat. Concrete
 Wall Mat. Vinyl Siding
 Window Type Double-hung, Bay
 Window Mat. Vinyl/Fiberglass
 Door Mat. Vinyl/Fiberglass
 Roof Type Front Gable
 Roof Features None Visible
 Roof Material Asphalt Shingles
 Outbuildings Garage
 Additions None
 Features Open Porch

Front façade

Eligibility Assessment Notes: Modifications to this resource have compromised the integrity necessary to convey its significance. The historic qualities of design, materials, workmanship, and feeling have been diminished by the alterations. This building does not possess sufficient distinguishing architectural characteristics to qualify as individually eligible for listing on the National Register. All exterior materials have been altered. The windows have been replaced. All character defining architectural details have been removed.

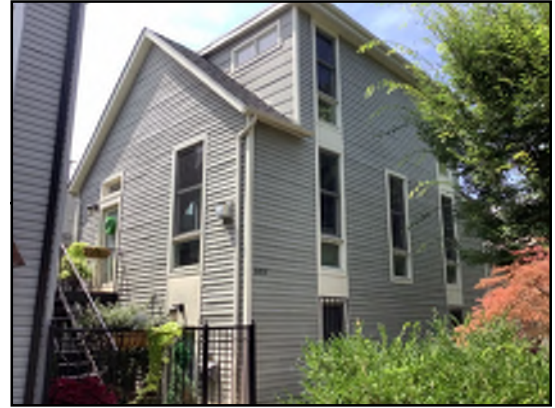
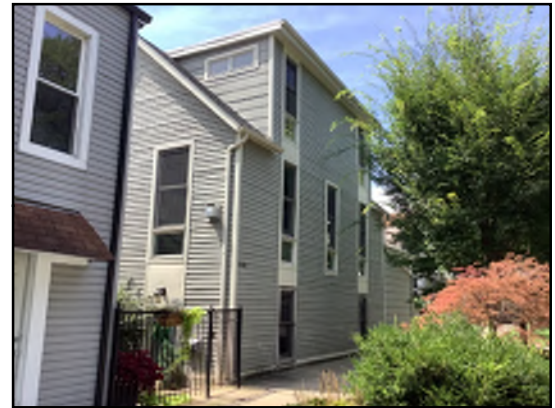
Side view

Integrity: Poor Condition: Good
 Notes

Found. Mat. Concrete
 Wall Mat. Vinyl Siding
 Window Type Double-hung, Awning/Hopper
 Window Mat. Vinyl/Fiberglass
 Door Mat. Glass, Vinyl/Fiberglass
 Roof Type Front Gable
 Roof Features None Visible
 Roof Material Asphalt Shingles
 Outbuildings None
 Additions Rear, Pop-up
 Features None

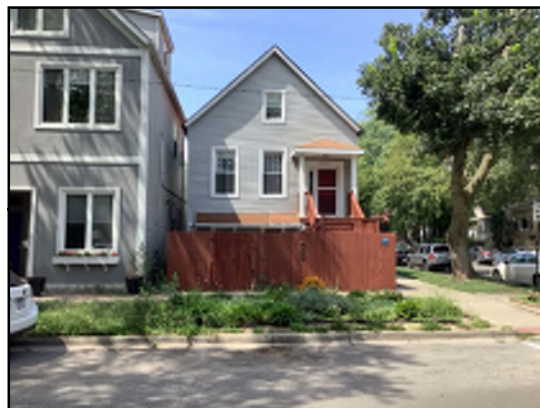
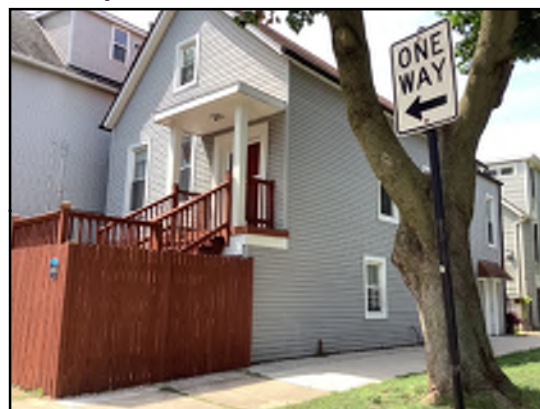
Front façade

Side view

Integrity: Poor Condition: Good
 Notes

Found. Mat. Not Visible
 Wall Mat. Vinyl Siding
 Window Type Double-hung
 Window Mat. Vinyl/Fiberglass
 Door Mat. Metal
 Roof Type Front Gable
 Roof Features None Visible
 Roof Material Asphalt Shingles
 Outbuildings None
 Additions None
 Features Open Porch

Eligibility Assessment Notes: Modifications to this resource have compromised the integrity necessary to convey its significance. The historic qualities of design, materials, workmanship, and feeling have been diminished by the alterations. This building does not possess sufficient distinguishing architectural characteristics to qualify as individually eligible for listing on the National Register. All character defining architectural details have been removed. The siding and windows have been replaced and the porch is modified.

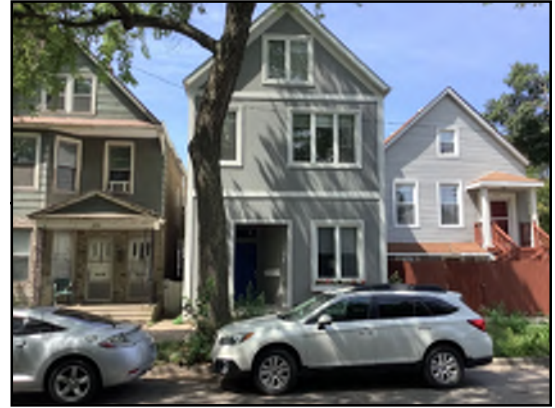
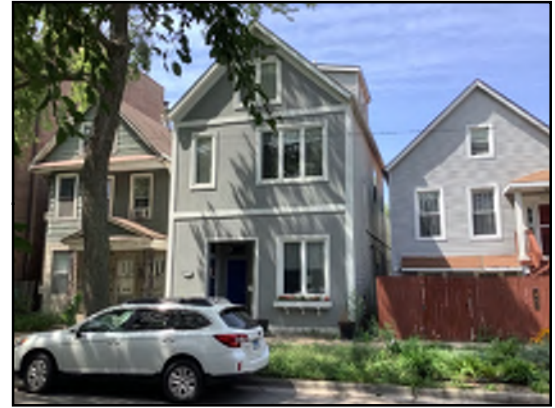
Integrity: Poor Condition: Good
 Notes

Found. Mat. Not Visible
 Wall Mat. Stucco
 Window Type Casement
 Window Mat. Vinyl/Fiberglass
 Door Mat. Metal
 Roof Type Front Gable
 Roof Features Dormer
 Roof Material Asphalt Shingles
 Outbuildings Garage
 Additions None
 Features None

Front façade

Eligibility Assessment Notes: Modifications to this resource have compromised the integrity necessary to convey its significance. The historic qualities of design, materials, workmanship, and feeling have been diminished by the alterations. This building does not possess sufficient distinguishing architectural characteristics to qualify as individually eligible for listing on the National Register. All exterior materials of the building have been altered. The windows have been replaced and porch has been removed. The addition of the pop-up is visible from the row.

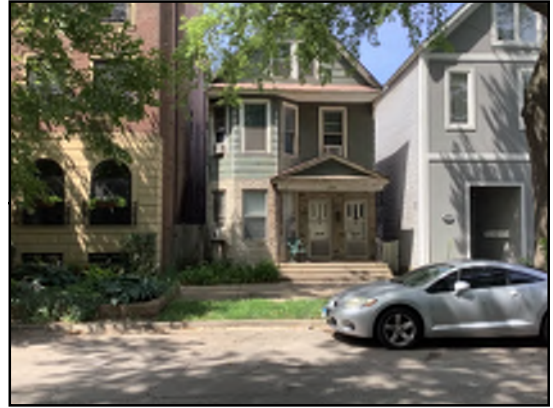
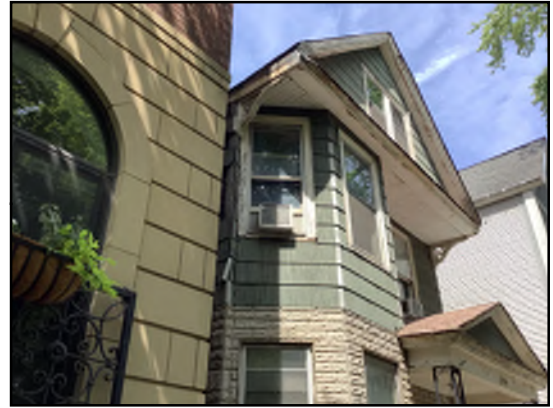
Front façade

Architectural detail

Integrity: Fair Condition: Poor
 Notes Siding type is transite (asbestos) shingles not asphalt
 Arch. Style Victorian-era
 Found. Mat. Not Visible
 Wall Mat. Perma-stone, Asphalt Shingle
 Window Type Double-hung, Bay
 Window Mat. Wood, Steel
 Door Mat. Wood, Glass
 Roof Type Front Gable
 Roof Features None Visible
 Roof Material Asphalt Shingles
 Outbuildings Garage
 Additions None
 Features Open Porch

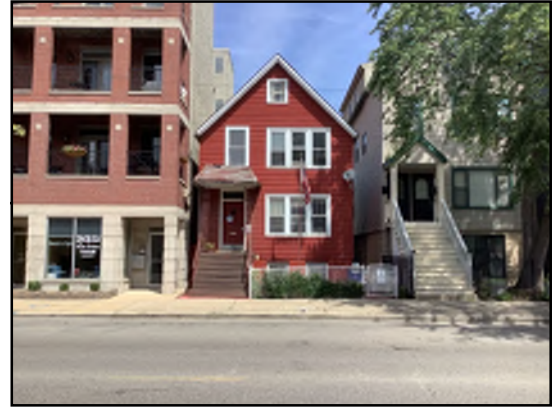
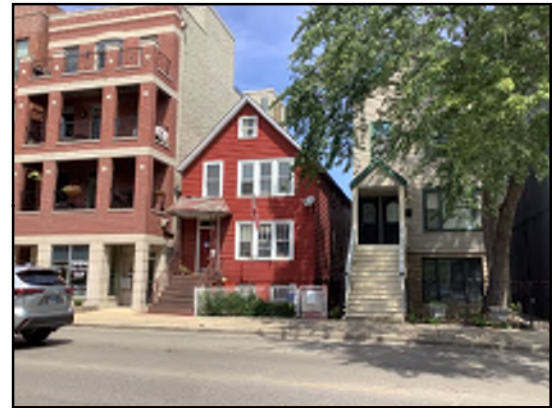
Integrity: Poor Condition: Good
 Notes

Found. Mat. Not Visible
 Wall Mat. Brick, Vinyl Siding
 Window Type Double-hung
 Window Mat. Vinyl/Fiberglass
 Door Mat. Wood
 Roof Type Front Gable
 Roof Features Chimney
 Roof Material Asphalt Shingles
 Outbuildings None
 Additions None
 Features Open Porch

Front façade

Side view

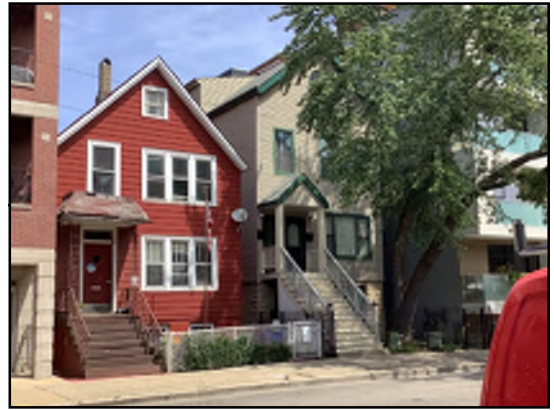
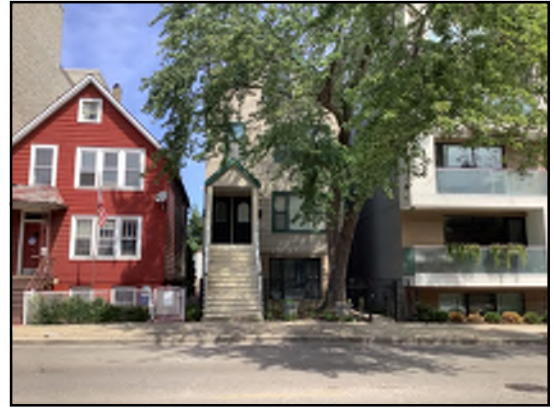
Found. Mat. Stone
 Wall Mat. Stone, Vinyl Siding
 Window Type Double-hung, Fixed
 Window Mat. Vinyl/Fiberglass
 Door Mat. Wood, Glass
 Roof Type Front Gable
 Roof Features Chimney
 Roof Material Asphalt Shingles
 Outbuildings None
 Additions Pop-up
 Features Open Porch

Front façade

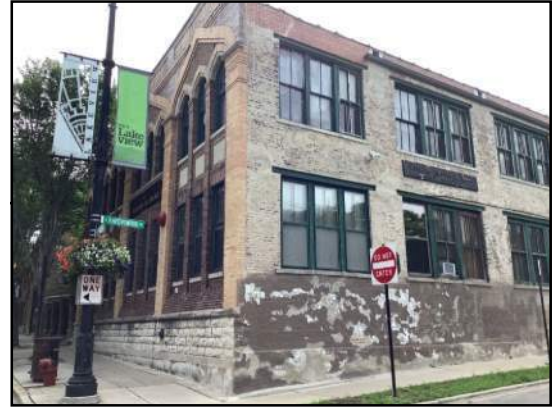
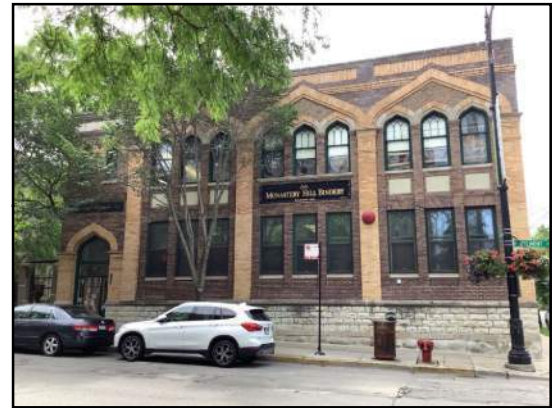
Integrity: Good Condition: Good
 Notes

Found. Mat. Not Visible
 Wall Mat. Stone, Brick
 Window Type Double-hung
 Window Mat. Wood
 Door Mat. Wood, Glass
 Roof Type Flat
 Roof Features None Visible
 Roof Material Not Visible
 Outbuildings Garage
 Additions None
 Features Ornamental Masonry

Side view

Front façade

Eligibility Assessment Notes: The commercial building with Tudor Revival influence at 1751-1757 Belmont Avenue was designed by George L. Pfeiffer for the Monastery Hill Binding business that was established in 1902. The building is rectangular in plan, 2-stories in height, and is clad in brick with ornamental brick work and a rusticated limestone base at the primary (North) façade. The primary façade is composed of 4 bays defined by distinct Tudor Revival polychrome brick pointed arches and limestone accents. The secondary and tertiary facades at the East, West and South are built of Chicago common brick with simple rectangular punched window openings. The main entrance of the building is located in the narrower, eastern bay and is set in a pointed arched opening with glass sidelights and transom. The 3 main bays are each defined by a large 2-story yellow brick pointed arch which captures 3 windows at each floor. The façade is terminated by a decorative masonry parapet with dentil ornamentation at the base of the parapet. The garage adjacent to the building is the only secondary structure at the site. The double-hung wood windows are multi-lite arched panes in a 3 over 1 composition with limestone sills. The 2nd floor window openings are hooded by limestone pointed arch lintel whereas the 1st floor windows have soldiered brick flat arch lintels. This resource is listed as Orange-rated in the Chicago Historic Resources Survey (CHRS)

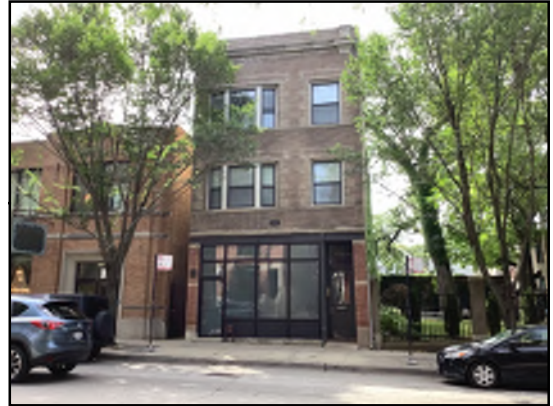
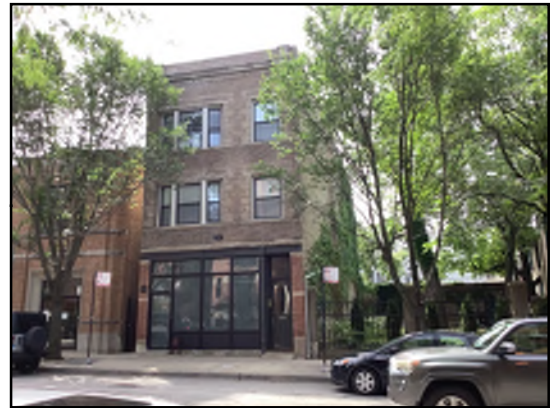
Integrity: Fair Condition: Good
 Notes
 Arch. Style Victorian-era
 Found. Mat. Stone
 Wall Mat. Brick
 Window Type Single-hung, Fixed
 Window Mat. Vinyl/Fiberglass
 Door Mat. Wood, Glass, Vinyl/Fiberglass
 Roof Type Flat
 Roof Features None Visible
 Roof Material Not Visible
 Outbuildings None
 Additions None
 Features Cornice/Belt Course

Front façade

Side view

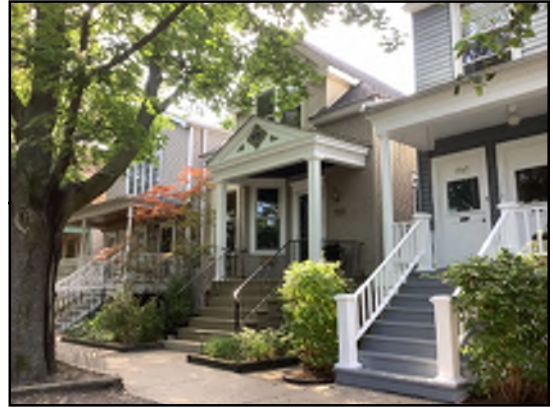
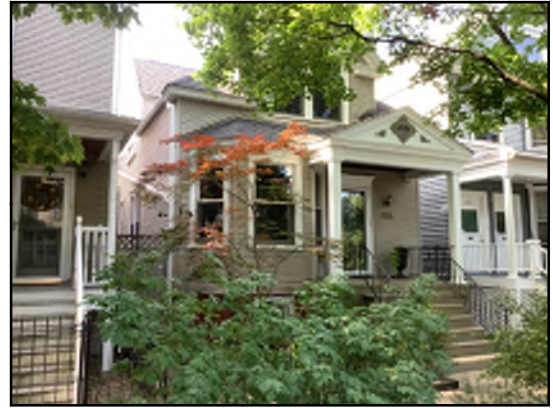
Integrity: Good Condition: Good
 Notes

Found. Mat. Concrete, Brick
 Wall Mat. Brick, Vinyl Siding
 Window Type Double-hung, Bay, Glass Block
 Window Mat. Vinyl/Fiberglass
 Door Mat. Glass, Vinyl/Fiberglass
 Roof Type Front Gable
 Roof Features Chimney, Dormer
 Roof Material Asphalt Shingles
 Outbuildings Garage
 Additions Rear, Pop-up
 Features Open Porch, Parapet

Front façade

Side view

Eligibility Assessment Notes: This building does not possess any distinguishing history or architectural features to qualify it as individually eligible for National Register listing. Character defining features include dentil ornamentation on porch and doors and window hoods. The siding and windows have been replaced.

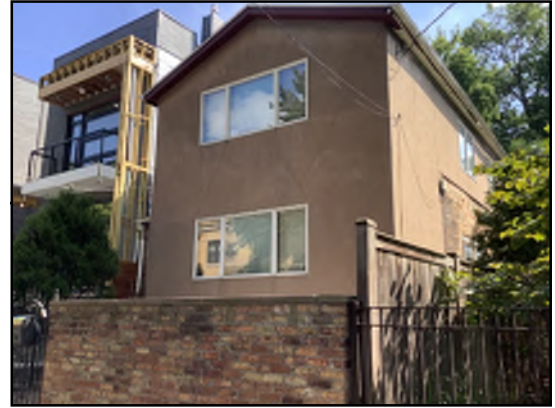
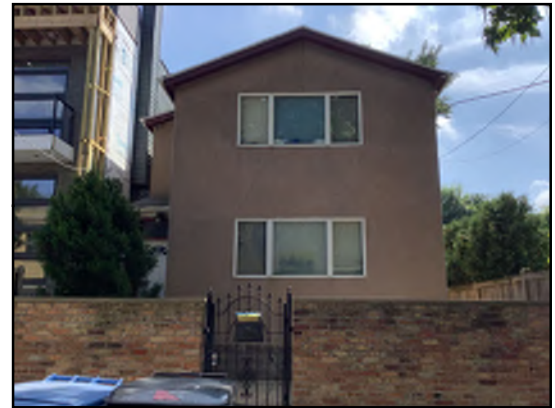
Integrity: Poor Condition: Fair
 Notes

Found. Mat. Not Visible
 Wall Mat. Brick, Stucco
 Window Type Fixed, Casement
 Window Mat. Vinyl/Fiberglass
 Door Mat. Vinyl/Fiberglass
 Roof Type Front Gable
 Roof Features None Visible
 Roof Material Asphalt Shingles
 Outbuildings None
 Additions None
 Features None

Front façade

Eligibility Assessment Notes: Modifications to this resource have compromised the integrity necessary to convey its significance. The historic qualities of design, materials, workmanship, and feeling have been diminished by the alterations. This building does not possess sufficient distinguishing architectural characteristics to qualify as individually eligible for listing on the National Register. Windows have been replaced and the facade materials have been altered. Character defining features have been removed.

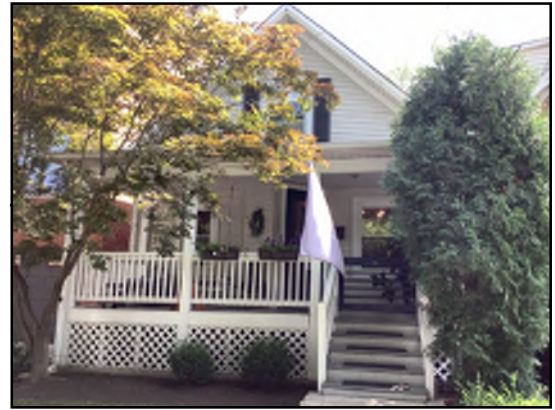
Integrity: Fair Condition: Good
 Notes

Found. Mat. Not Visible
 Wall Mat. Vinyl Siding
 Window Type Double-hung
 Window Mat. Vinyl/Fiberglass
 Door Mat. Glass, Vinyl/Fiberglass
 Roof Type Front Gable
 Roof Features Chimney, Dormer
 Roof Material Asphalt Shingles
 Outbuildings None
 Additions Pop-up
 Features Exterior Vestibule/Entry

Front façade

Eligibility Assessment Notes: Modifications to this resource have compromised the integrity necessary to convey its significance. The historic qualities of design, materials, workmanship, and feeling have been diminished by the alterations. This building does not possess sufficient distinguishing architectural characteristics to qualify as individually eligible for listing on the National Register. Some character defining unique features include angled entryway of the cottage and the historic form. The siding and windows have been replaced and the addition of pop-ups are visible from the row.

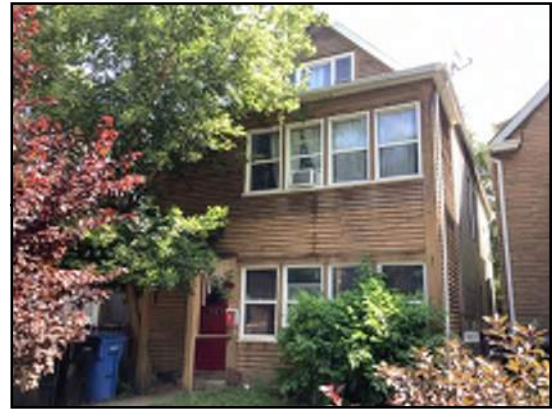
Integrity: Fair Condition: Fair
 Notes

Found. Mat. Not Visible
 Wall Mat. Wood Siding
 Window Type Double-hung
 Window Mat. Vinyl/Fiberglass
 Door Mat. Wood, Glass
 Roof Type Front Gable
 Roof Features Chimney, Skylights
 Roof Material Asphalt Shingles
 Outbuildings None
 Additions Front
 Features Enclosed Porch

Front façade

Eligibility Assessment Notes: Modifications to this resource have compromised the integrity necessary to convey its significance. The historic qualities of design, materials, workmanship, and feeling have been diminished by the alterations. This building does not possess sufficient distinguishing architectural characteristics to qualify as individually eligible for listing on the National Register. Windows have been replaced and openings have been modified. The historic form has been altered.

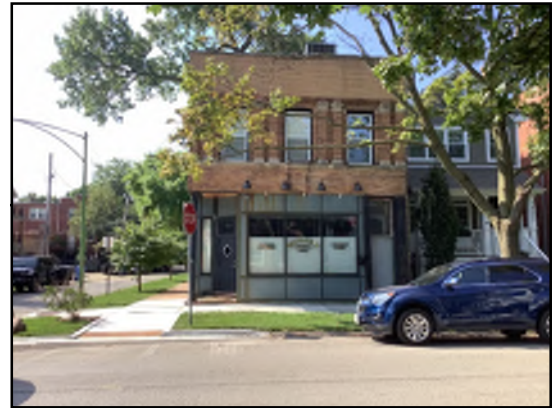
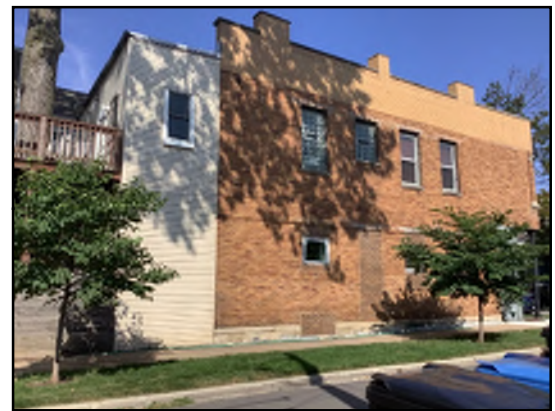
Photo by KPa 08/17/2021
 Front façade

Photo by KPa 08/17/2021
 Side view

Integrity: Fair Condition: Fair
 Notes

Found. Mat. Not Visible
 Wall Mat. Stone, Brick, Metal Siding
 Window Type Double-hung, Fixed
 Window Mat. Vinyl/Fiberglass
 Door Mat. Vinyl/Fiberglass
 Roof Type Flat
 Roof Features None Visible
 Roof Material Not Visible
 Outbuildings Garage
 Additions Rear
 Features Cornice/Belt Course, Parapet, Ornamental Masonry

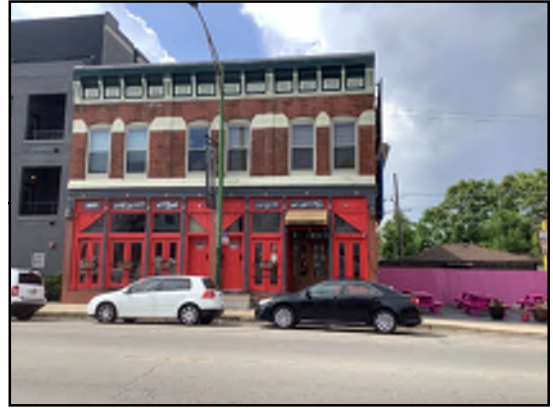
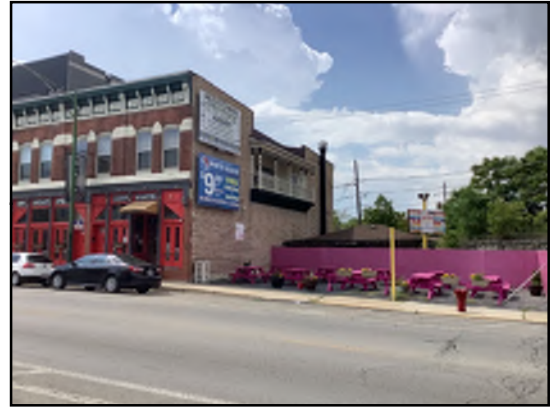
Integrity: Good Condition: Good
 Notes

Arch. Style Italiante

Found. Mat. Not Visible
 Wall Mat. Brick
 Window Type Double-hung, Casement
 Window Mat. Vinyl/Fiberglass
 Door Mat. Wood, Glass
 Roof Type Flat
 Roof Features None Visible
 Roof Material Not Visible
 Outbuildings None
 Additions Rear
 Features Cornice/Belt Course, Parapet

Eligibility Assessment Notes: This building does not possess any distinguishing history or architectural features to qualify it as individually eligible for National Register listing. Windows have been replaced and the storefront has been altered. Character defining architectural details include bracketed wooden cornice and decorative balcony railings and columns on the side facade.

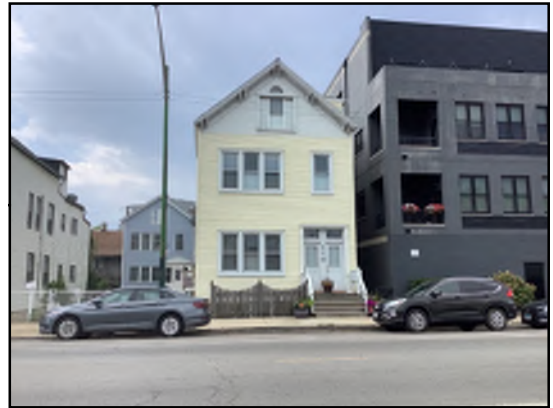
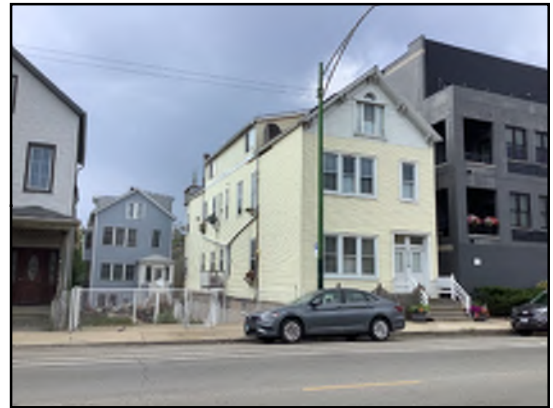
Integrity: Good Condition: Good
 Notes

Arch. Style Italiante

Found. Mat. Not Visible
 Wall Mat. Vinyl Siding, Wood Shingle
 Window Type Double-hung, Fixed
 Window Mat. Vinyl/Fiberglass
 Door Mat. Glass, Vinyl/Fiberglass
 Roof Type Front Gable
 Roof Features Chimney, Skylights
 Roof Material Asphalt Shingles
 Outbuildings Garage
 Additions Rear, Pop-up
 Features Cornice/Belt Course

Eligibility Assessment Notes: This building does not possess any distinguishing history or architectural features to qualify it as individually eligible for National Register listing. Windows and siding have been replaced. Character defining Italianate details include paired brackets at the cornice with fish scale shingles at the gable. Additions are visible from the row.

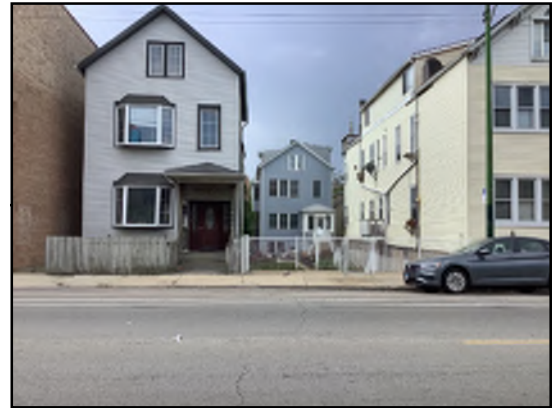
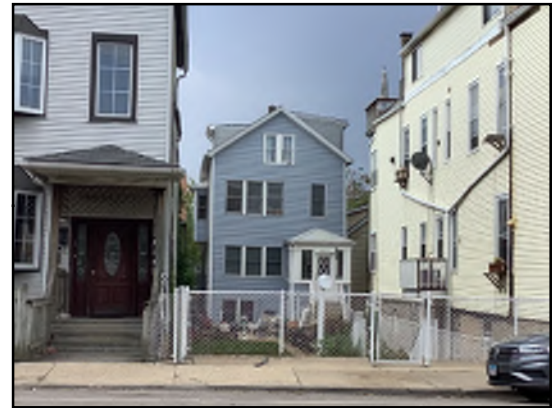
Integrity: Poor Condition: Fair
 Notes

Arch. Style Victorian-era

Found. Mat. Not Visible
 Wall Mat. Vinyl Siding
 Window Type Double-hung
 Window Mat. Vinyl/Fiberglass
 Door Mat. Glass, Vinyl/Fiberglass
 Roof Type Front Gable
 Roof Features Chimney
 Roof Material Asphalt Shingles
 Outbuildings None
 Additions Rear, Pop-up
 Features Enclosed Porch

Eligibility Assessment Notes: Modifications to this resource have compromised the integrity necessary to convey its significance. The historic qualities of design, materials, workmanship, and feeling have been diminished by the alterations. This building does not possess sufficient distinguishing architectural characteristics to qualify as individually eligible for listing on the National Register. Windows and siding have been replaced. The character defining architectural details have been removed and additions are visible from the row. The building is set back from street and not at street level.

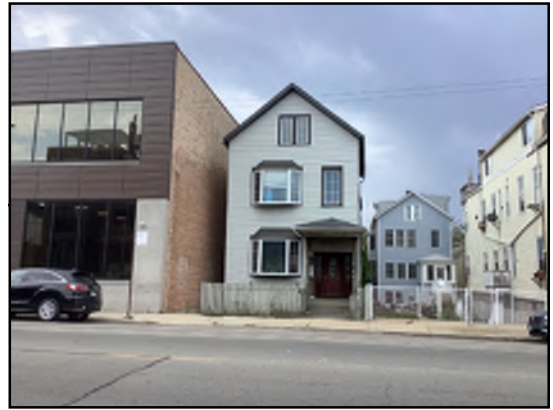
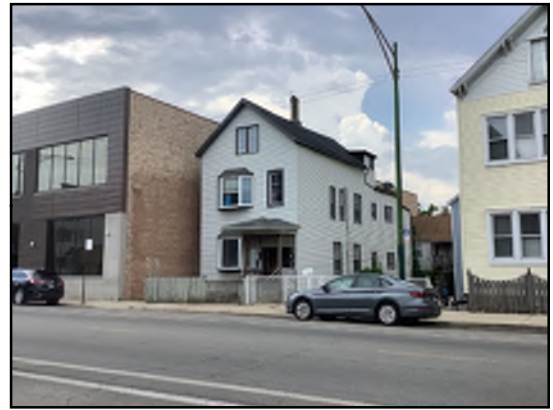
Integrity: Poor Condition: Fair
 Notes

Arch. Style Victorian-era

Found. Mat. Not Visible
 Wall Mat. Vinyl Siding
 Window Type Bay, Fixed, Casement
 Window Mat. Vinyl/Fiberglass
 Door Mat. Wood, Glass
 Roof Type Front Gable
 Roof Features Chimney
 Roof Material Not Visible
 Outbuildings Carriage House
 Additions Rear, Pop-up
 Features Open Porch

Eligibility Assessment Notes: Modifications to this resource have compromised the integrity necessary to convey its significance. The historic qualities of design, materials, workmanship, and feeling have been diminished by the alterations. This building does not possess sufficient distinguishing architectural characteristics to qualify as individually eligible for listing on the National Register. Windows and siding have been replaced. the character defining architectural details have been removed and the roof material has also been changed.

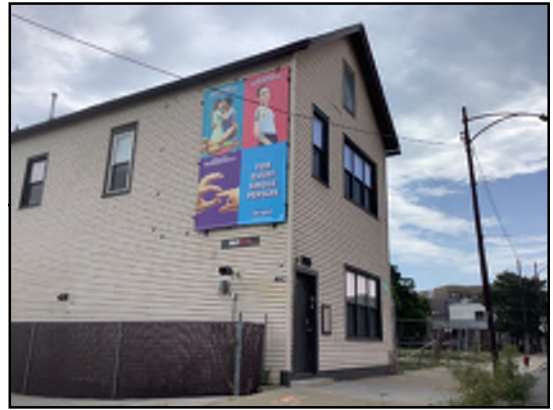
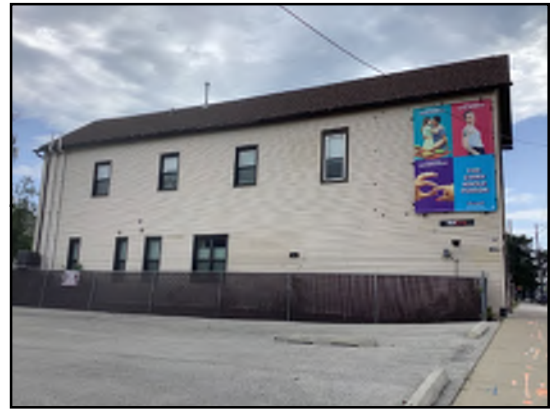
Integrity: Poor Condition: Good
 Notes

Arch. Style Victorian-era

Found. Mat. Not Visible
 Wall Mat. Vinyl Siding
 Window Type Double-hung
 Window Mat. Vinyl/Fiberglass
 Door Mat. Vinyl/Fiberglass
 Roof Type Front Gable
 Roof Features None Visible
 Roof Material Asphalt Shingles
 Outbuildings Garage
 Additions None
 Features None

Eligibility Assessment Notes: Modifications to this resource have compromised the integrity necessary to convey its significance. The historic qualities of design, materials, workmanship, and feeling have been diminished by the alterations. This building does not possess sufficient distinguishing architectural characteristics to qualify as individually eligible for listing on the National Register. Siding and windows have been replaced along with modifications to the openings and the roof. The character defining architectural details have been removed.

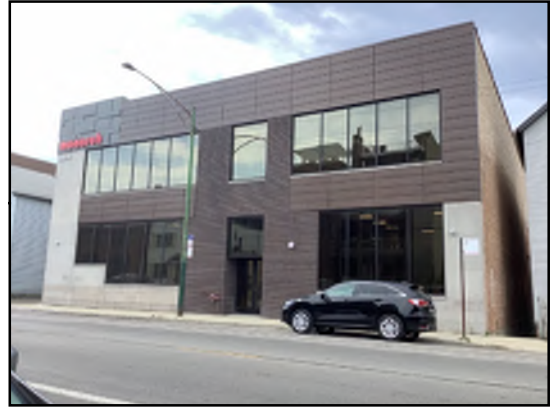
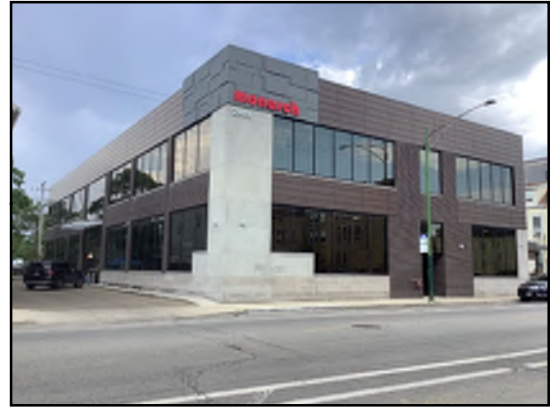
Resource has been determined as not eligible due to not meeting age requirements and being otherwise unexceptional.

Front façade

Side view

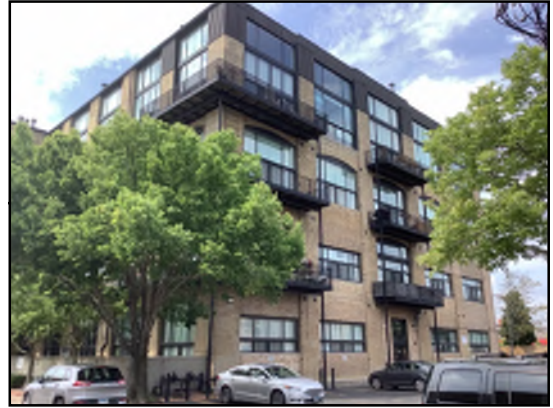
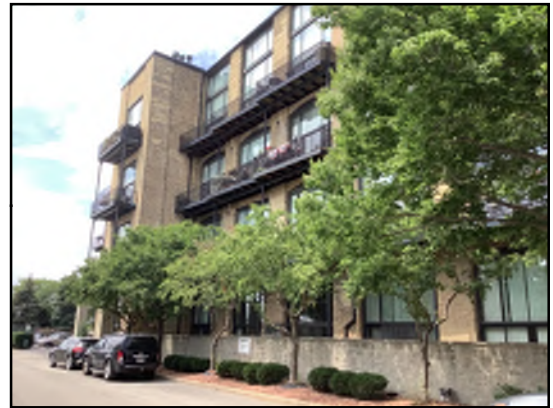
Integrity: Fair Condition: Good
 Notes

Found. Mat. Not Visible
 Wall Mat. Brick, Metal Siding
 Window Type Industrial
 Window Mat. Vinyl/Fiberglass
 Door Mat. Glass, Metal
 Roof Type Flat
 Roof Features None Visible
 Roof Material Not Visible
 Outbuildings None
 Additions Second Floor
 Features Parapet

Side view

Eligibility Assessment Notes: Modifications to this resource have compromised the integrity necessary to convey its significance. The historic qualities of design, materials, workmanship, and feeling have been diminished by the alterations. This building does not possess sufficient distinguishing architectural characteristics to qualify as individually eligible for listing on the National Register. Windows have been replaced and some window openings have been modified. The building has been rehabilitated to multiple-family residence. Addition/alteration on the top floor with metal siding and balconies on the top floors are visible from the row.

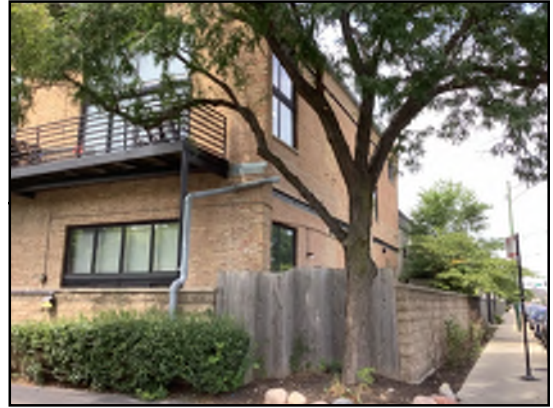
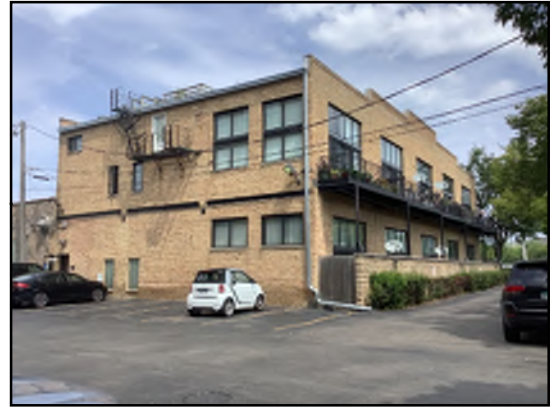
Front façade

Rear view

Integrity: Fair Condition: Good
 Notes

Found. Mat. Not Visible
 Wall Mat. Brick
 Window Type Casement, Glass Block, Industrial
 Window Mat. Vinyl/Fiberglass
 Door Mat. Glass, Metal
 Roof Type Flat
 Roof Features None Visible
 Roof Material Not Visible
 Outbuildings None
 Additions None
 Features Parapet

Eligibility Assessment Notes: Modifications to this resource have compromised the integrity necessary to convey its significance. The historic qualities of design, materials, workmanship, and feeling have been diminished by the alterations. This building does not possess sufficient distinguishing architectural characteristics to qualify as individually eligible for listing on the National Register. Windows have been replaced and window openings have been modified. The building is Utilitarian in design and has been rehabilitated to a multiple-family residence and possesses no character defining details.

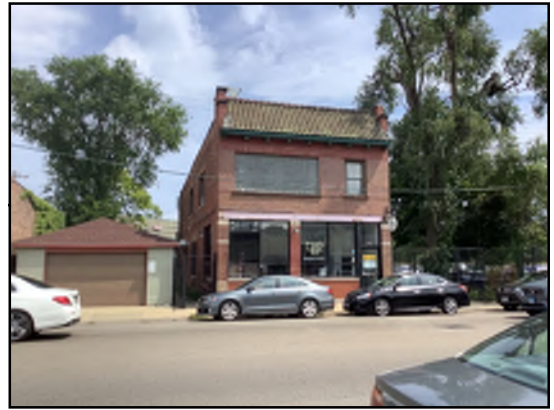
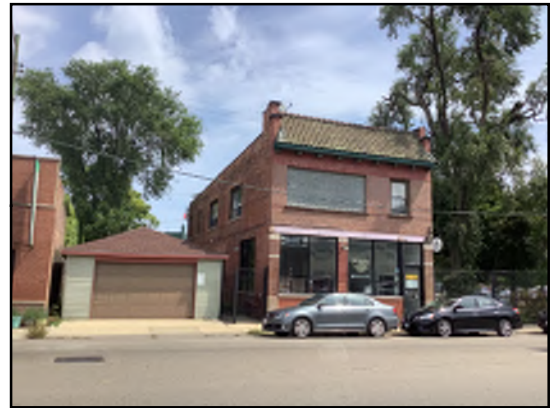
Integrity: Good Condition: Fair
 Notes

Found. Mat. Not Visible
 Wall Mat. Brick
 Window Type Double-hung, Fixed, Glass Block
 Window Mat. Vinyl/Fiberglass
 Door Mat. Glass, Metal
 Roof Type Flat
 Roof Features None Visible
 Roof Material Not Visible
 Outbuildings Shed
 Additions None
 Features Cornice/Belt Course, Parapet

Front façade

Side view

Eligibility Assessment Notes: This building does not possess any distinguishing history or architectural features to qualify it as individually eligible for National Register listing. Windows have been replaced. The character defining architectural details include the dentil cornice on the facade.

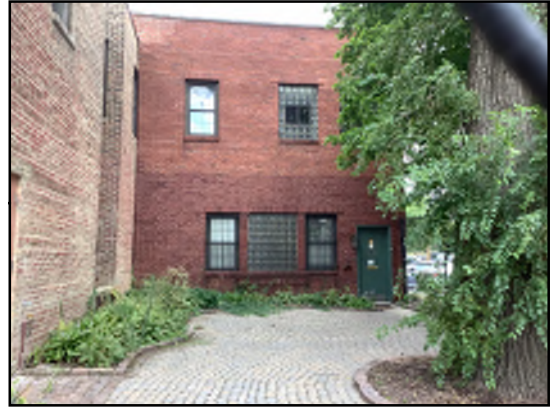
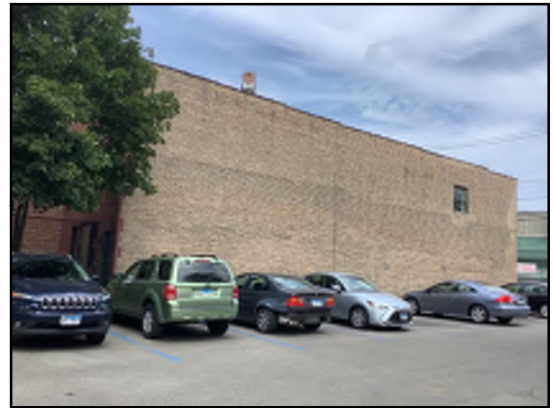
Front façade

Side view

Integrity: Fair Condition: Fair
 Notes

Found. Mat. Not Visible
 Wall Mat. Brick
 Window Type Double-hung, Sliding, Glass Block
 Window Mat. Vinyl/Fiberglass
 Door Mat. Vinyl/Fiberglass
 Roof Type Flat
 Roof Features None Visible
 Roof Material Not Visible
 Outbuildings None
 Additions None
 Features Parapet

Eligibility Assessment Notes: Modifications to this resource have compromised the integrity necessary to convey its significance. The historic qualities of design, materials, workmanship, and feeling have been diminished by the alterations. This building does not possess sufficient distinguishing architectural characteristics to qualify as individually eligible for listing on the National Register. Windows have been replaced and window openings have been modified. Character defining features have been removed.

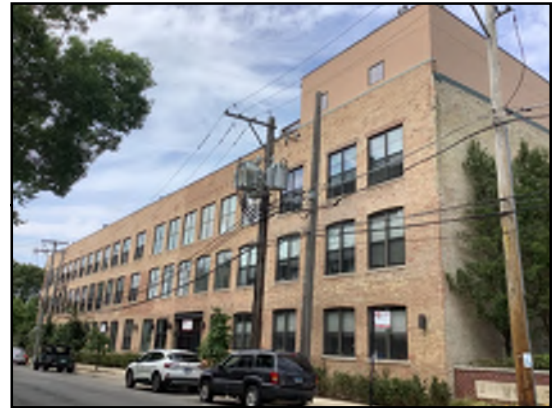
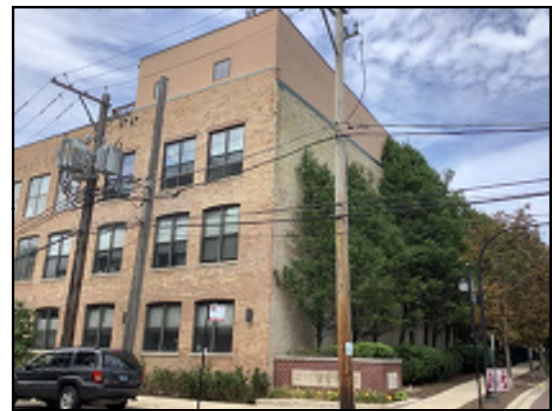
Integrity: Fair Condition: Good
 Notes

Found. Mat. Not Visible
 Wall Mat. Brick
 Window Type Double-hung, Fixed
 Window Mat. Vinyl/Fiberglass
 Door Mat. Metal
 Roof Type Flat
 Roof Features None Visible
 Roof Material Not Visible
 Outbuildings None
 Additions Second Floor
 Features None

Front façade

Side view

Eligibility Assessment Notes: Modifications to this resource have compromised the integrity necessary to convey its significance. The historic qualities of design, materials, workmanship, and feeling have been diminished by the alterations. This building does not possess sufficient distinguishing architectural characteristics to qualify as individually eligible for listing on the National Register. Windows have been replaced. The building has been rehabilitated to a multiple-family residence. The building is Utilitarian in design. Addition on top floor is visible from the row.

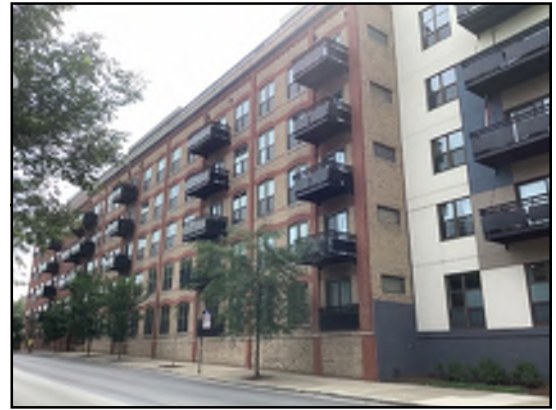
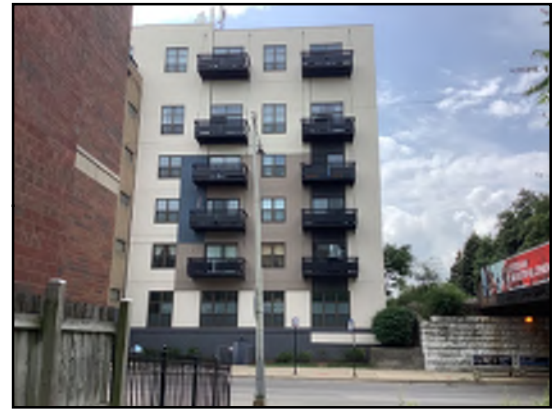
Integrity: Fair Condition: Good
 Notes

Found. Mat. Brick
 Wall Mat. Stone, Brick
 Window Type Double-hung, Sliding
 Window Mat. Vinyl/Fiberglass
 Door Mat. Glass, Metal, Vinyl/Fiberglass
 Roof Type Flat
 Roof Features None Visible
 Roof Material Not Visible
 Outbuildings None
 Additions Rear, Second Floor
 Features Enclosed Porch, Cornice/Belt Course, Ornamental Masonry

Front façade

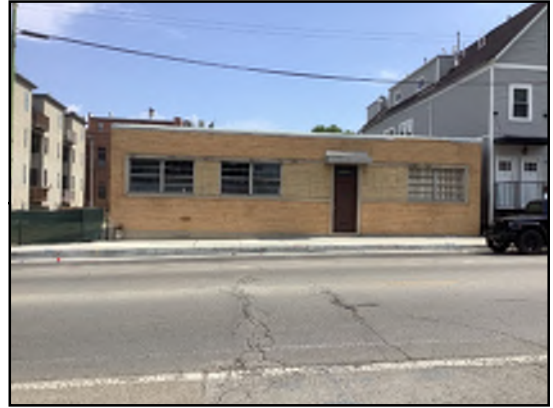
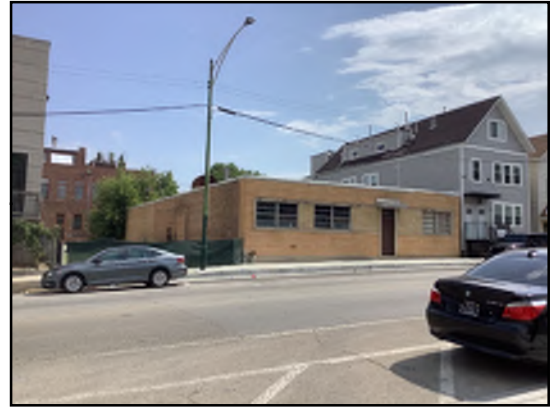
Integrity: Good Condition: Good
 Notes

Found. Mat. Concrete
 Wall Mat. Stone, Brick
 Window Type Double-hung
 Window Mat. Vinyl/Fiberglass
 Door Mat. Vinyl/Fiberglass
 Roof Type Flat
 Roof Features None Visible
 Roof Material Not Visible
 Outbuildings None
 Additions None
 Features Cornice/Belt Course, Parapet

Front façade

Side view

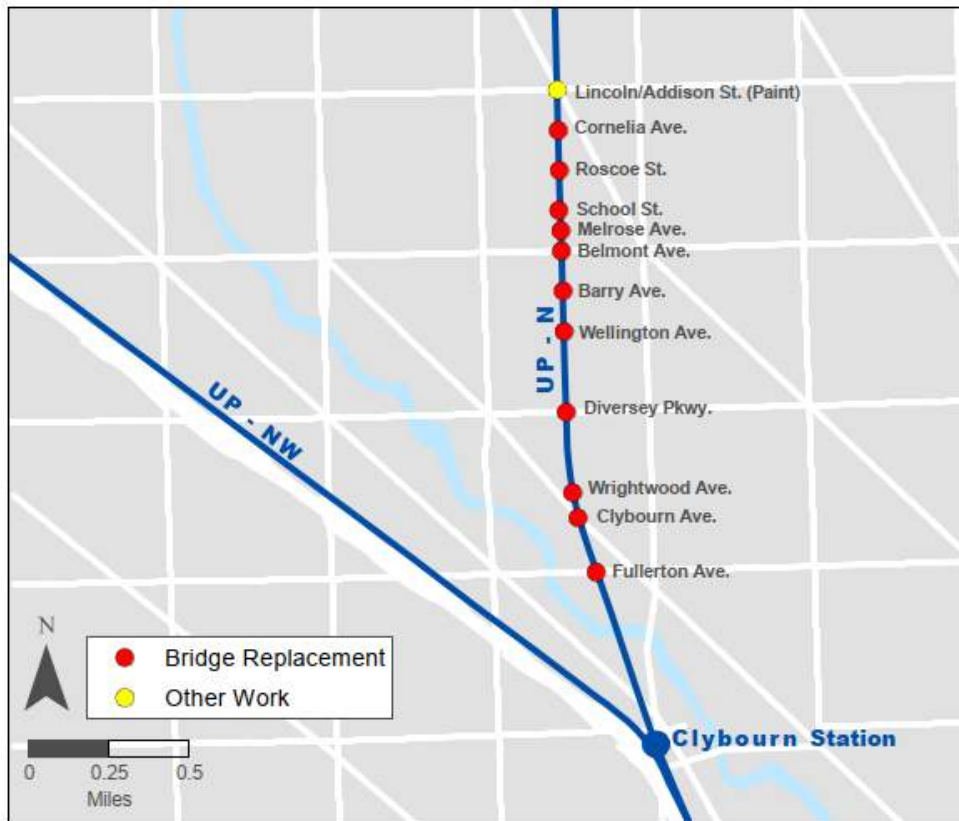
The general location of the project elements can be found in the figure below. The general footprint of disturbed area for each bridge/wall location and the track realignment can be found in Attachment 1.

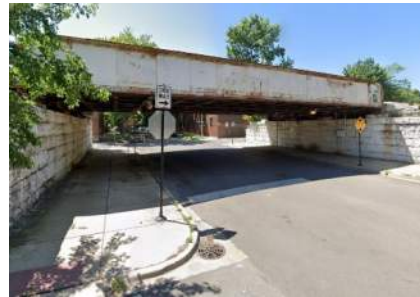
- Inspections of the existing bridges on Metra's UP-North line within the Project Study Area confirmed that 11 of the 12 bridges included in the Project need to be replaced and not just rehabbed (see photo on the right).

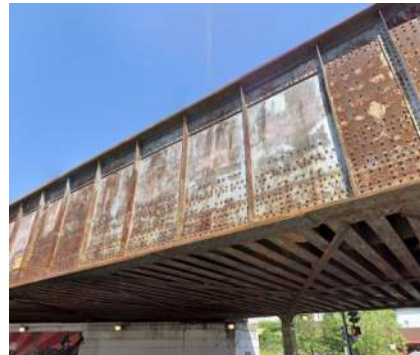
- Lead paint testing on similarly-aged bridges identified the need for lead abatement, so it is expected that lead abatement, prepping, and painting of the existing steel bridge at Lincoln/Addison Street on the UP-North line will be needed as part of the rehabilitation (see photo on the right).

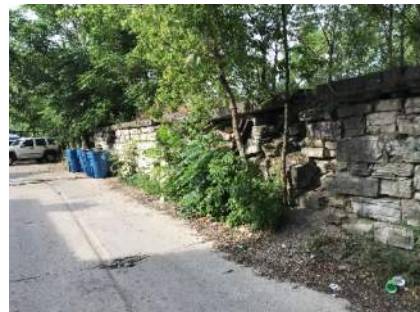
- Inspection of the retaining walls within the Project Study Area identified the need to replace the existing retaining walls from Fullerton Avenue to north of Lincoln/Addison Street along Metra's UP-North line (see photo on the right). The retaining walls are continuous along the project except for a small area where there is a slope. All walls are located on the property line, and the new walls will be constructed in the same location. The height of the walls may increase to prevent erosion.

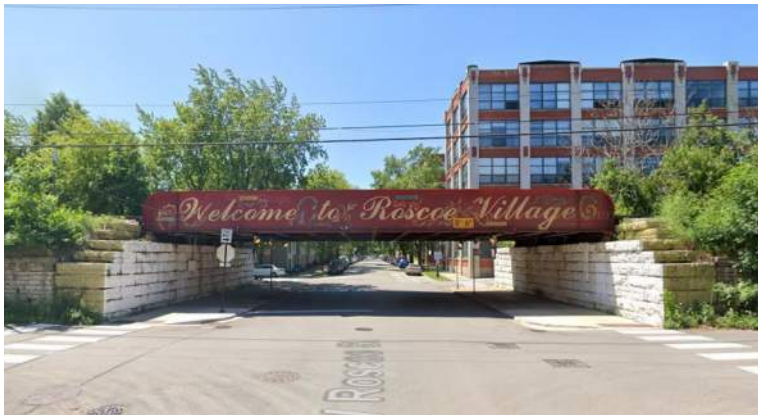
The bridge at Roscoe Street includes a welcome sign for the Roscoe Village neighborhood that will need to be removed when the bridge is replaced (see photo below). Coordination will be conducted with the community on the removal of this feature.

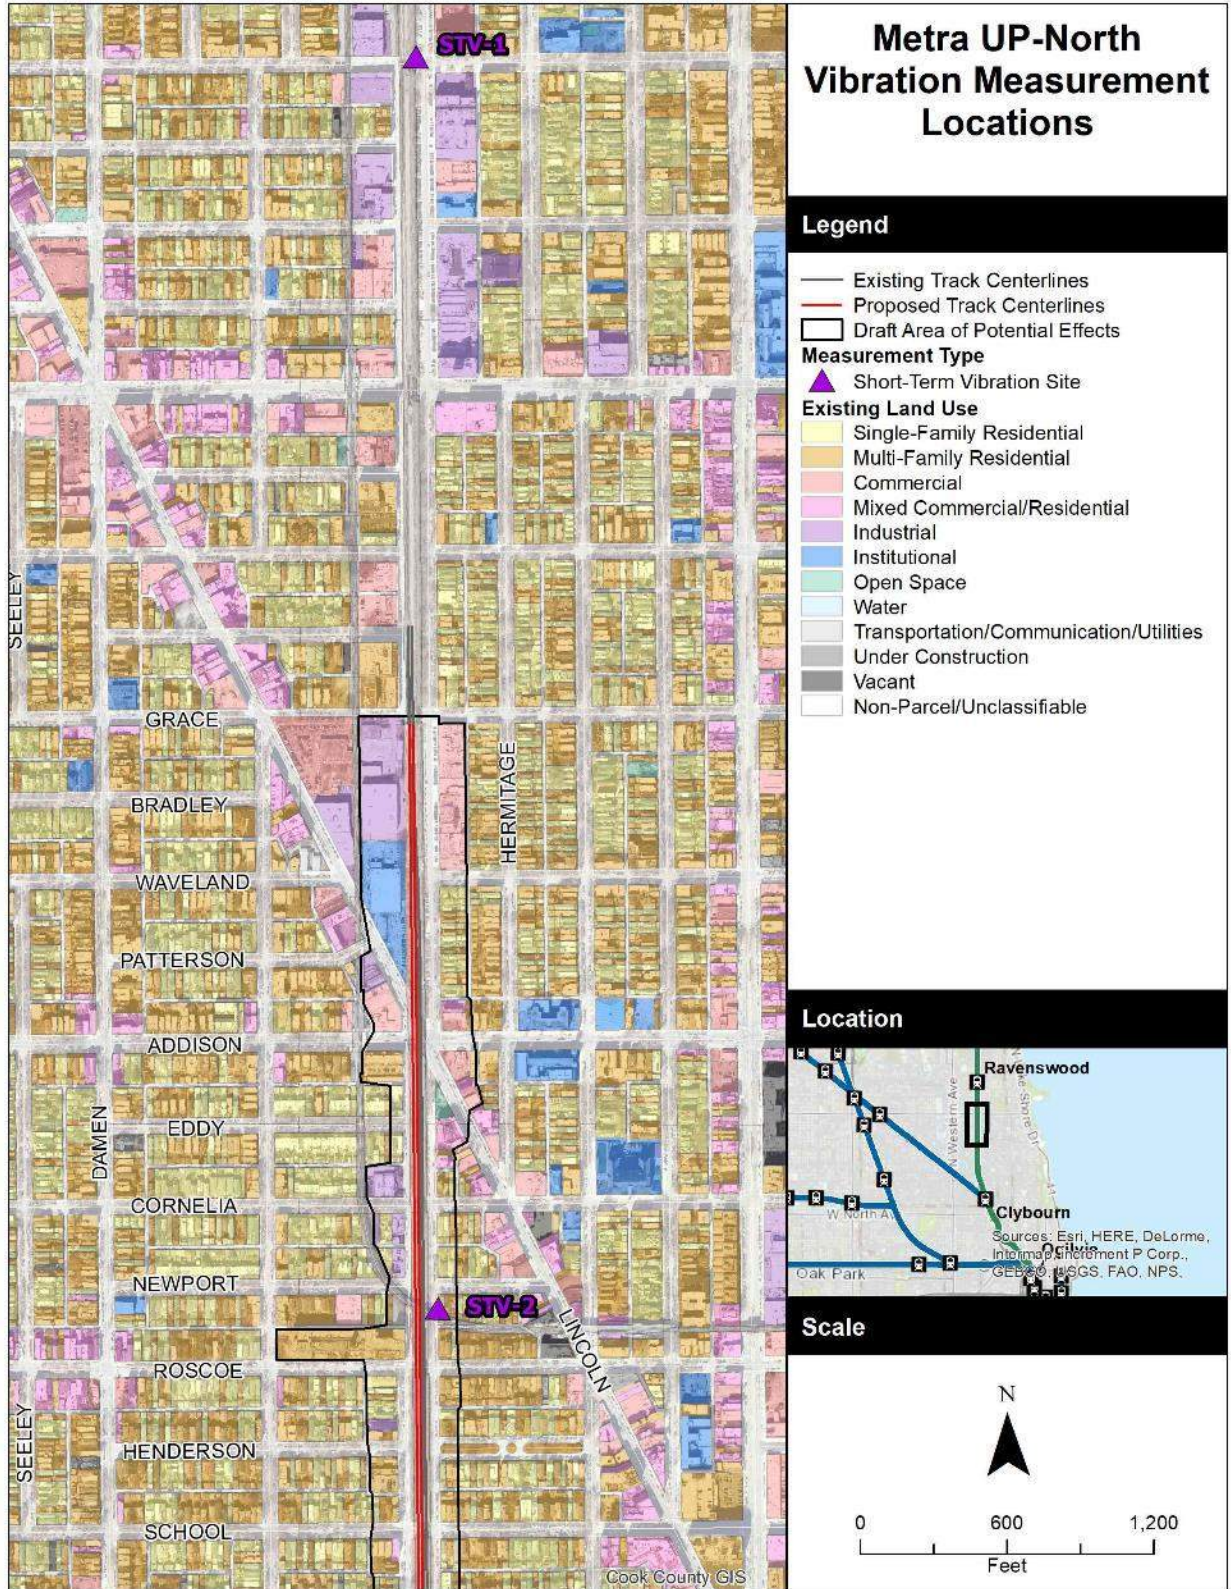
Figure 6: Vibration Measurement Locations (Map 1 of 2)

The vibration measurement program consisted of short-term (1 to 2-hour) monitoring of the overall and one-third octave band vibration velocity levels. The short-term vibration measurements were made at seven (7) sites (designated STV-1 through STV-7). The vibration measurement locations are shown in plan view on Figures 6 and 7, and measurement site photographs are included in Appendix A. Descriptions of each site are provided below:

STV-6: Wang (Chi Che) Park. Ground vibration measurements were made on the grass surface at four positions at this park, located 25, 50, 100 and 200 feet from the Metra near track centerline to the east of the tracks. The objective of these measurements was to document ground-borne vibration levels and propagation characteristics (i.e., the variation of vibration level with distance) for Metra train operations on embankment.

Site STV-7: 1777A W. Wrightwood Avenue. The accelerometer at this site was mounted on the ground adjacent to the northwest corner of this residential building, located on the south side of W. Wrightwood Avenue and east of the Metra tracks that run along an embankment just south of the Metra bridge. This site is representative of residences closest to the Metra track at the southern end of the Project. The dominant sources of ground-borne vibration at this site were Metra trains.

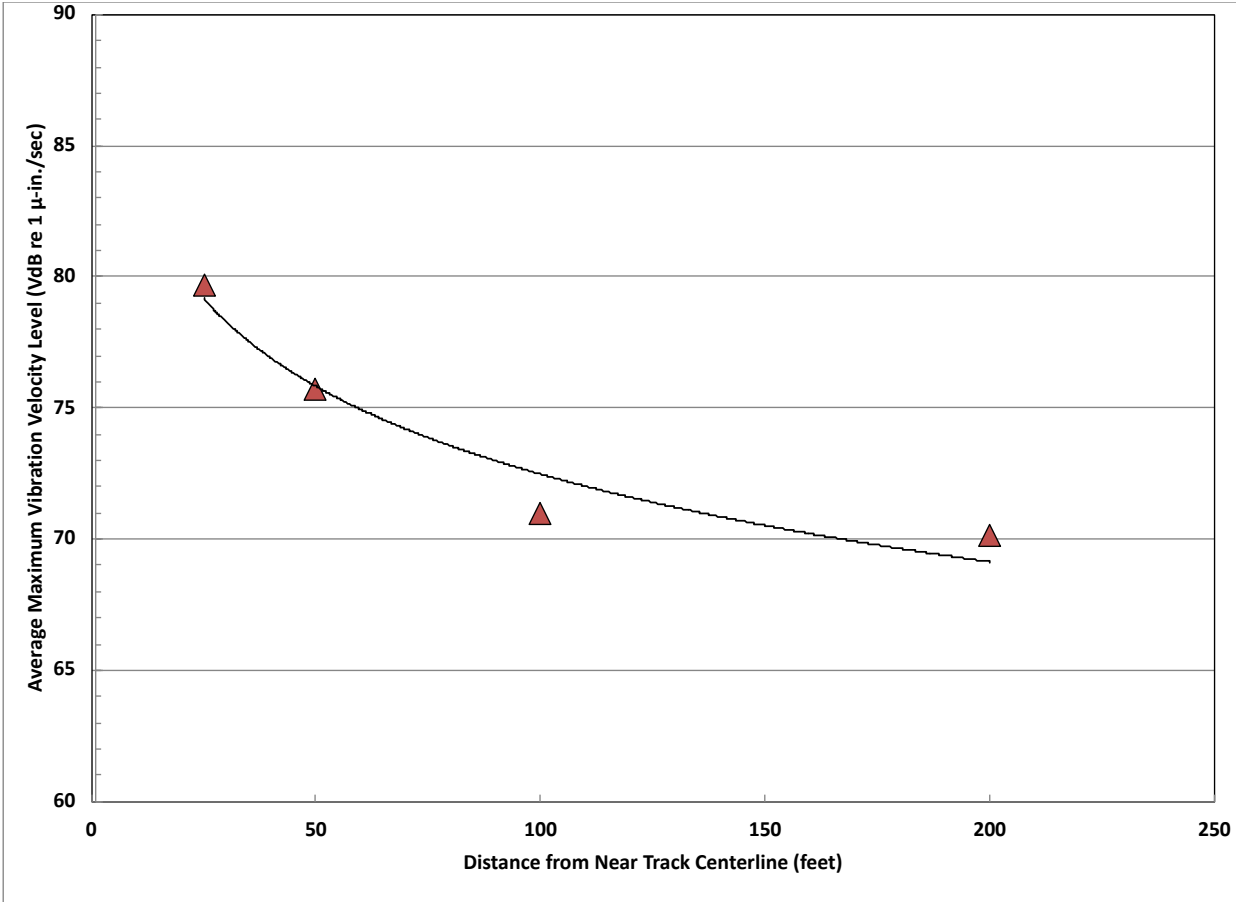
Figure 8: Average Maximum Metra Train Vibration Levels vs. Distance at Site STV-6
