Appendix A

LOCATION NAME: METRA UP-N RECONSTRUCTION
KENOSHA SUBDIVISION

TITLE: PROJECT LIMITS

Shift Track Alignment & Replace Retaining Walls and 11 Bridges, UP North Line
Between Bridge Milepost 3.27 (North of Deering) and Milepost 5.22 (Grace Street Bridge)
METRA-4840
SHPO Log #026081921

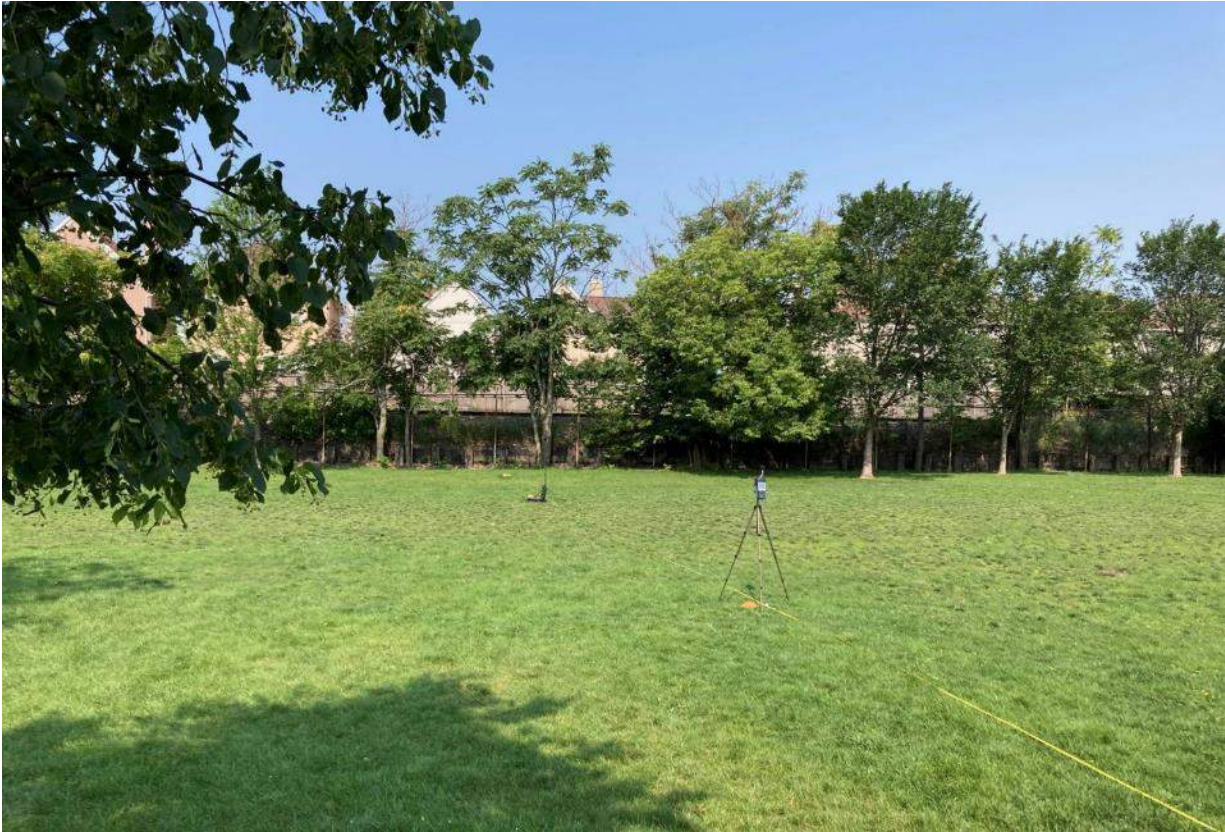
Figure A-16: Site STN-5, Wang (Chi Che) Park 50 ft. and 100 ft measurement positions, looking west toward Metra tracks

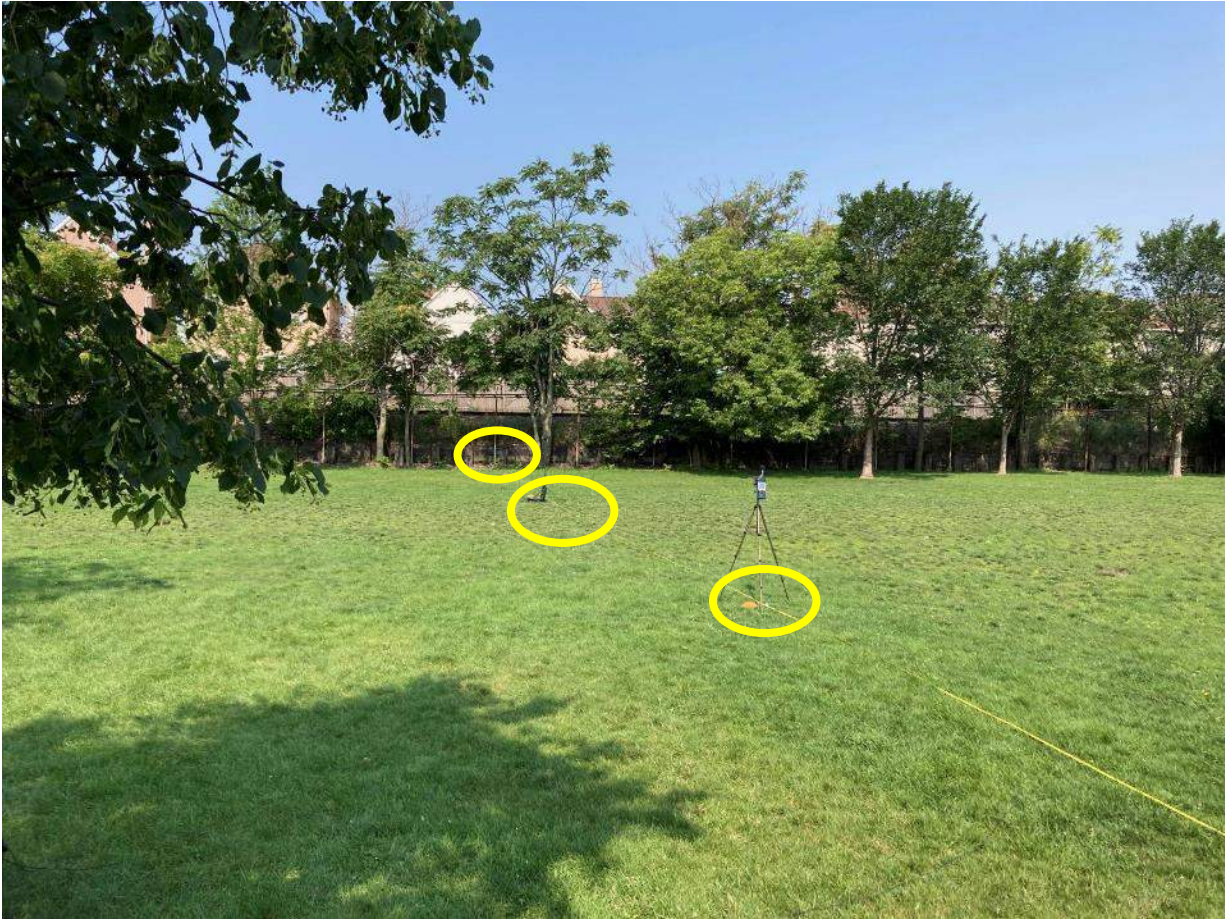
Figure A-27: Site STV-6, Wang (Chi Che) Park, looking west toward Metra tracks (200 ft position behind the camera)

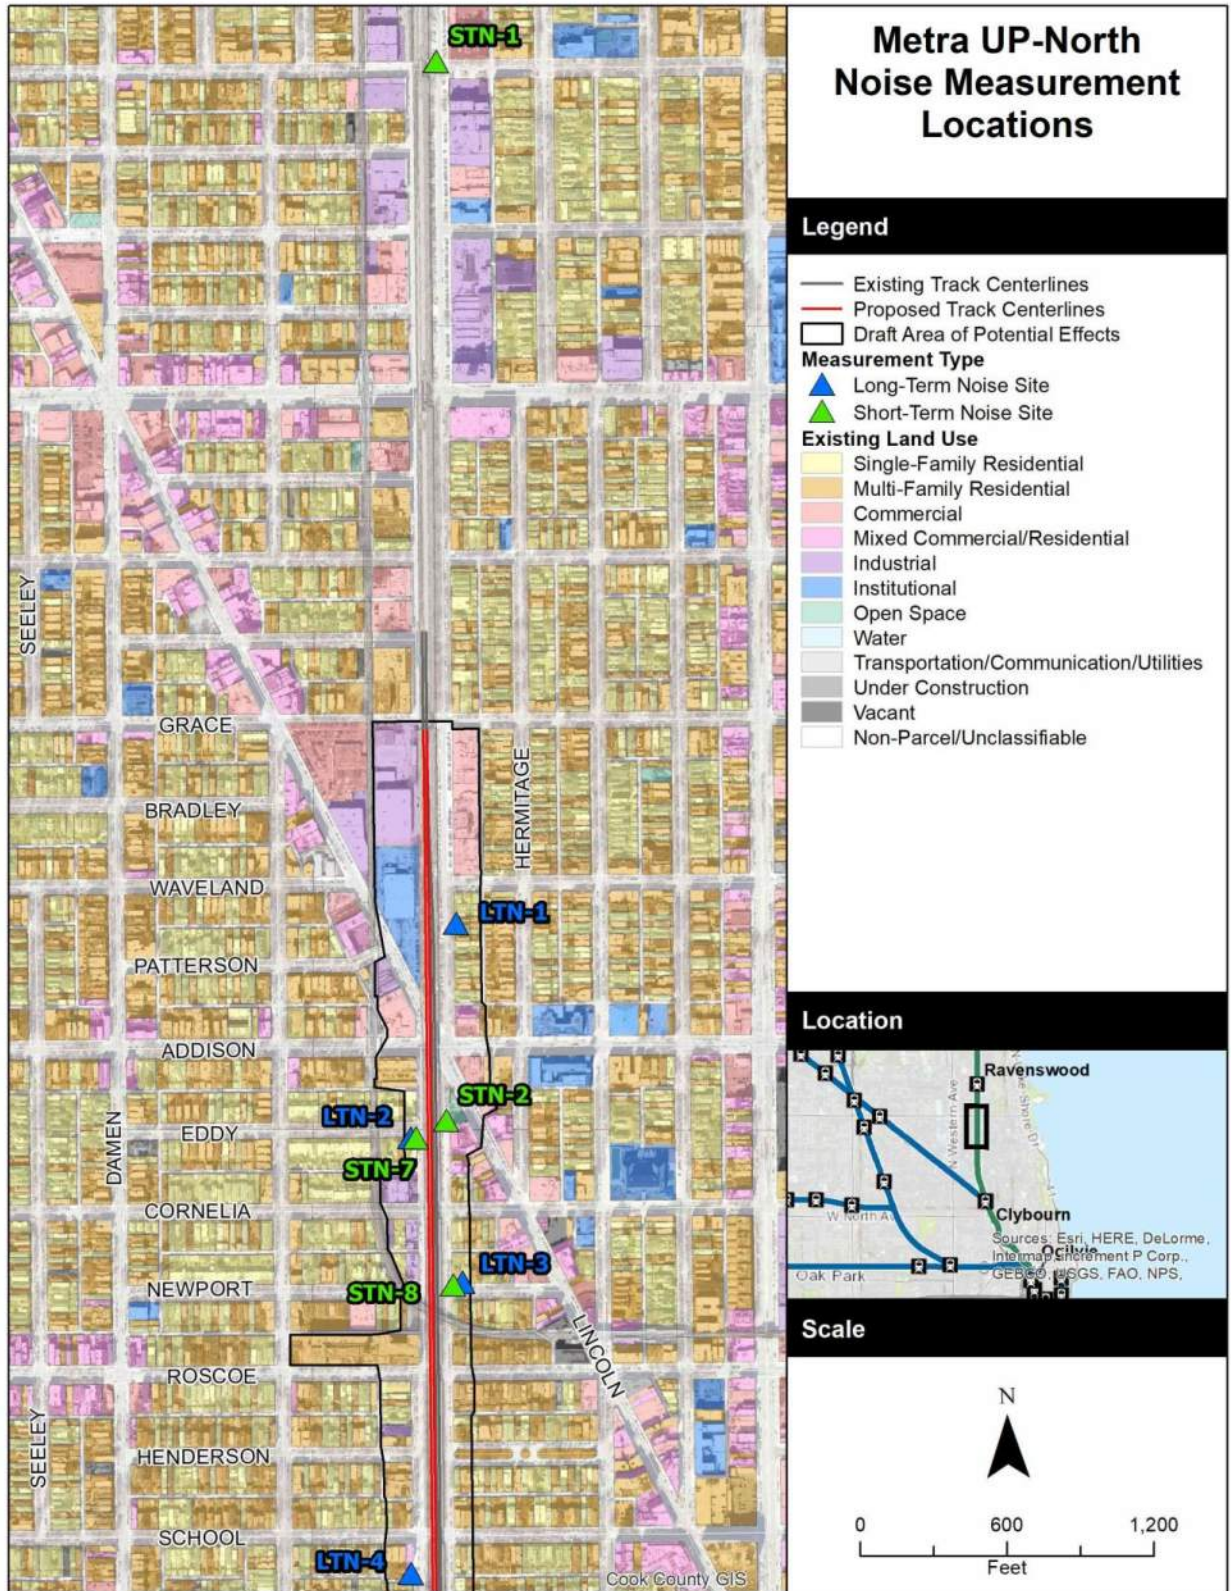
Figure 9: Noise Measurement Locations (Map 1 of 2)

The noise measurement program consisted of both long-term (24-hour) and short-term (1 to 2-hour) monitoring of the A-weighted sound levels. Long-term noise measurements were made at eleven (11) sites (designated as LTN-1 through LTN-11) and short-term noise measurements were made at ten (10) sites (designated as STN-1 through STN-10). **Figure 9** and **Figure 10** show the noise measurement locations in plan view.
